# **LESMURDIE HOUSE**

## Heritage Impact Statement

For  
Saleeba Adams Architects  
November 2017

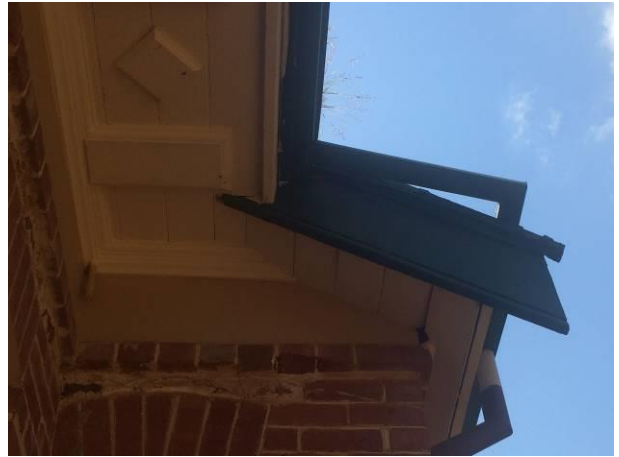
Figure 14 Exposed downpipe in gutter

| <b>GENERAL</b> | |
|---|---|
| GUTTERS & DOWNPIPES | <ul style="list-style-type: none"> <li>Clean out gutters and downpipes. Inspect condition. Replace damaged sections</li> <li>Clean out rain heads. Inspect for leaks and remediate where necessary</li> <li>Additional downpipe to be added to 1912 addition to address capacity of existing system.</li> </ul> |

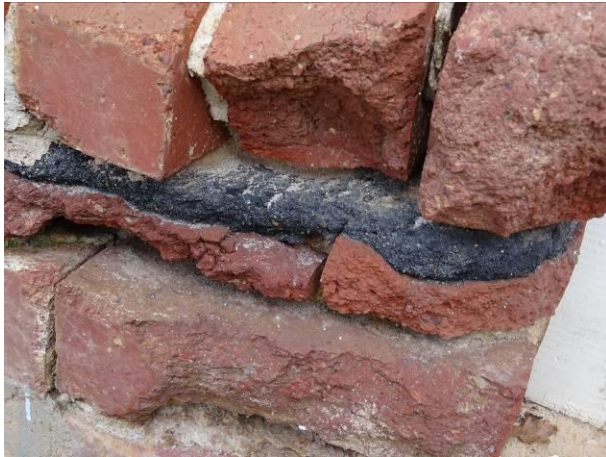
Figure 23 Damaged brickwork

| <b>GENERAL</b> | |
|---|---|
| WALLS | <ul style="list-style-type: none"> <li>Remove cement mortar. Rake out joints and repoint using lime mortar to match original</li> <li>Repoint areas of fretted brickwork / stonework using lime mortar to match original</li> <li>Clean rust from wall vents. Apply protective rust treatment</li> <li>Remove paint from brickwork / stonework</li> <li>Reinstate missing brickwork and stonework</li> <li>Replace damaged bricks</li> <li>Carefully clean all brickwork and stonework to remove dirt, organic growth, white efflorescence salts and stains. Use steam cleaning methods, do not use high pressure water cleaning or acid.</li> </ul> |

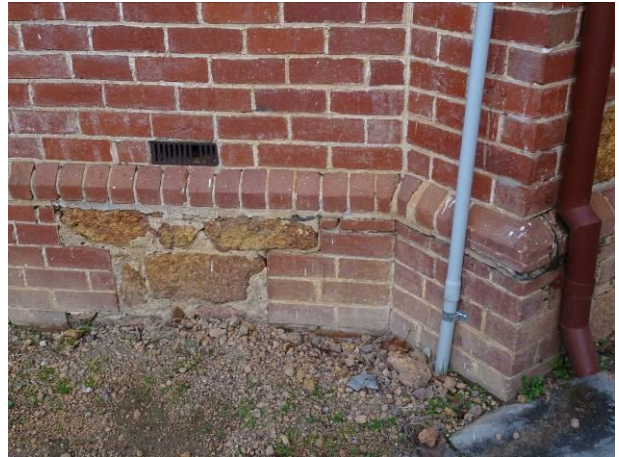
Figure 24 Fretted & damaged brickwork

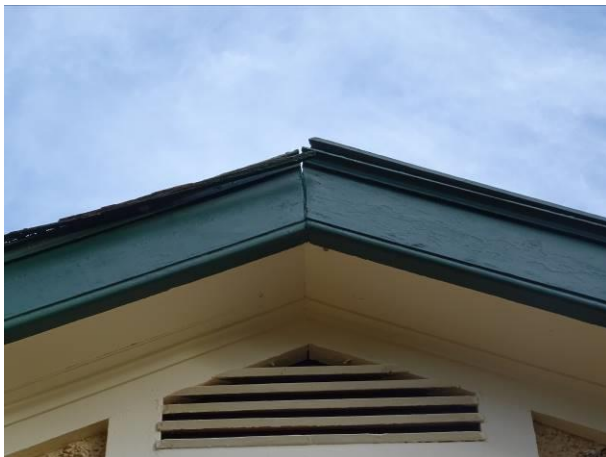
Figure 25 Damaged timberwork

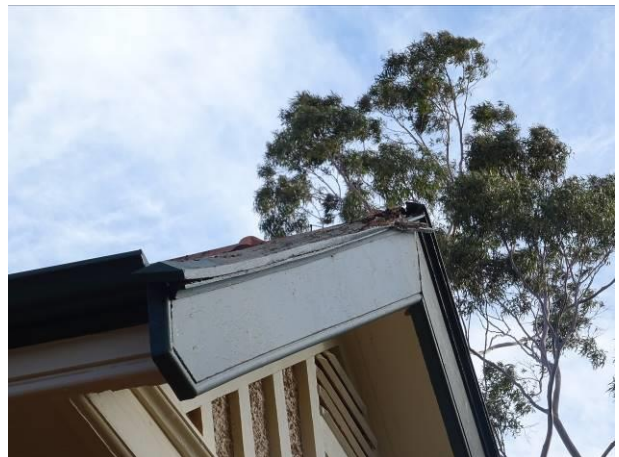
Figure 26 Damaged timberwork to gable end

| <b>GENERAL</b> | |
|---|---|
| ASBESTOS | <ul style="list-style-type: none"> <li>Remove and replace asbestos in gable ends</li> </ul> |

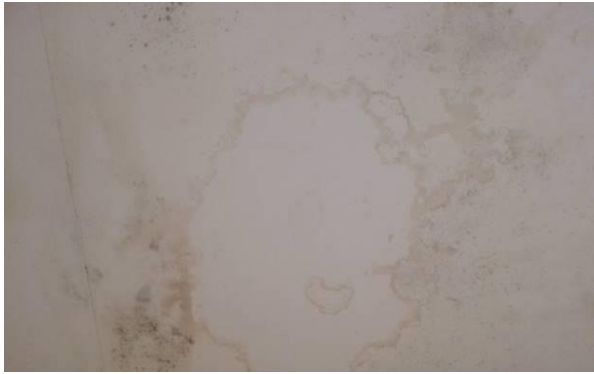
Figure 101 Water staining to ceiling of kitchen

| CEILING | <ul style="list-style-type: none"> <li>• Evidence of damp. NW and SE particularly bad</li> <li>• Staining above rangehood exhaust.</li> <li>• Check roof for potential water ingress points</li> </ul> |

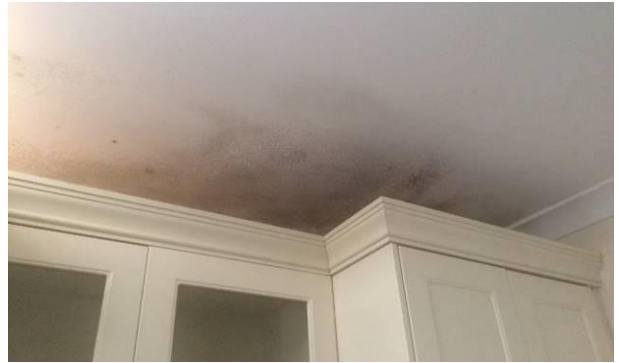
Figure 102 Water staining to ceiling of kitchen

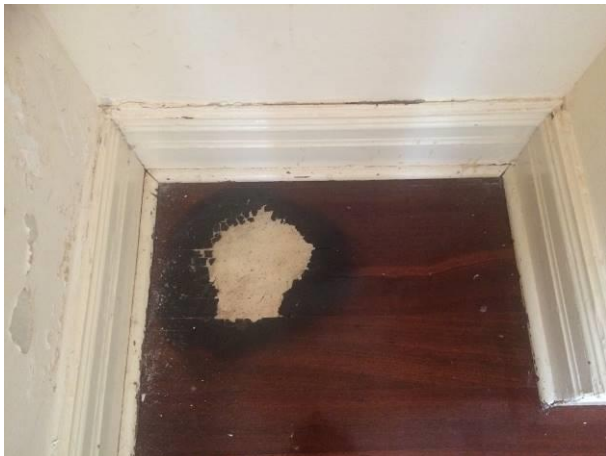
Figure 123 Bed 8, damaged floor

| FLOORS | <ul style="list-style-type: none"> <li>Assess condition of existing sub floor structure to timber floors. Remediate where necessary</li> </ul> |

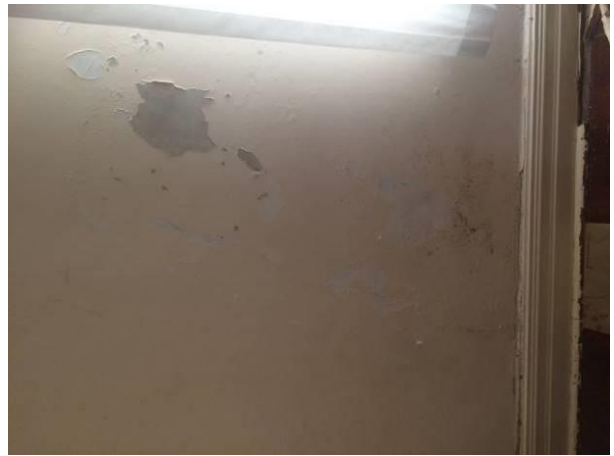
Figure 124 Evidence of damp to bedroom 8

— EVIDENCE OF DAMP. REMOVE DAMAGED AND DRUMMY PLASTER. ALLOW WALL TO DRY OUT PRIOR TO REINSTATING NEW LIME PLASTER TO MATCH EXISTING.

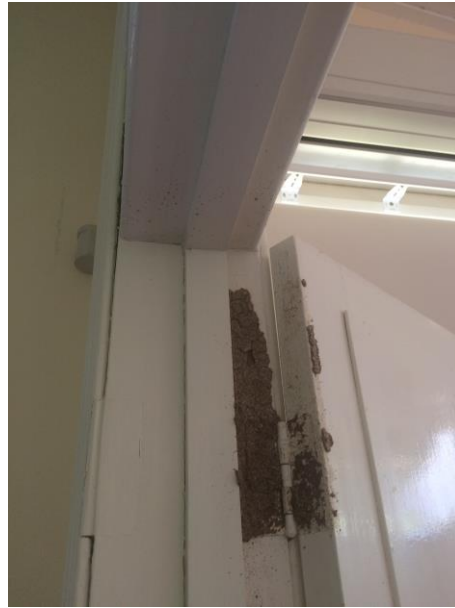
*Figure 128 Sunroom, termite damage*

| VERMIN | <ul style="list-style-type: none"> <li>Remove wasp nests from behind window shutters. Install pest treatment</li> <li>Carry out termite inspection to determine extent of damage. Repair / replace damaged timber with timber to match existing. Install new termite treatment</li> </ul> |

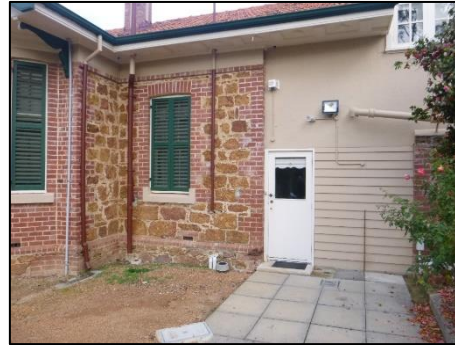
Western Entry- It is presumed this is not a heritage doorway, which could be replaced to create an accessible entrance to a proposed children's play area / undercroft

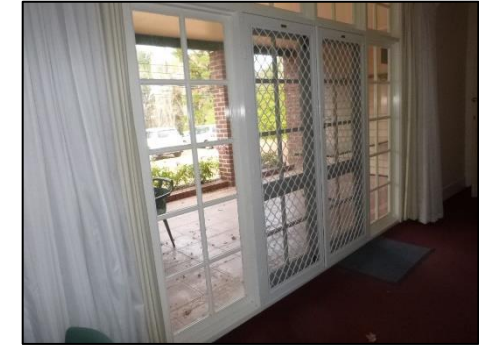
Terrace double doors could be retained with staff opening the doors to enable children to play externally
