# ARBORIST REPORT

Arboricultural assessment on: Proposed development site trees

Site Address: Cnr Heath Road/Canning Road, Kalamunda

Date: 04.03.24

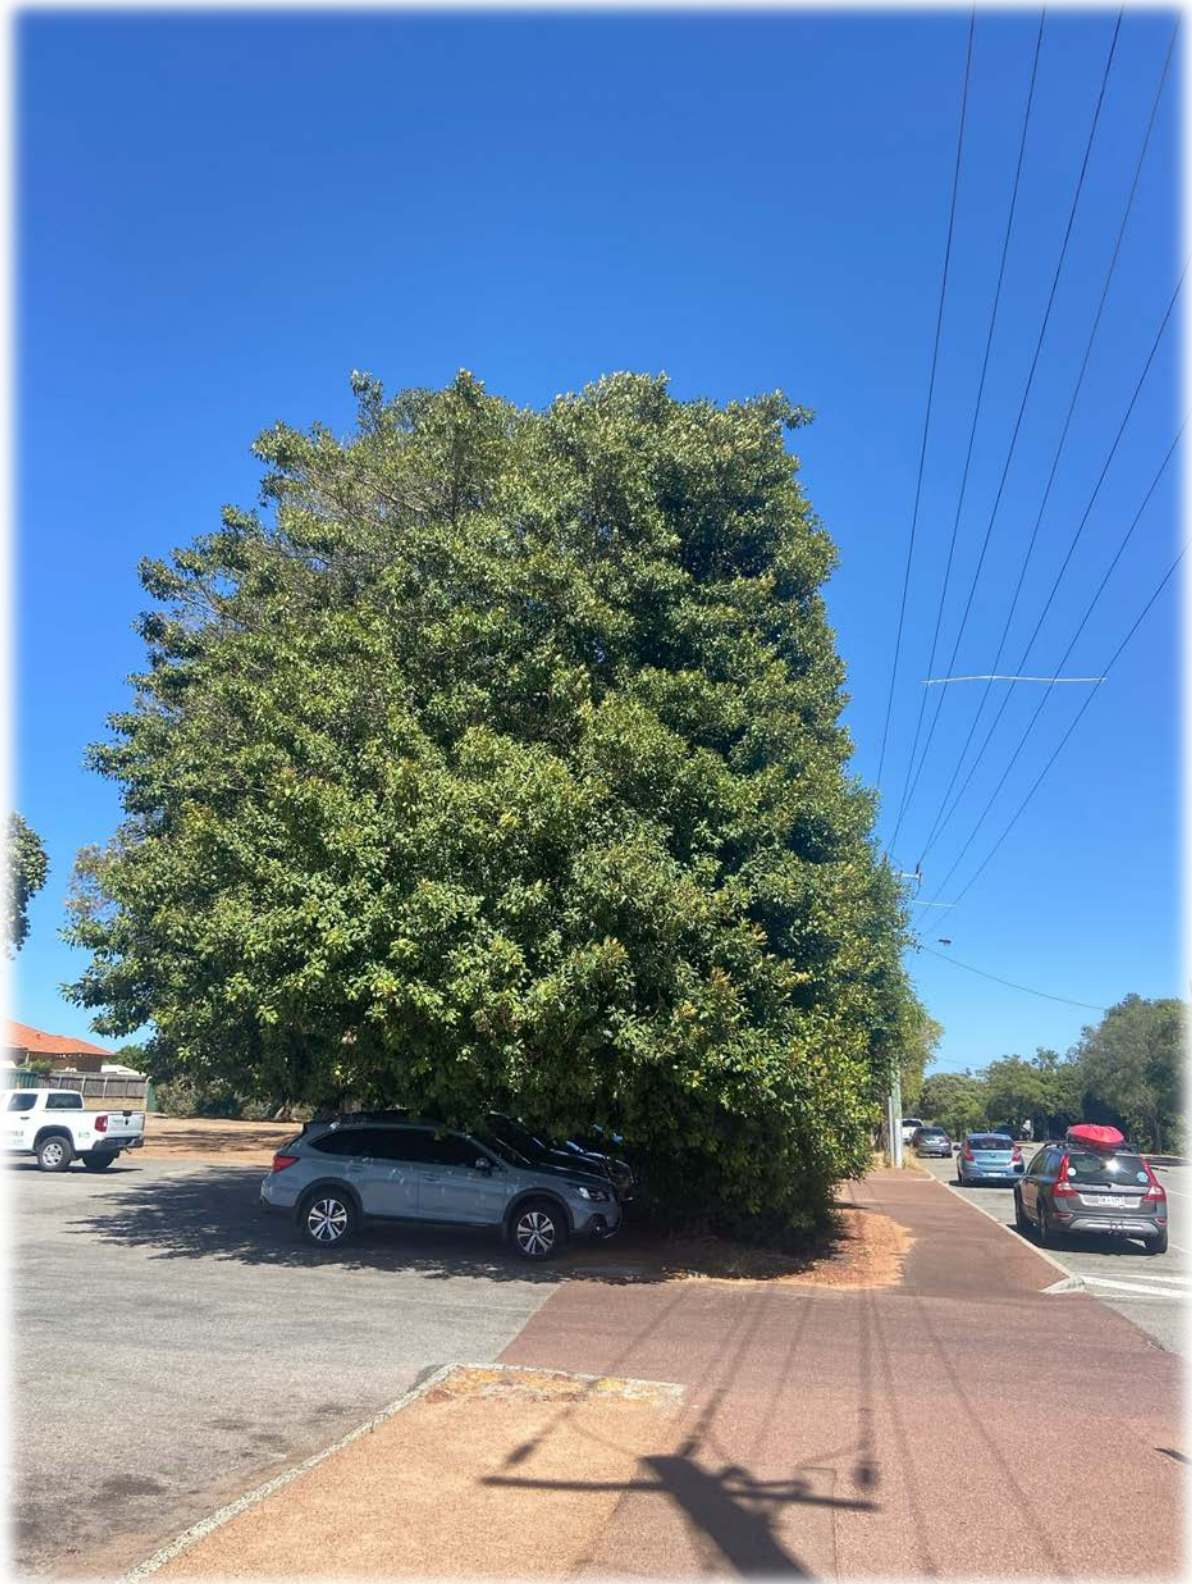
## Appendix A

### 5.1 Subject tree – Appendix A

- Species – *Ficus microphylla* – Moreton Bay fig
- Height – 20.9m
- Diameter Breast Height (DBH) – 1.14 m taken at 1.4m
- Tree Protection Zone (TPZ) – 14 m
- Diameter Root Crown (DRC) – 1.27m
- Structural Root Zone (SRZ) – 3.66m
- Age – Mature
- Health – Good
- Useful Life Expectancy (ULE) – 50+ years
- Live Canopy Ratio (LCR) – 90%
- Canopy spread – S 10.8m, E 8m, N 2m, W 6.5m

The first tree assessed is located close to the council verge on the northern boundary of the property line, next to the bitumen footpath. The mature *Ficus* encroaches into the car park, and has been crown lifted, allowing cars to park underneath for shade.

The northern canopy extends out over the footpath and appears to have been pruned back on a number of occasions.

The tree sits in a degraded soil planter bed, 2m wide and 10m long.

The radial surface roots have lifted the dividing kerbing between the planter bed and bitumen.

The tree bifurcates at 0.6m, with the stems extending to the east and west.

Multiple branches emanate from the 3m east, and west trunks, all heavily weighted with secondary growth. The canopy has been lifted on the southern side to accommodate car parking, lifted to a height of approximately 1.8m.

The northern side reaches down to the pavement. The upper canopy has been regularly cut back from encroaching into the overhead powerlines.

The branch architecture shows good balance with sound unions, no signs of branch failure was observed.

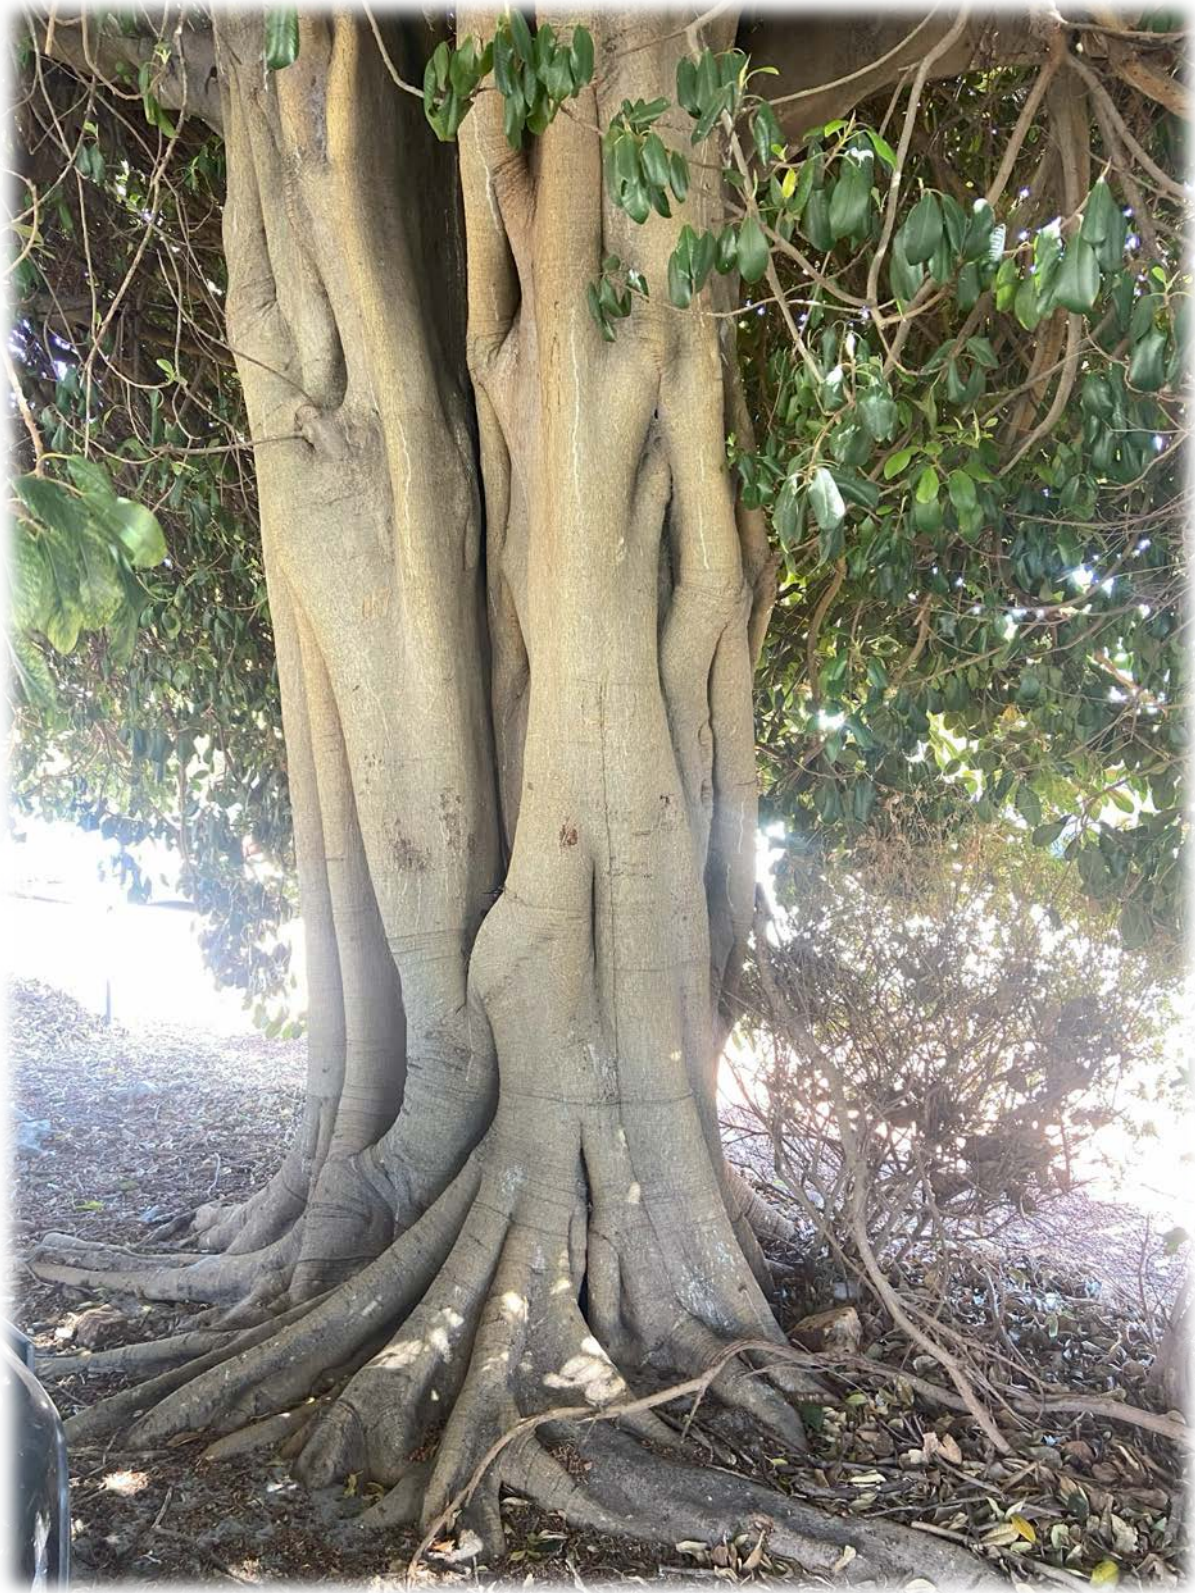
Appendix B

Typical of the species the roots buttress out radially from the trunk, but are constrained by the confines of their environment, Appendix B.

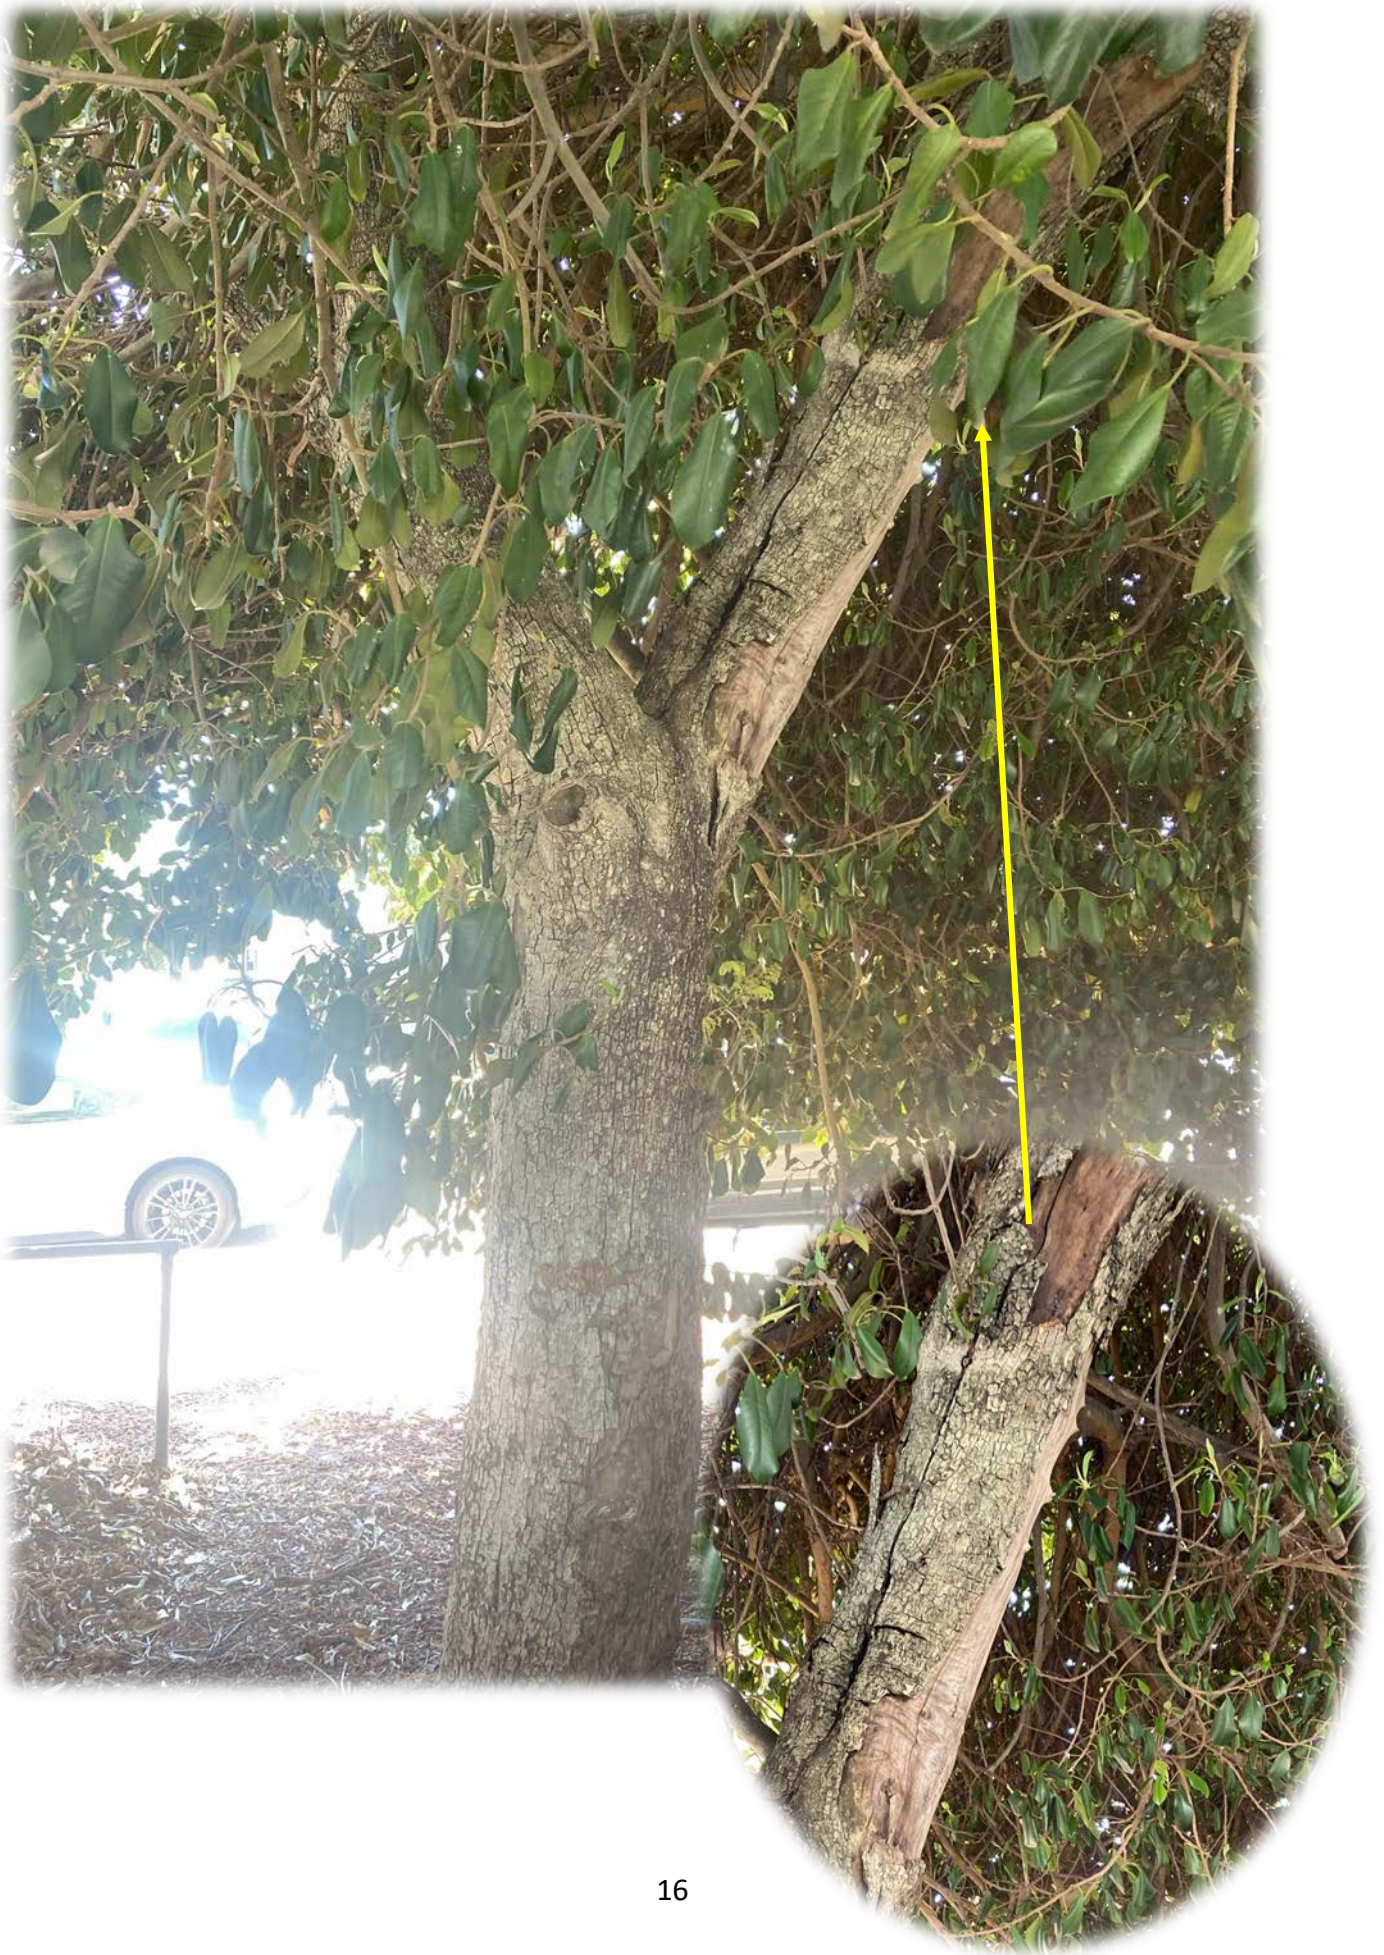
Appendix C

### **5.3 Subject tree – Appendix C**

- Species – *Jacaranda mimosifolia* - Jacaranda
- Height – 12m
- Diameter Breast Height (DBH) – 0.44 m taken at 1.4m
- Tree Protection Zone (TPZ) – 5.28m
- Diameter Root Crown (DRC) – 0.48m
- Structural Root Zone (SRZ) – 2.43m
- Age – Mature
- Health – poor
- Useful Life Expectancy (ULE) – 1 - 5 years
- Live Canopy Ratio (LCR) – 10%
- Canopy spread – N 1.5m,

The Jacaranda is the second tree, located next to the Ficus, and almost covered by the large fig. With minimal canopy accessing light, an estimated 10% (seen poking through at Appendix D) the tree is in a state of decline. The trunk of 2m branches out into two stems, one to the north, and one to the south. The northern stem is dead, the southern stem supports minimal growth.

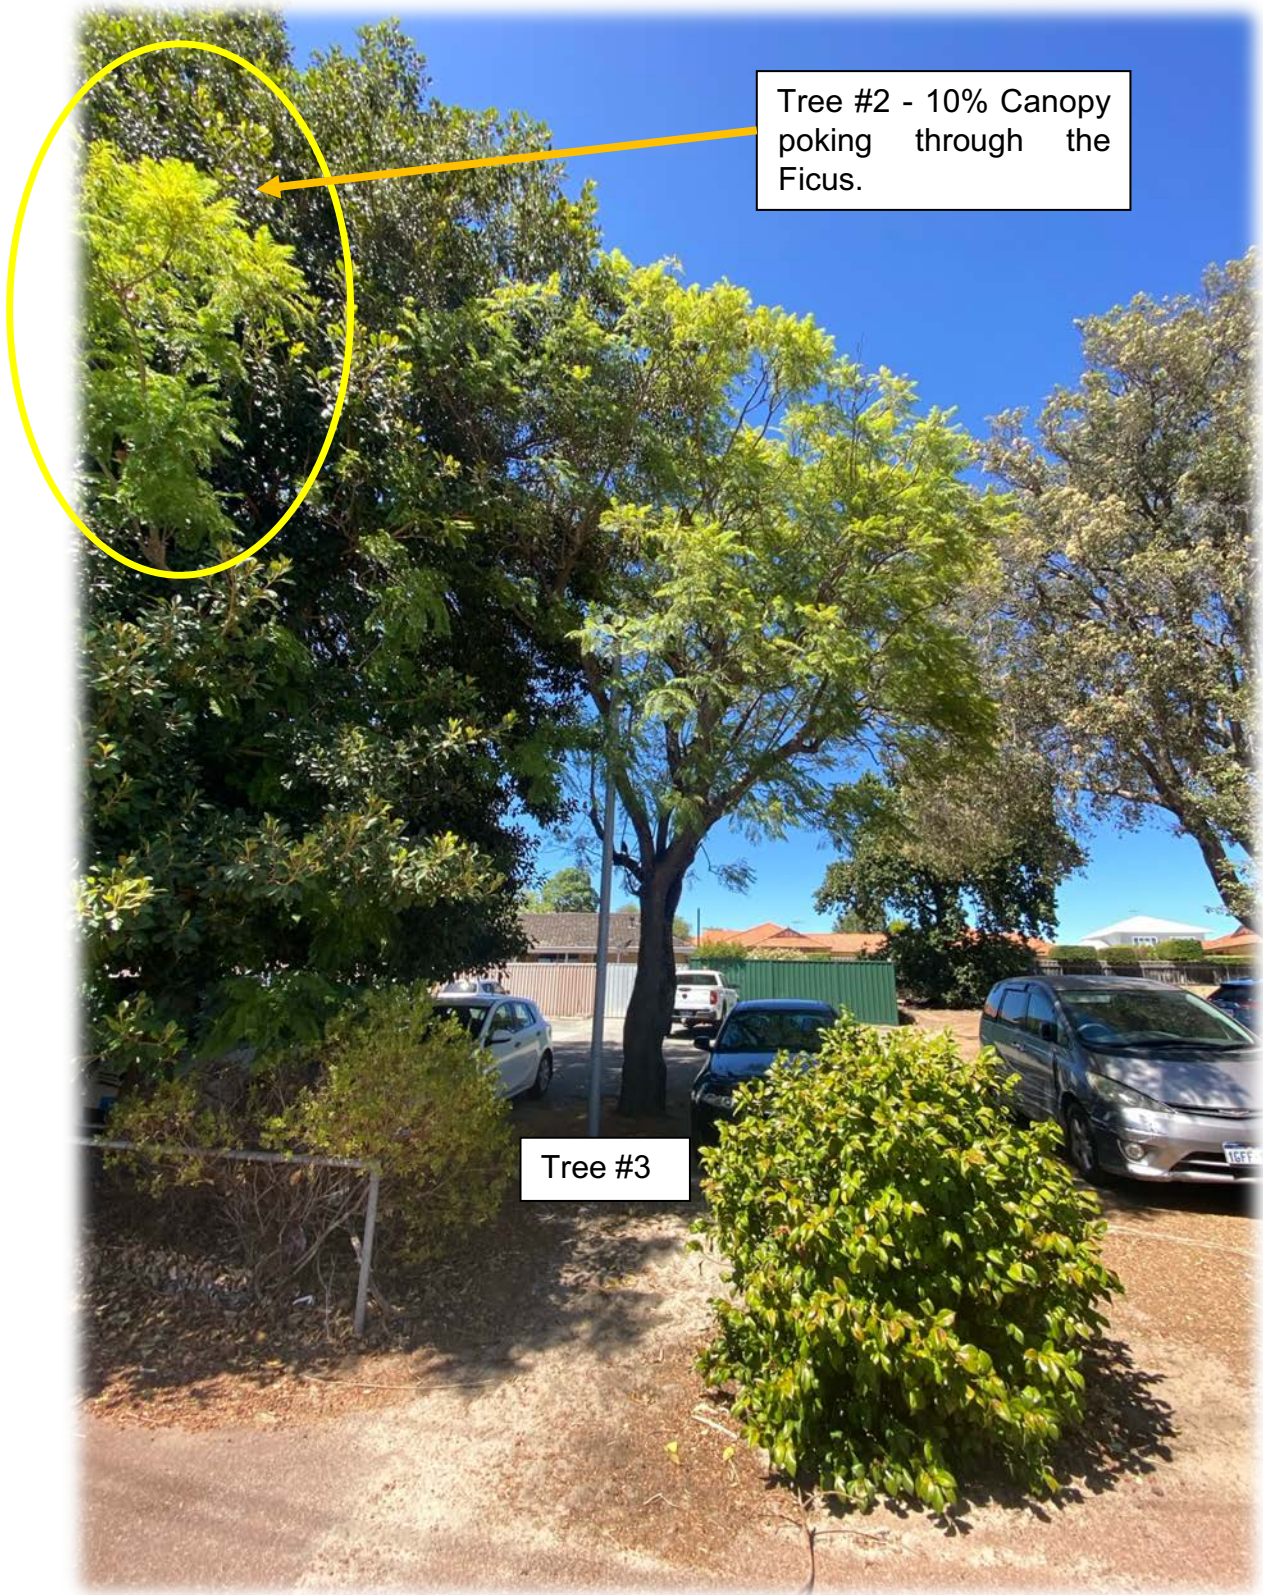
Appendix D

### **5.5 Subject tree – Appendix D**

- Species – *Jacaranda mimosifolia* - Jacaranda
- Height – 11m
- Diameter Breast Height (DBH) – 0.61 m taken at 1.4m
- Tree Protection Zone (TPZ) – 7.32m
- Diameter Root Crown (DRC) – 0.62m
- Structural Root Zone (SRZ) – 2.71m
- Age – Mature
- Health – Good
- Useful Life Expectancy (ULE) – 20+ years
- Live Canopy Ratio (LCR) – 70%
- Canopy spread – S 8m, E 3.5m, N 6m, W 6m

The tree sits in a compacted gravel bed, with no protection from the vehicles parking alongside. The trunk of 0.5m leads into a bifurcated stem that has an included bark union (typically a weak union unless compensating wood has been added), with bulges either side to strengthen the junction. The trunk shows previous pruning, on smaller and larger limbs, mainly to raise the canopy. The southern stem has a large wound 1.6m up, the result of a previous pruning cut, and is slow to occlude the wound. The tree shows poor

pruning practices, with flush cuts allowing potential harmful pathogens entry into the trees xylem tissue (inner wood).

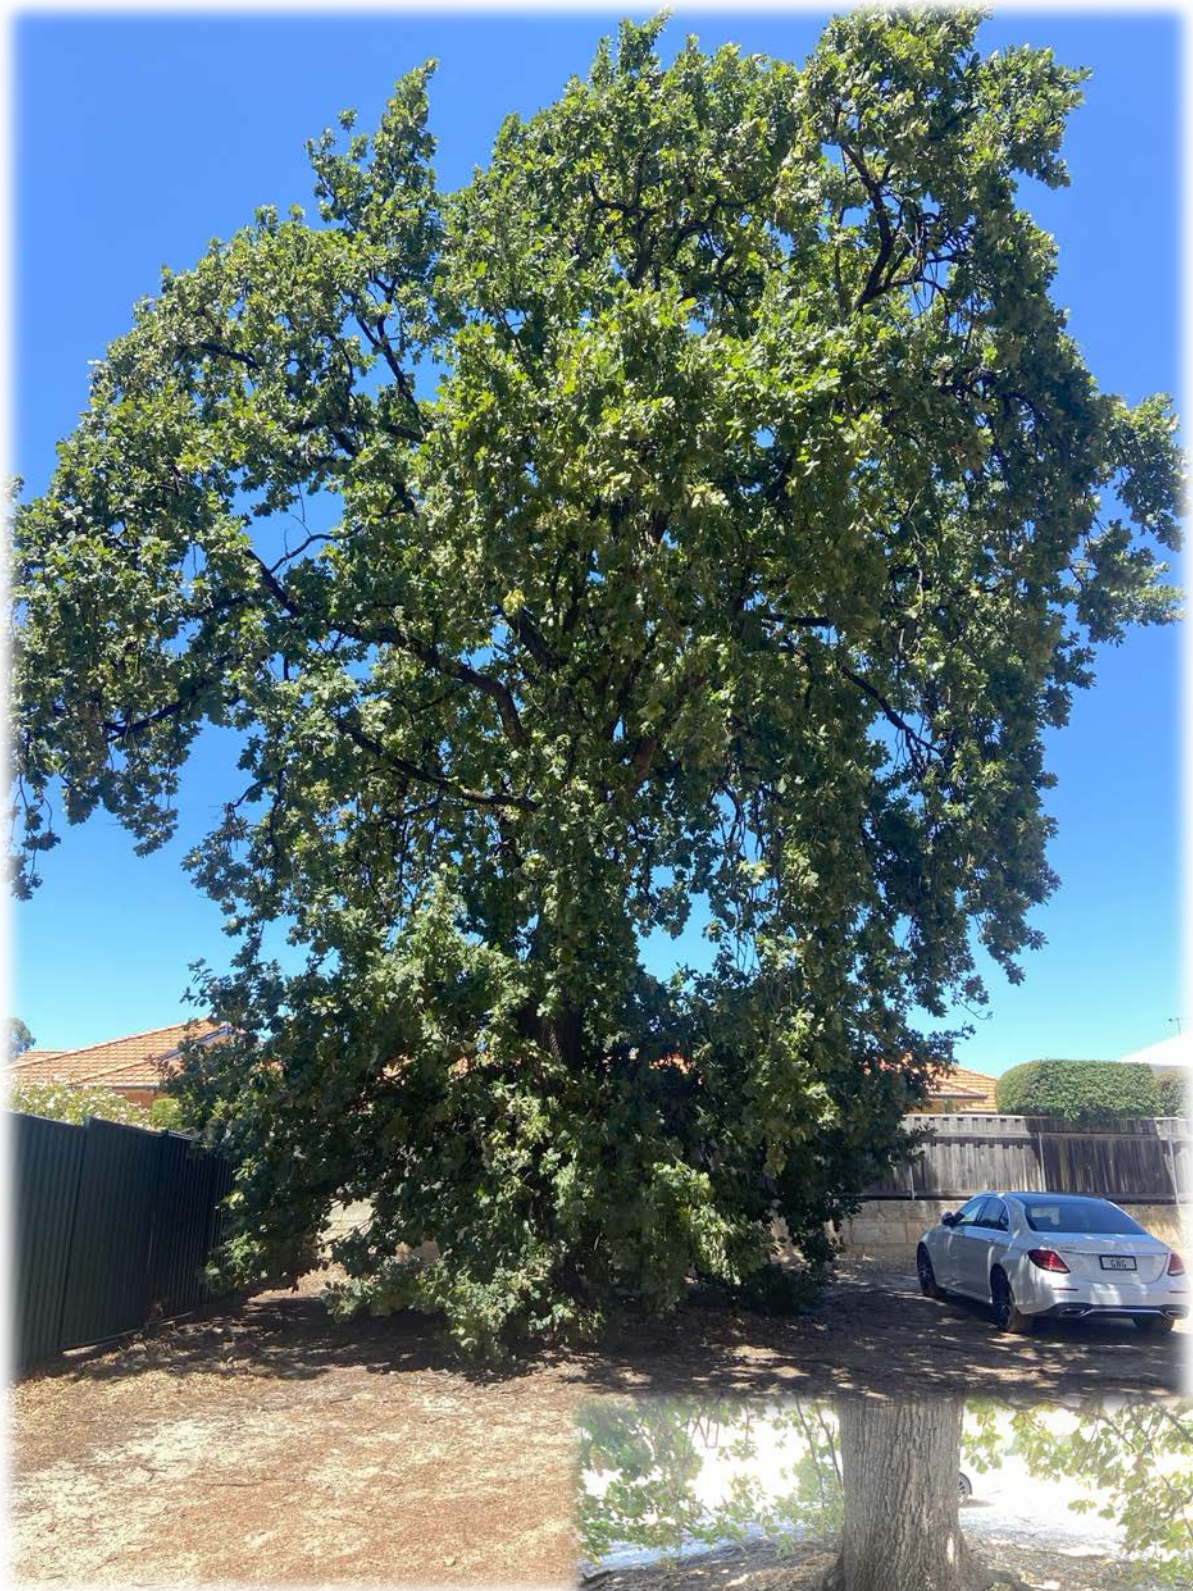
### **5.7 Subject tree – Appendix E**

- Species – *Quercus robur* (English oak)
- Height – 21m
- Diameter Breast Height (DBH) – 0.82 m taken at 1.4m
- Tree Protection Zone (TPZ) – 9.84m
- Diameter Root Crown (DRC) – 1m
- Structural Root Zone (SRZ) – 2.43m
- Age – Mature
- Health – Good
- Useful Life Expectancy (ULE) – 50+ years
- Live Canopy Ratio (LCR) – 100%
- Canopy spread – W 8m, N 10m, E 9m, S 7.5m.

The English oak tree is located next to the southern boundary fence, and property boundary fence of Lot 3. Surface roots radiate out from the trunk and can be seen above ground out to 8m underneath the canopy. Several have degraded due to vehicle damage.

Remaining largely untouched, the tree shows very little signs of pruning, with many small shoots growing out from the trunk creating a dense lower understory.

The trunk of 5m, bifurcates with a sound union between two north and south facing stems. At the top of the stems at 1.5m, multiple stems extend out forming a dense crown that is well balanced. Looking within the canopy the primary and secondary branches show no weak attachments, with no cavities, major dead branches, or hangers. The tree shows balance with good branch architecture. The leaves do show signs of psyllid attack.

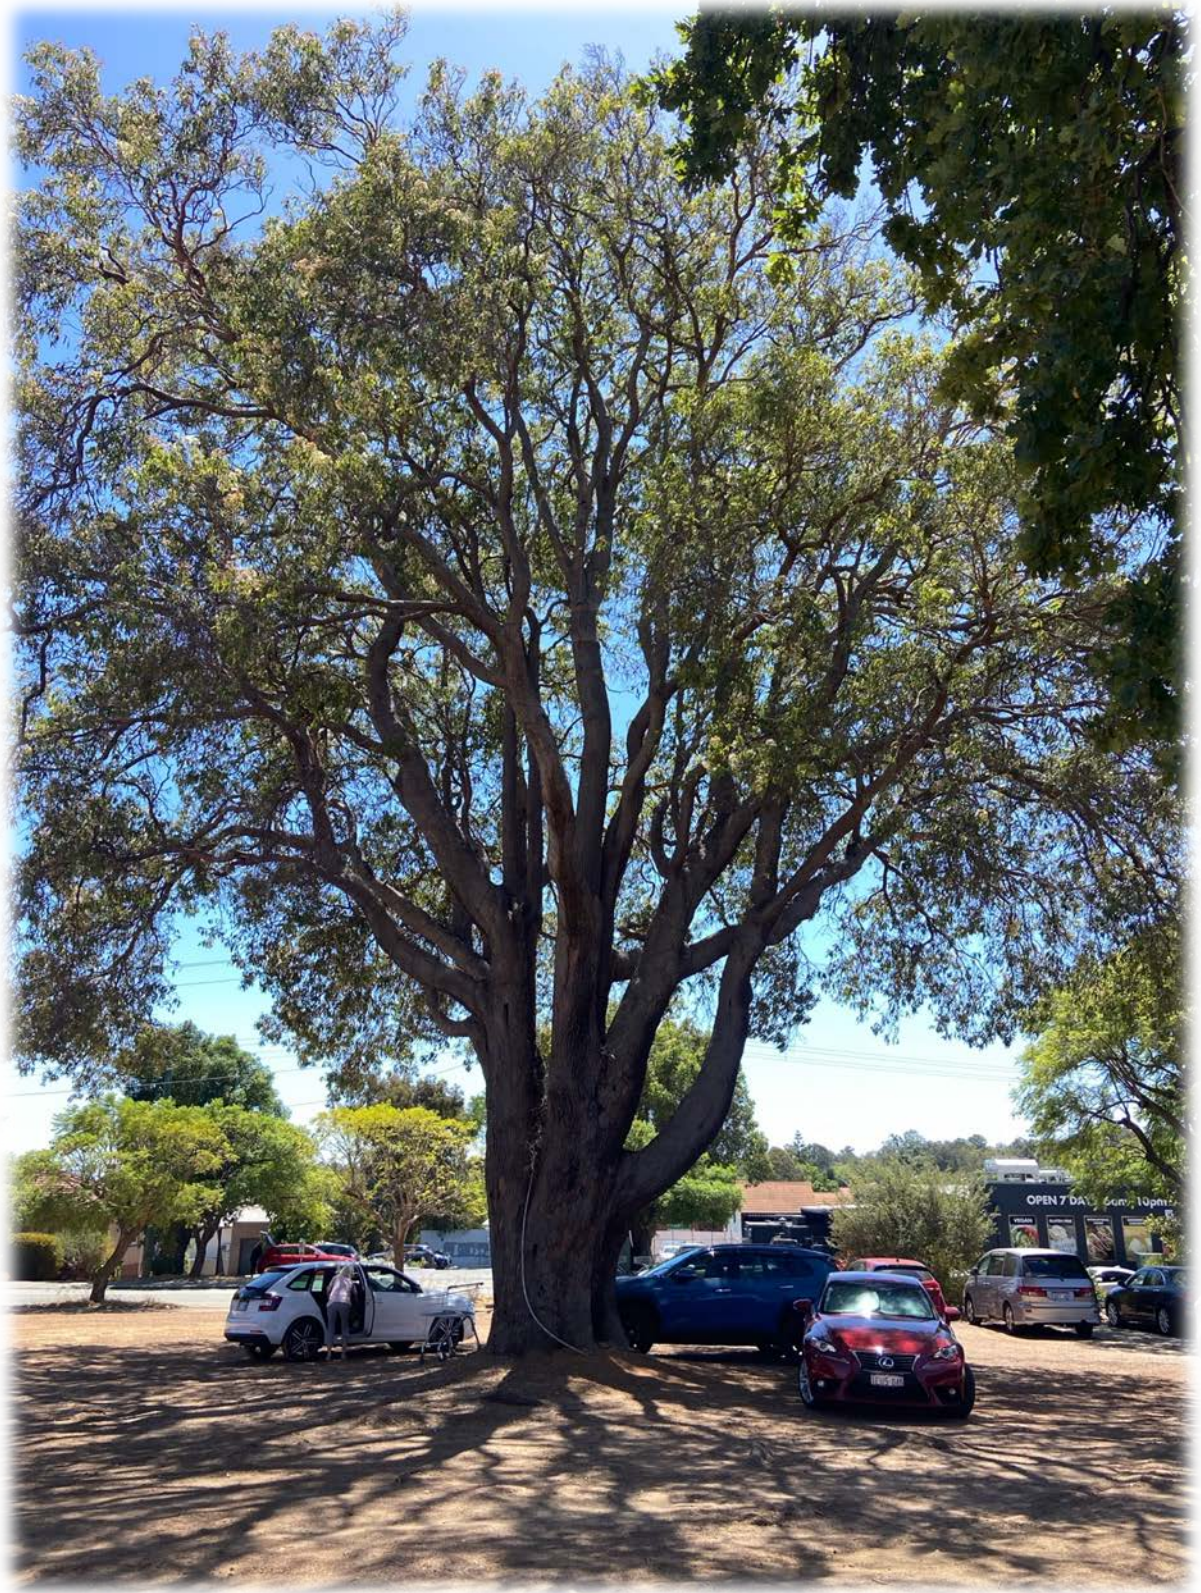
### **5.9 Subject tree – Appendix F**

- Species – *Corymbia calophylla* (Marri tree)
- Height – 24m
- Diameter Breast Height (DBH) – 1.62 m taken at 1.4m
- Tree Protection Zone (TPZ) – 15m
- Diameter Root Crown (DRC) – 1.79m
- Structural Root Zone (SRZ) – 4.23m
- Age – Mature
- Health – Good
- Useful Life Expectancy (ULE) – 50+ years
- Live Canopy Ratio (LCR) – 50%
- Canopy spread – N 11.6m, W 10.7m, S 10m, E 12.6m

The mature Marri tree, estimated to be in the region of 100 – 120 years of age, is situated in the middle of the unofficial car parking lot. The ground around the tree is hard compacted gravel, and coffee rock, consequently leading to a shallow root plate.

The above ground root flare extends out to the west, this is to support the heavy western lateral branch, along with a reinforcing rib of compensating wood to counter the lean. Several surface roots have been degraded due to vehicle damage, mainly superficial with the outer bark (periderm) being removed.

The trunk of 2.5m shows no signs of major damage, only minor, probably caused by vehicle impact.

At the top of the trunk 4 stems emerge, evenly spaced growing unopposed. The upper canopy consists of approximately 50% live growth, showing slightly stunted chlorotic leaves, possibly due to heat stress.

A hanging broken branch can be seen in the upper western part of the crown. All primary and secondary branches that were visible from the ground, appeared to be sound.

The vertical stem on the southern side in the upper canopy shows wear marks/damage from something being wrapped around it. The subject tree has a small amount of deadwood, not of any significant weight or size.

There were no observable signs of the fatal Marri canker (*Quambalaria coyercup*).

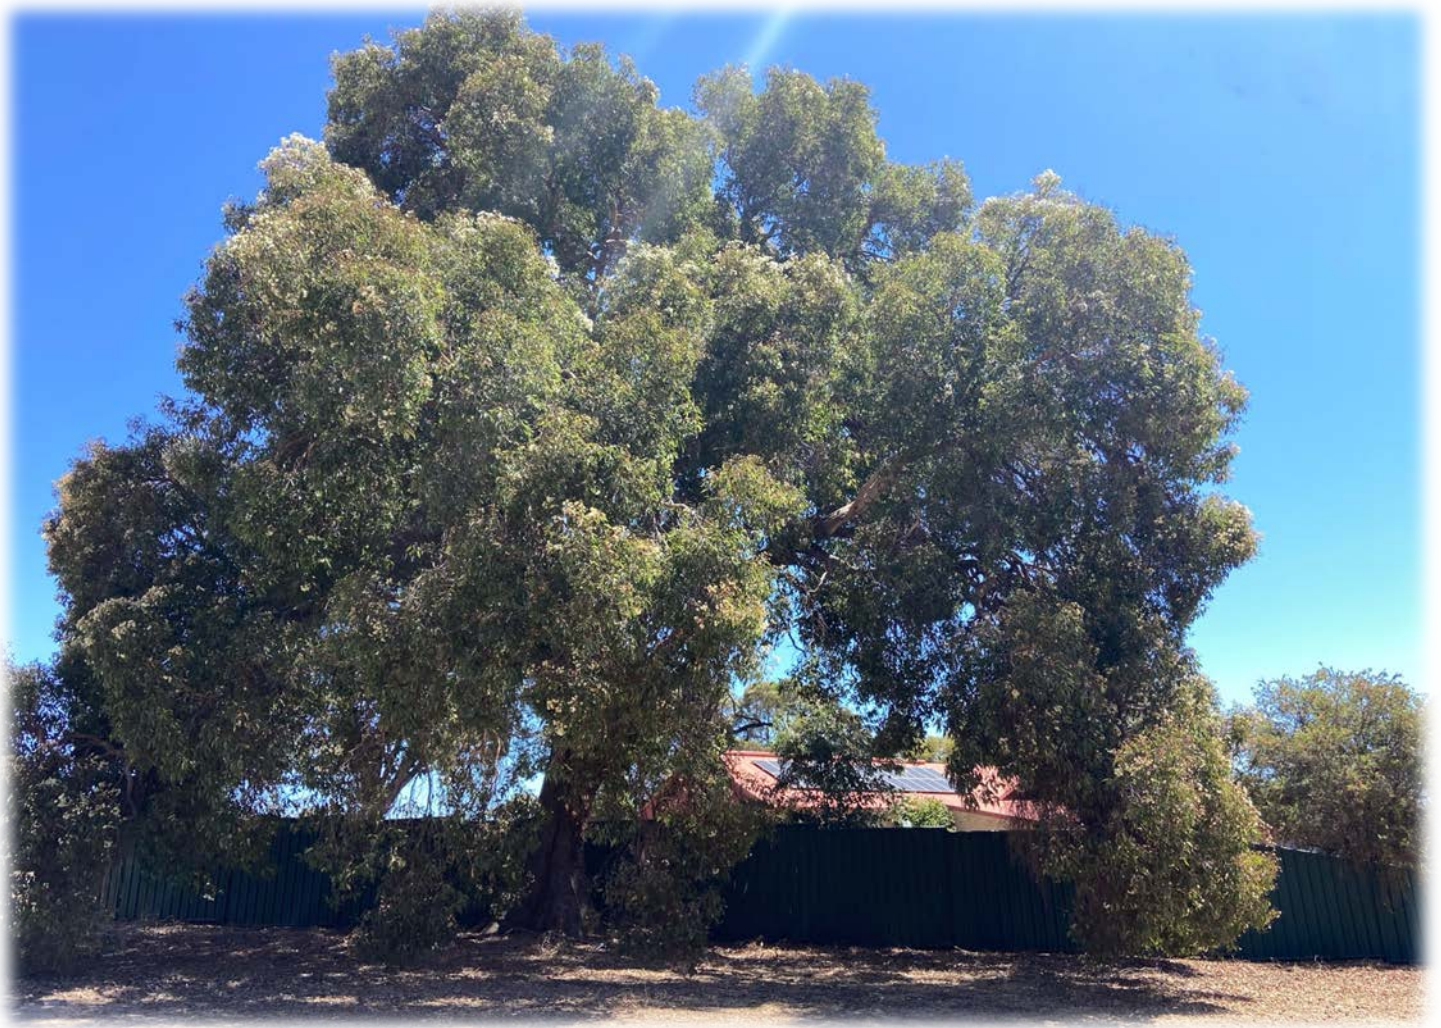
## Appendix G

## 5.11 Subject tree – Appendix G

- Species – *Corymbia calophylla* (Marri tree)
- Height – 22m
- Diameter Breast Height (DBH) – 1.14m taken at 1.4m
- Tree Protection Zone (TPZ) – 15m
- Diameter Root Crown (DRC) – 1.32m
- Structural Root Zone (SRZ) – 3.72m
- Age – Mature
- Health – Good
- Useful Life Expectancy (ULE) – 50+ years
- Live Canopy Ratio (LCR) – 75%
- Canopy spread – E 12m, N 13.3m, W 10m, S 9.8m

The last tree to be assessed was the Marri tree closest to the church.

A considerable amount of organic matter sits under the tree, which probably accounts for the full, and rich green canopy. The tree, similar to the oak, remains largely unpruned, apart from previous pruning back from hanging over the church boundary to the west. The canopies to the north, east and south hang down to the ground, as the tree is not a convenient place to park for the shopping centre over the road.

No surface roots were found, mainly because they would have been covered by leaf litter.

The trunk stands at 3m, then bifurcates into a northern leaning stem, and a vertical stem. To the west, several limbs have been poorly cut leaving jagged branch stubs and decay as a result.

Sporadic deadwood is present >60mm in the upper canopy.
