## Arboricultural Inspection Report

BLOKK PROPERTY AUSTRALIA

21 BERKSHIRE ROAD

FORRESTFIELD

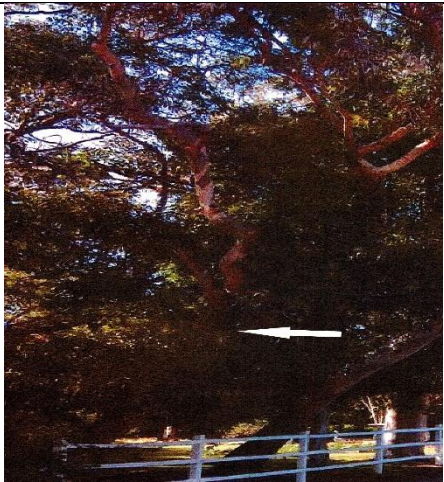
| Tree # | Species | Height (m) | DBH (m) | Health | Structure | Sule | Canopy Spread | GPS Coordinates | Photo | Comment |
|---|---|---|---|---|---|---|---|---|---|---|
| 1 | Sugar Gum<br>Eucalyptus cladocalyx | 7 | 0.4 | poor | poor | | 8m E/W<br>9m N/S | Not required | | Remove tree as it has been shaded and is now growing 90% over the road |

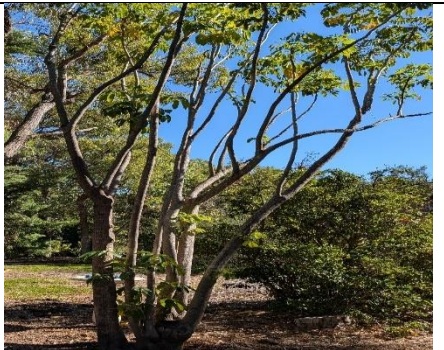
| Tree # | Species | Height (m) | DBH (m) | Health | Structure | Sule | Canopy Spread | GPS Coordinates | Photo | Comment |
|---|---|---|---|---|---|---|---|---|---|---|
| 2 | Umbrella Tree<br>Schefflera actinophylla | 6.5m | multi | Good Typical | poor | Long term .10 Years | 7 E/W<br>5N/S | Not required | | Remove both as tree will compete with tree 1, remove sapling as too close to properties being built next door |

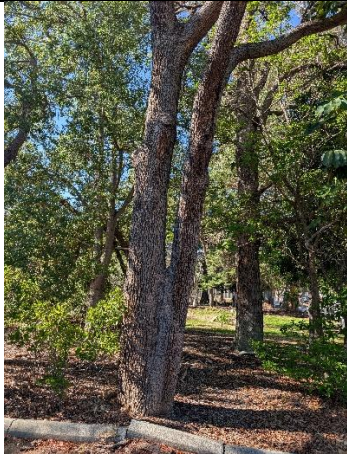
| 3 | Red Flowering Gum<br><i>Corymbia ficifolia</i> | 12m | 0.6 | Good Typical | good | Long term >12Years | 8 E/W<br>8N/S | S31 58.9399<br>E 116 00.9772 | | Retain<br><br>Will need safety pruning throughout canopy with deadwood removal also. |

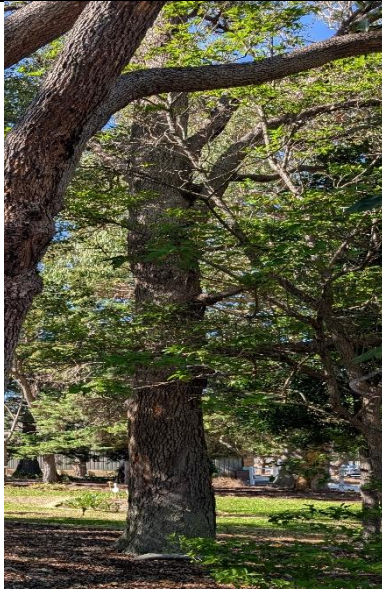
| 3a | Red Flowering Gum<br><i>Corymbia ficifolia</i> | 15m | 0.4 | Good Typical | good | Long term >12 Years | 8 E/W<br>14 N/S | Not required | | Retain.<br><br>Will require safety pruning and deadwood removal |

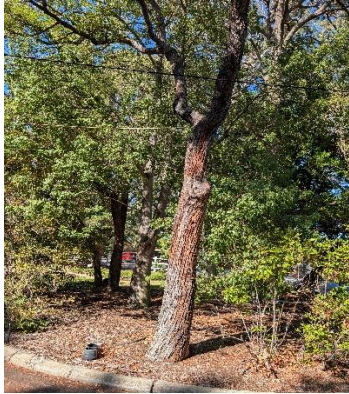
| 4 | Jarrah<br>Eucalyptus<br>marginata | 9.5m | 0.45 | Good<br>Typical | Poor | Long<br>term >20<br>Years | 6 E/W<br>5 N/S | S 31 58.9399<br>S 116 00.9772 | | Retain<br>good<br>specimen<br>has been<br>shaded on<br>the<br>western<br>side. |

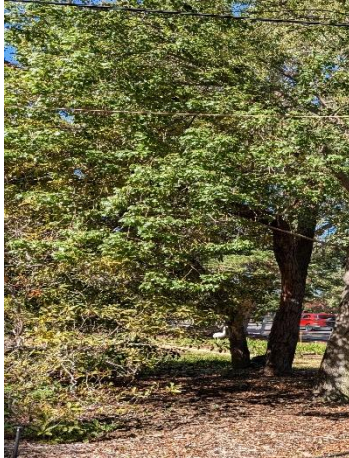
| 5a | Jarrah<br>Eucalyptus<br>marginata | 9 | Multi<br>stem | Good<br>Typical | acceptable | Long<br>term >20<br>Years | 7 E/W<br>11 N/S | S 31 58.9408<br>S 116 00.9740 | | Retain<br>tree |

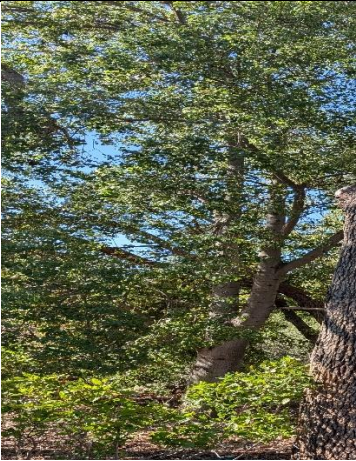
| 5 | Kurrajong<br>Brachychiton<br>populneus | 10m | 0.6 | Good<br>Typical | good | 9 E/W<br>7 N/S | Not required | | Retain tree. |

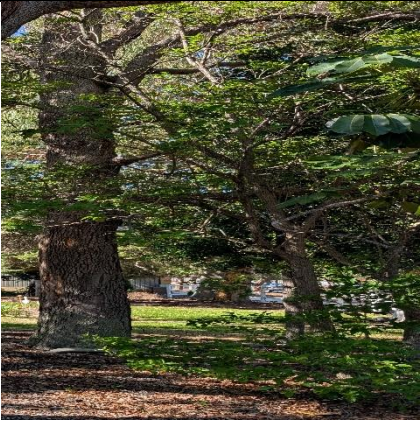
| 6 | Fiddlewood<br>Citharexylum<br>spinosum | 7.5m | 0.3 | poor | poor | immature | Not required | | Remove tree<br>has been<br>lopped<br>previously<br>and in poor<br>condition. |

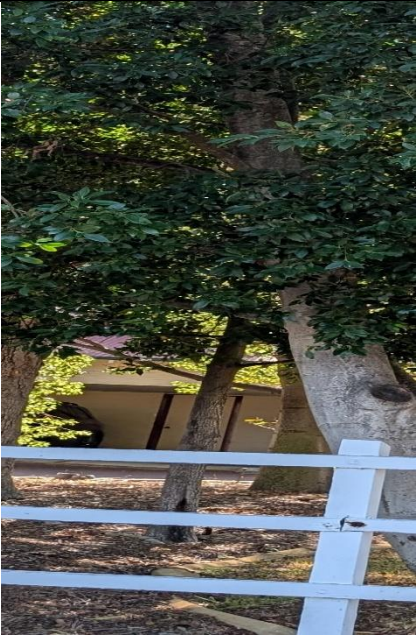
| 7 | Silky Oak<br><i>Grevillea robusta</i> | 15 | 0.5 | Poor | Questionable | immature | Not required | | Remove tree as Being shaded by all trees around it will grow into a poor specimen. |

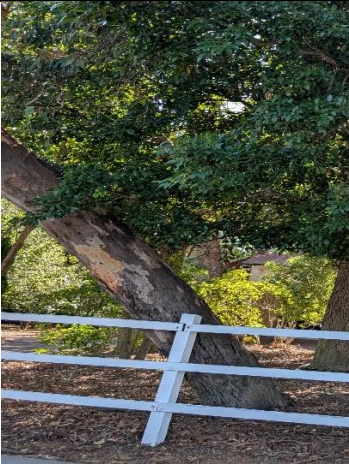
| 8 | River Gum<br><i>Eucalyptus camaldulensis</i> | 14 | 0.45 | Good<br>Typical | Questionable | 9 E/W<br>10 N/S | Not required | | Remove as shaded and growing over road. |

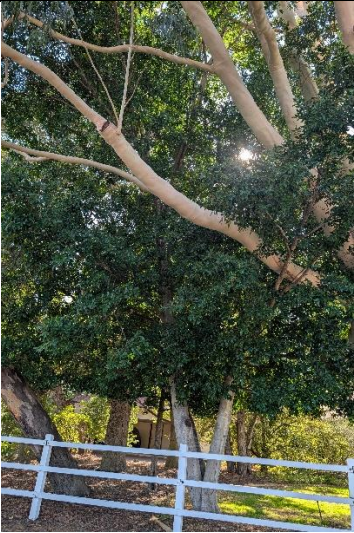
| 9 | Hills Weeping Fig<br><i>Ficus macrocarpa</i><br>var <i>Hillii</i> | 11.5 | 0.6m<br>Double<br>stem | Good<br>Typical | Questionable | 12 E/W<br>8 N/S | Not required | | Retain.<br>No pruning<br>required. |

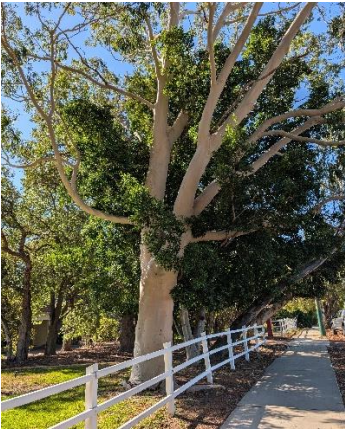
| 10 | Lemon Scented<br>Gum<br><i>Corymbia</i><br><i>citriodora</i> | 20.5 | 0.8 | Good<br>Typical | good | 17 E/W<br>21 N/S | Not required | | Retain.<br>Safety prune<br>and<br>deadwood |

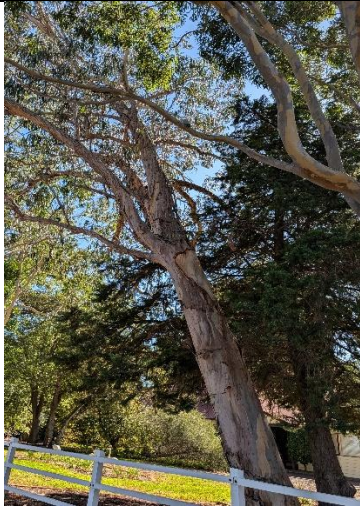
| 11 | Tasmanian Blue Gum<br><i>Eucalyptus globulus</i> | 16 | 0.45 | poor | poor | 21 E/W<br>10 N/S | Not required | | Poor condition<br>needs<br>removing. |

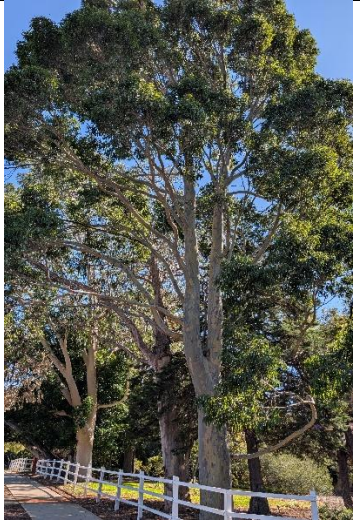
| 12 | Spotted Gum<br><i>Corymbia maculata</i> | 22 | 0.5 | Good<br>Typical | good | 13 E/W<br>18 N/S | Not required | | Retain.<br><br>Safety prune,<br>remove to<br>source lower<br>lateral toward<br>driveway. |

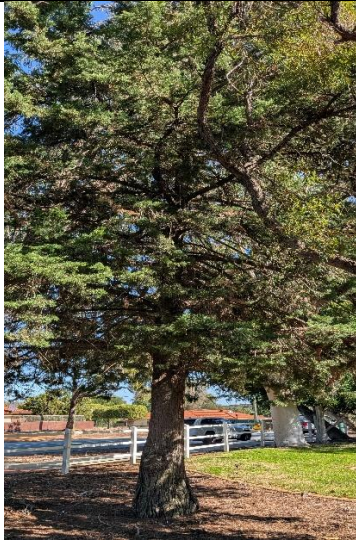
| 13 | Monterey Cypress<br><i>Cupressus macrocarpa</i> | 11.5 | 0.45 | good | good | 11 N/S<br>13 E/W | S 31 58.9514<br>E 116 00.9862 | | Retain.<br>Some pruning required to deadwood. |

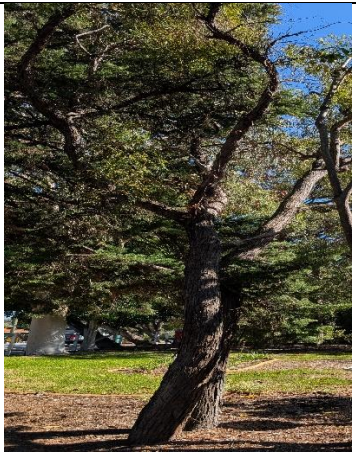
| 14 | Jarrah<br><i>Eucalyptus marginata</i> | 16 | 0.7 | Good<br>Typical | Questionable | 6 E/W<br>6 N/S | S 31 58.9514<br>E 116 00.9862 | | Remove tree as in poor condition. |

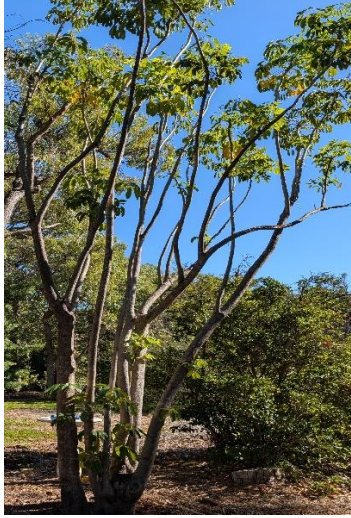
| 15 | Umbrella Tree<br>Schefflera<br>actinophylla | 8 | 0.7<br>Multi stem | Poor | Questionable | 4 E/W<br>5 N/S | | | Remove.<br><br>Poor quality<br>has been<br>lopped and<br>now regrowth<br>unsafe. |

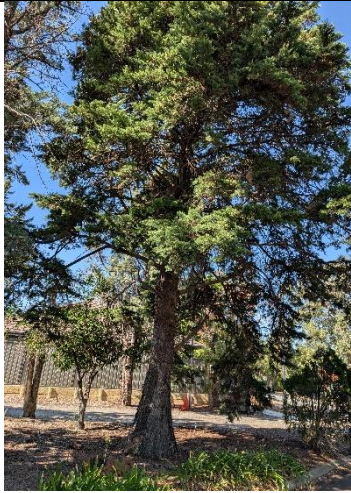
| 16 | Monterey Cypress<br>Cupressus<br>macrocarpa | 13 | 0.5 | Good<br>Typical | good | 11 E/W<br>11 N/S | S 31 58.9526<br>E 116 00.9915 | | Retain<br><br>Some pruning<br>required to<br>deadwood. |

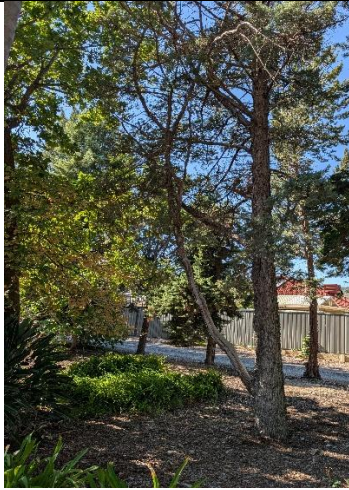
| 17 | Possibly<br>Arizona Cypress<br><i>Hesperocyparis<br/>arizonica</i> | 12 | 0.3 | Good Typical | good | 5 N/S<br>5 E/W | S 31 58.9493<br>E 116 00.9920 | | Remove too close to<br>boundary. |

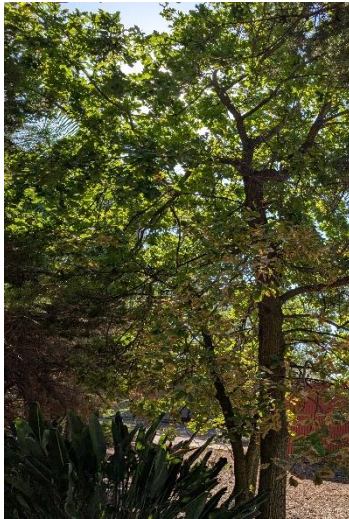
| 18 | English Oak.<br><i>Quercus robur</i> | 10 | 0.35 | Good Typical | good | 7 E/W<br>7 N/S | | | Retain.<br><br>Remove to source<br>competing secondary<br>stem. |

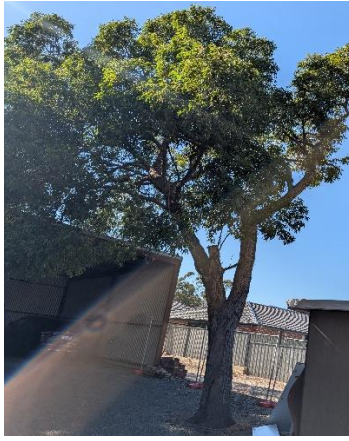
| 19 | Jarrah<br><i>Eucalyptus marginata</i> | 8.5 | 0.4 | Good Typical | Good | 9 E/W<br>10 N/S | S 31 58.9390<br>E 116 01.0015 | | Remove as too close to structure. |

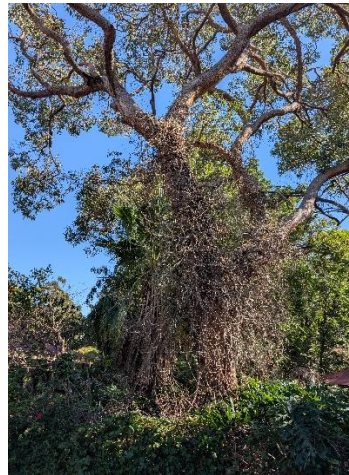
| 20 | Marri<br><i>Corymbia calophylla</i> | 14 | 0.8 | Good Typical | fair | 19 E/W<br>12 N/S | | | Retain.<br>Remove deadwood and reduce weight in large lateral branches to reduce forces at attachment points. Remove the creeper. |

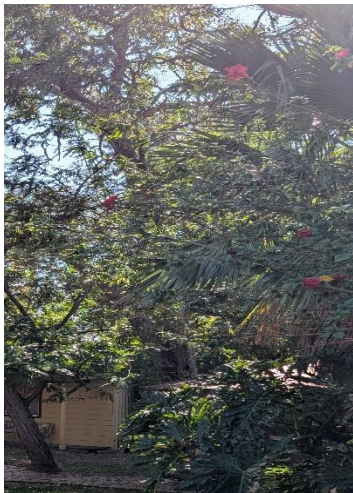
| 21 | Marri<br><i>Corymbia calophylla</i> | 18 | 0.4 | Good Typical | Fair | NO ACCESS | | | Retain tree.<br><br>Remove deadwood and reduce weight in large lateral branches to reduce forces at attachment points.<br><br>Could not get into rear of house (dogs) |

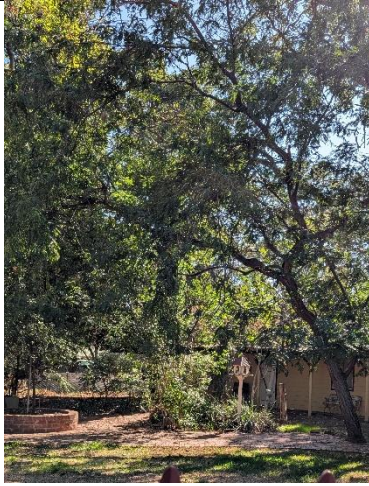
| 22 | Honey Locust<br><i>Gleditsia tricanthos</i> | 9 | 0.4 | Good Typical | good | 14 N/S<br>10 E/W | | | Retain tree.<br><br>Very close to structure may need some pruning, could not get into the back of the house (dogs) |

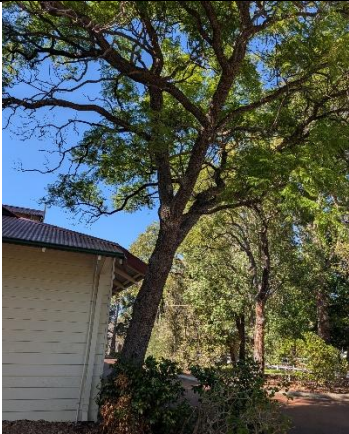
| 23 | Jacaranda.<br>Jacaranda<br>mimosifolia | 9 | 0.5 | Good Typical | Fair | 11 E/W<br>12 N/S | A 31 58.9399<br>E 116 00.9772 | | Remove tree as too close to structure to retain. |

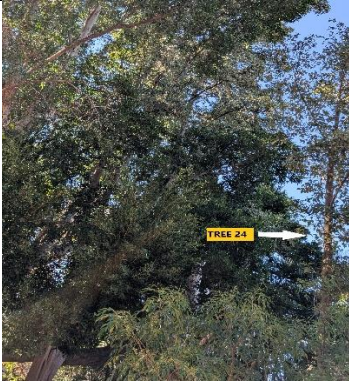
| 24 | Norfolk Island Hibiscus<br>Lagunaria patersonia | 11 | 0.2 | Good Typical | Questionable | 3 E/W<br>4 N/S | | | Remove tree.<br><br>This tree causes allergies and the seed pods and leaves touched by children will cause itchiness like Fibreglass. |

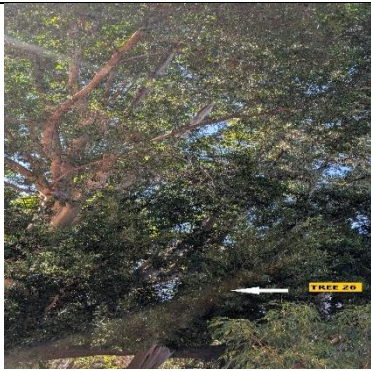
| 26 | Norfolk Island<br>Hibiscus<br>Lagunaria patersonia | 20 | 0.4 | Good | Questionable | 11 E/W<br>7 N/S | | | Remove tree.<br><br>This tree causes allergies and the seed pods and leaves touched by children will cause itchiness like Fibreglass. |

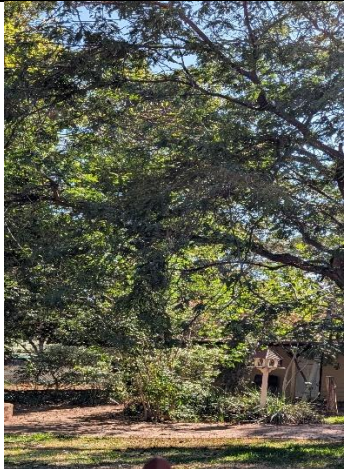
| 27 | Illawarra Flame<br>Brachchiton<br>acerfolius | 16 | | Good Typical | Fair | NO ACCESS | | | Remove tree,<br>growing within<br>the root ball of<br>Ficus next to it<br>and being<br>shaded. |

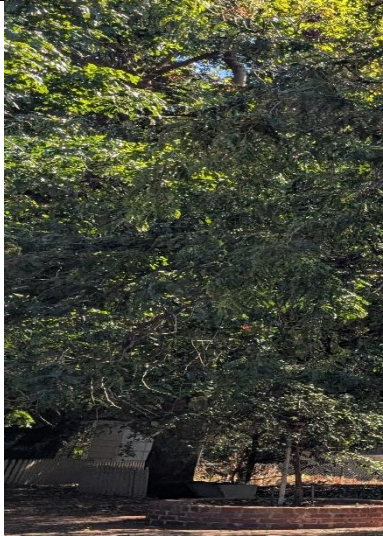
| 28 | Illawarra Flame<br>Brachchiton<br>acerfolius | 13 | 0.4 | Good<br>Typical | Fair | 8 E/W | | | Remove tree,<br>growing within<br>the root ball of<br>Ficus next to it<br>and being<br>shaded. |

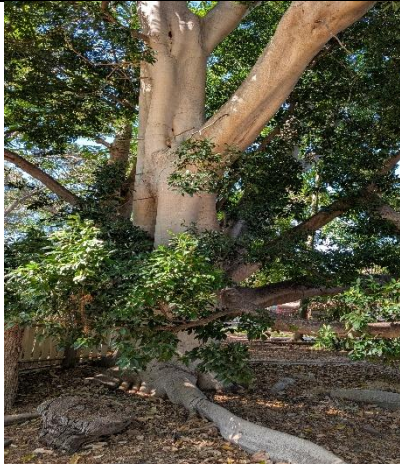
| 29 | Hills Weeping Fig .<br>Ficus macrocarpa<br>var. Hillii | 24 | 1.1 | Good<br>Typical | Fair | 28 E/W<br>20 N/S | S 31 58.9261<br>E 116 00.9874 | | Keep this tree.<br>Will need<br>crown<br>reduction and<br>lateral pruning<br>to keep<br>maintained. |

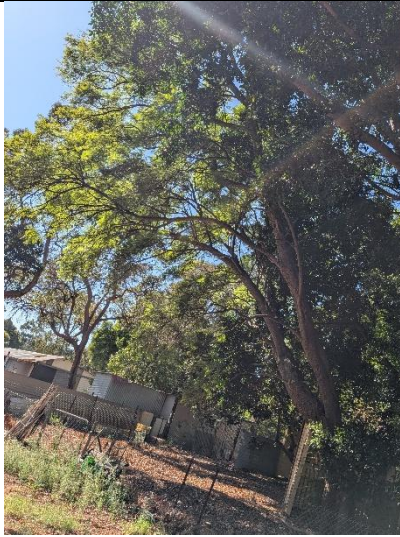
| 30 | Jacaranda.<br>Jacaranda<br>mimosifolia | 14 | 0.6 | Good<br>Typical | Fair | 19 E/W<br>14 N/S | | | Retain.<br>Will need some<br>of the lateral<br>growth<br>reduced.<br>Root ball to<br>close to trunk<br>of Ficus to<br>remove. |

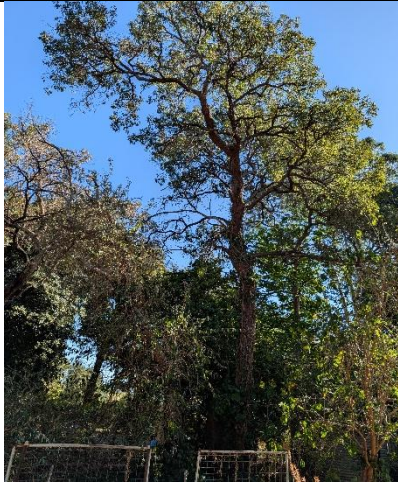
| 31 | Red Flowering Gum<br><i>Corymbia ficifolia</i> | 16.5 | 0.45 | Good<br>Typical | Fair | 14 E/W<br>12 N/S | S 31 58.9174<br>E 116 00.9863 | | Retain.<br><br>This tree has been shaded and has poor growth.<br><br>Will need substantial pruning to make safe |

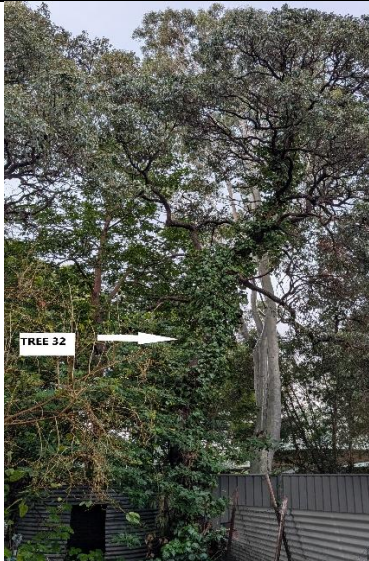
| 32 | Red Flowering Gum<br>Corymbia ficifolia | 16 | 0.4 | Good<br>Typical | Fair | 12 E/W<br>10 N/S | | | Retain.<br><br>This tree has been shaded and has poor growth.<br><br>Will need substantial pruning to make safe.<br><br>Remove the Ivy on the trunk. |
