# ARBORIST REPORT

Arboricultural assessment on: Two trees designated for retention

Site Address: Cnr Heath Road/Canning Road, Kalamunda

Date: 31.07.24

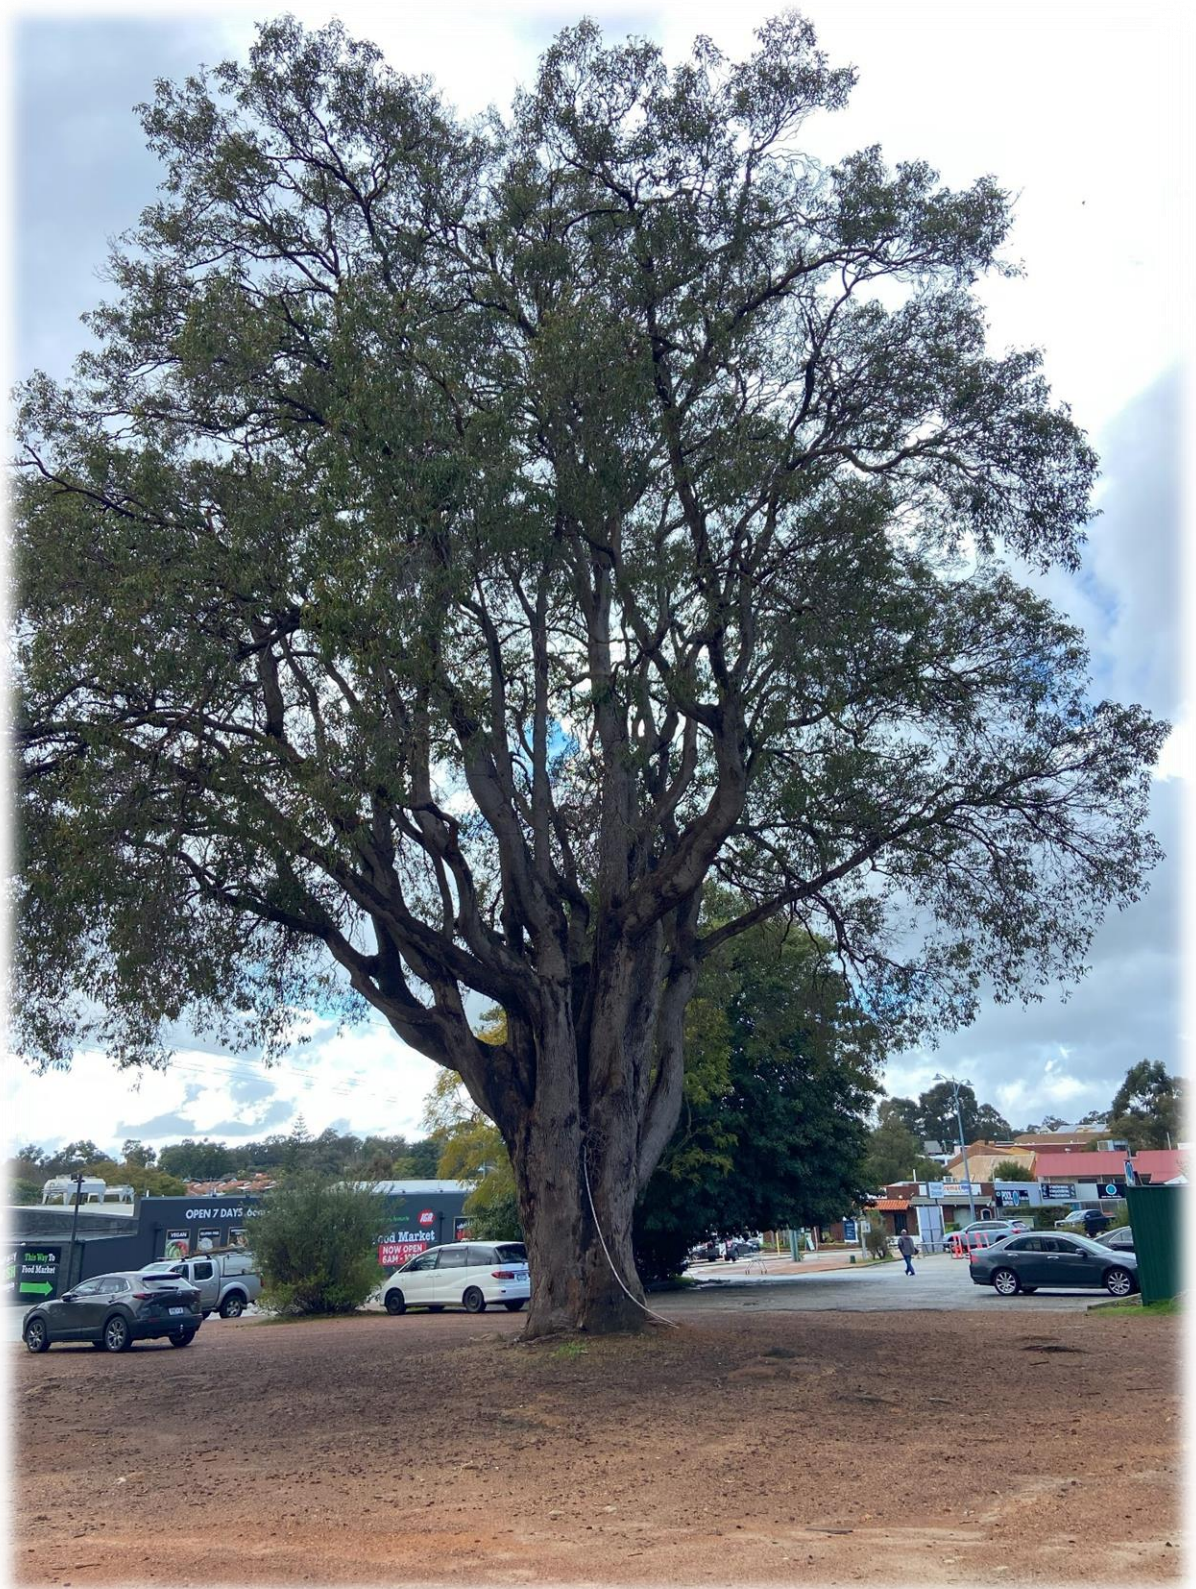
## Appendix A

- Species – *Corymbia calophylla* (Marri)
- Height – 24m
- Diameter Breast Height (DBH) – 1.63 m taken at 1.4m
- Tree Protection Zone (TPZ) – 15m
- Diameter Root Crown (DRC) – 1.79m
- Structural Root Zone (SRZ) – 4.23m
- Age – Mature
- Health – Good/Fair
- Useful Life Expectancy (ULE) – 50+ years
- Live Canopy Ratio (LCR) – 50%
- Canopy spread – N 11.6m, W 10.7m, S 10m, E 12.6m.
- Soil compaction – impenetrable
- pH – 5.5 – 5.7
- Temperature 17c (ideal 10c-24c)

The tree appears to be experiencing stress, possibly due to the drought like conditions over the last 6 months. Although the recent rain will be beneficial, it will take time to percolate through the soil to make any significant difference. The stress can be seen in the quality of the chlorophyll in the leaf – a rich green colour is ideal, as opposed to the dull green/brown colour now showing on the tree.

The upper canopy, primary and secondary stems appear sound, no change was seen from the previous visit. There are several pieces of deadwood present, that are of a size that have the potential to cause harm or damage and should be removed.

- 6.1** The tree at Appendix A is a significant tree, its age, size and amenity value are of considerable importance and every attempt must be made to minimise the impact on the tree. The following measures, based on AS4970-2009 should be employed to increase the likelihood of the survival of the tree.

- Roots >35mm within the SRZ are considered significant and should not be removed without consulting with the project arborist.
  - Deadwood removal.
  - A regular monitoring plan of both trees should be implemented at a minimum of 3 monthly intervals, or as required.

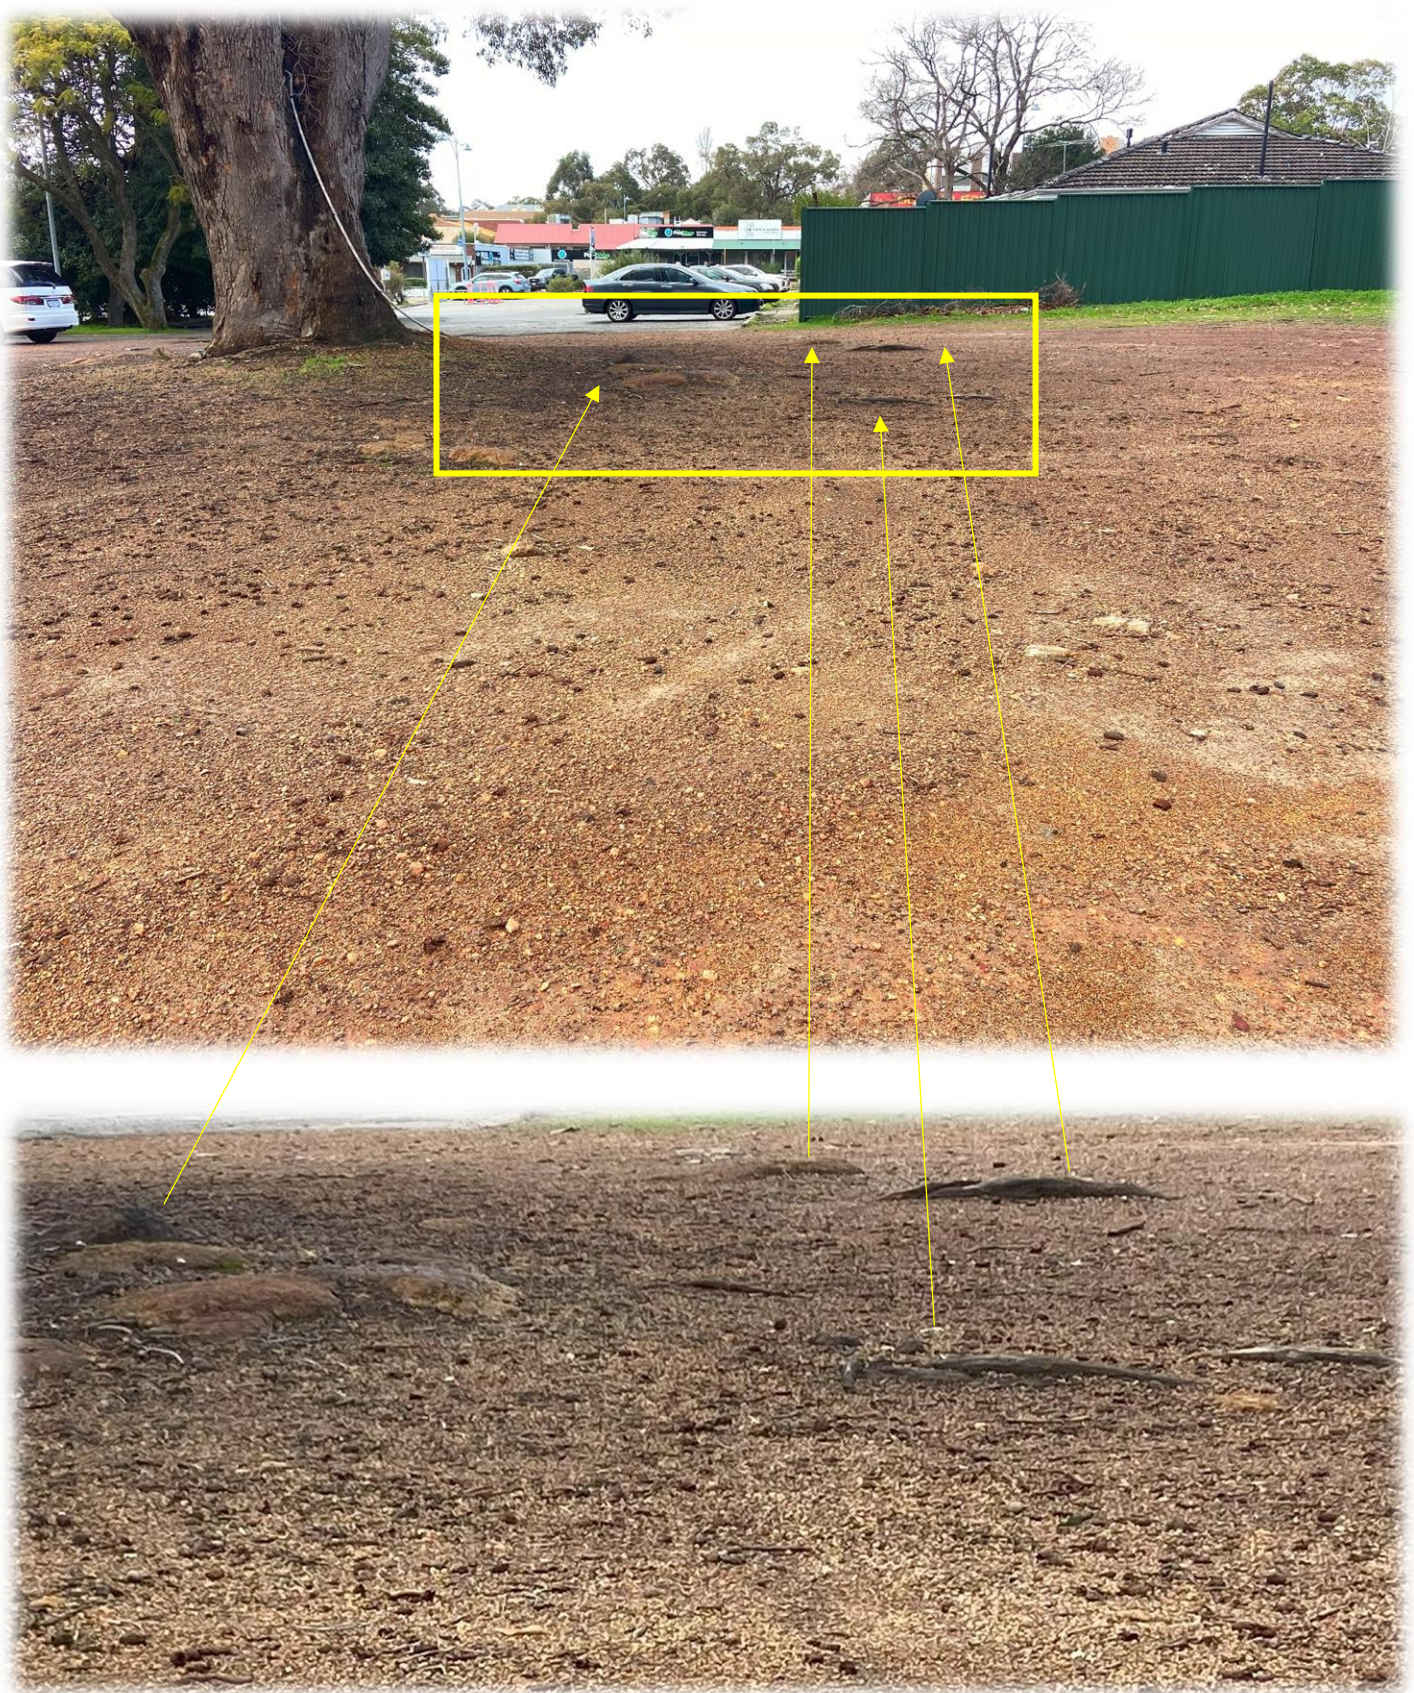
Appendix B

Several surface roots are present on the southern side, detailed at Appendix D. The roots are considered significant, due to their width, length and height protruding from the ground, the largest being 0.6m in length, 0.2m wide and 0.11. high. The heavy laterite rock presence around the tree seems to be more prominent on the southern side, which would explain the large number of surface roots. The method used to excise the rocks must take into account the value of these roots, the preferred method would be with a small 2-ton excavator and a narrow bucket. A project arborist should be present to work with the machine operator.

The size and the number of roots on the southern side are significant, and depending on the growth pattern, between them and the main trunk has a bearing on how it will impact the tree if removed. Finished soil height is another consideration.

Given the above ground nature of the roots they have sustained significant mechanical damage, mainly from cars driving over them. The outer bark or periderm has peeled back exposing dried out xylem tissue. Underground, they may still be viable as they are protected by the soil.

- Substrate for the bitumen within the TPZ should be a roadbase other than limestone.
  - Roots within the SRZ will be assessed for removal at the time of excavation by the project arborist, to ensure the tree remains viable. The determination will be made when most of the root is exposed.

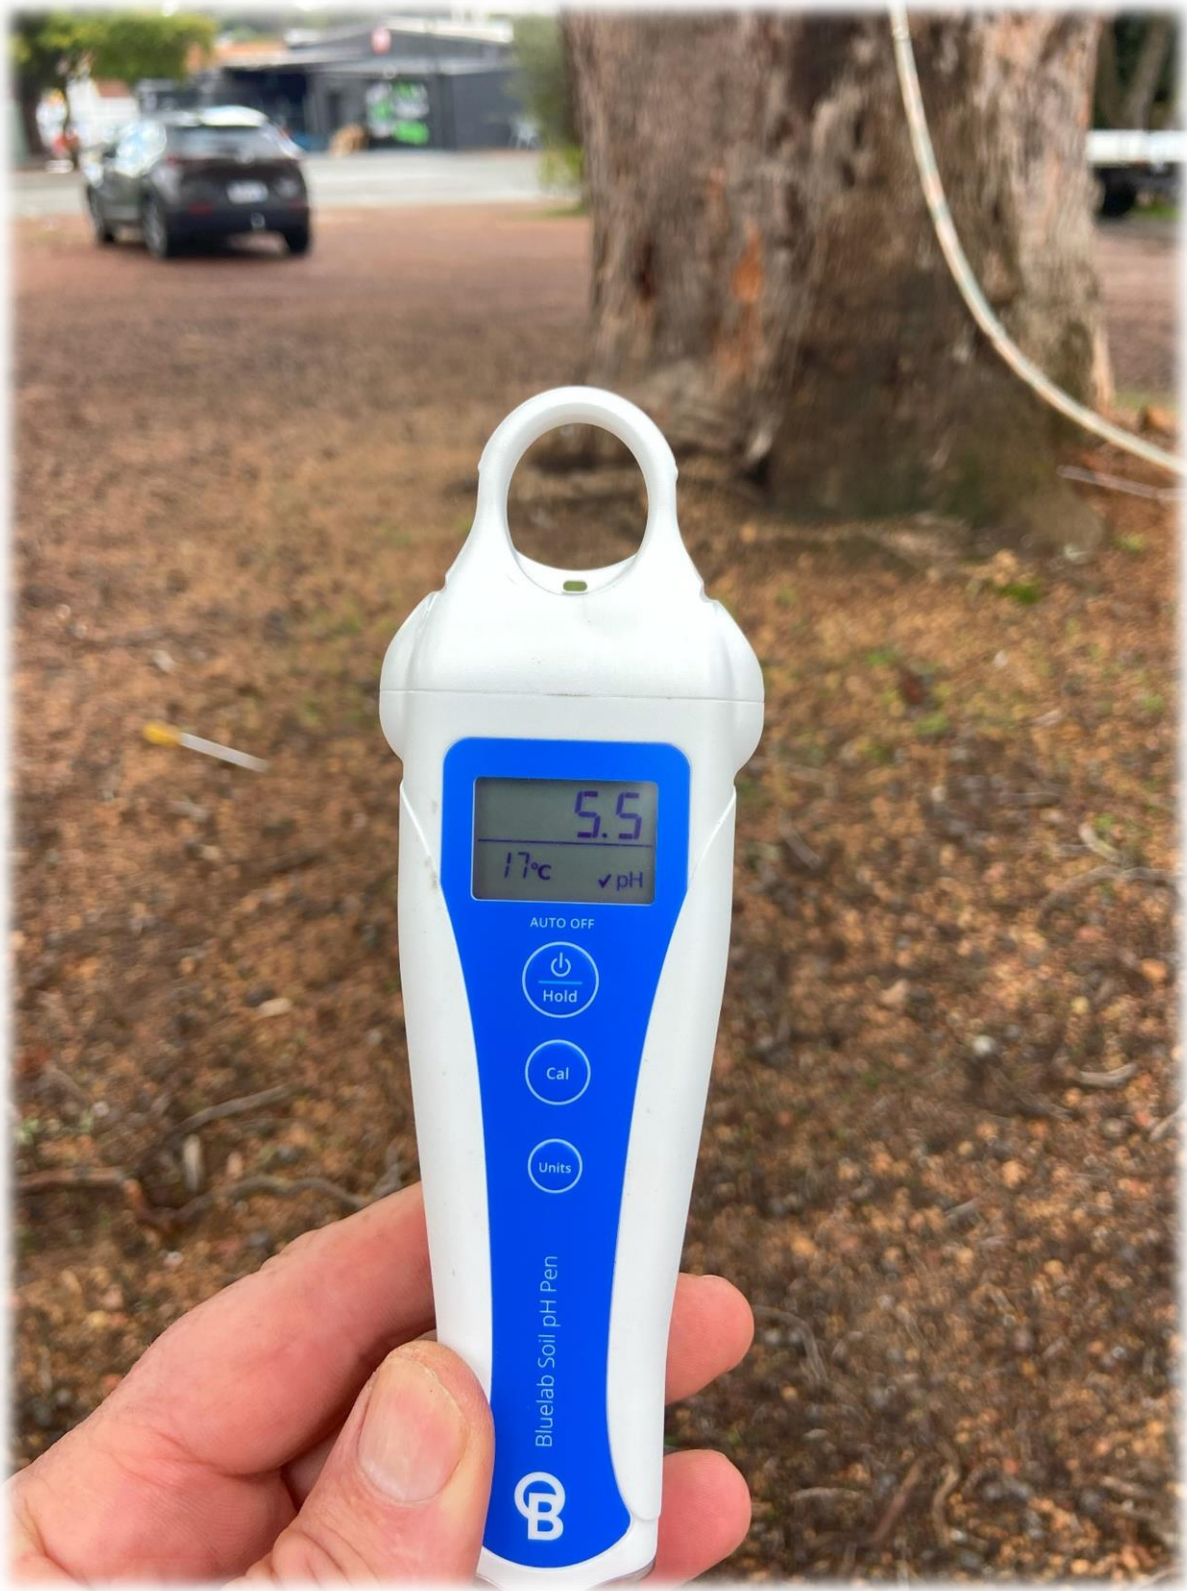
The ground around the tree is natural compacted laterite, typically laterite has a pH range of 4.5 to 5.5, our pH range is 5.5 and 5.7 taken within 6m of the base of the tree – Appendix D. Any imported soil for the garden beds should take this into consideration. The recommendation is that the imported soil be slightly acidic to neutral pH 6 – pH 7.

- Imported soil for landscaping must be certified pathogen free and of a soil pH no greater than pH 7. The Green Life Soil Co is a reputable soil supplier.

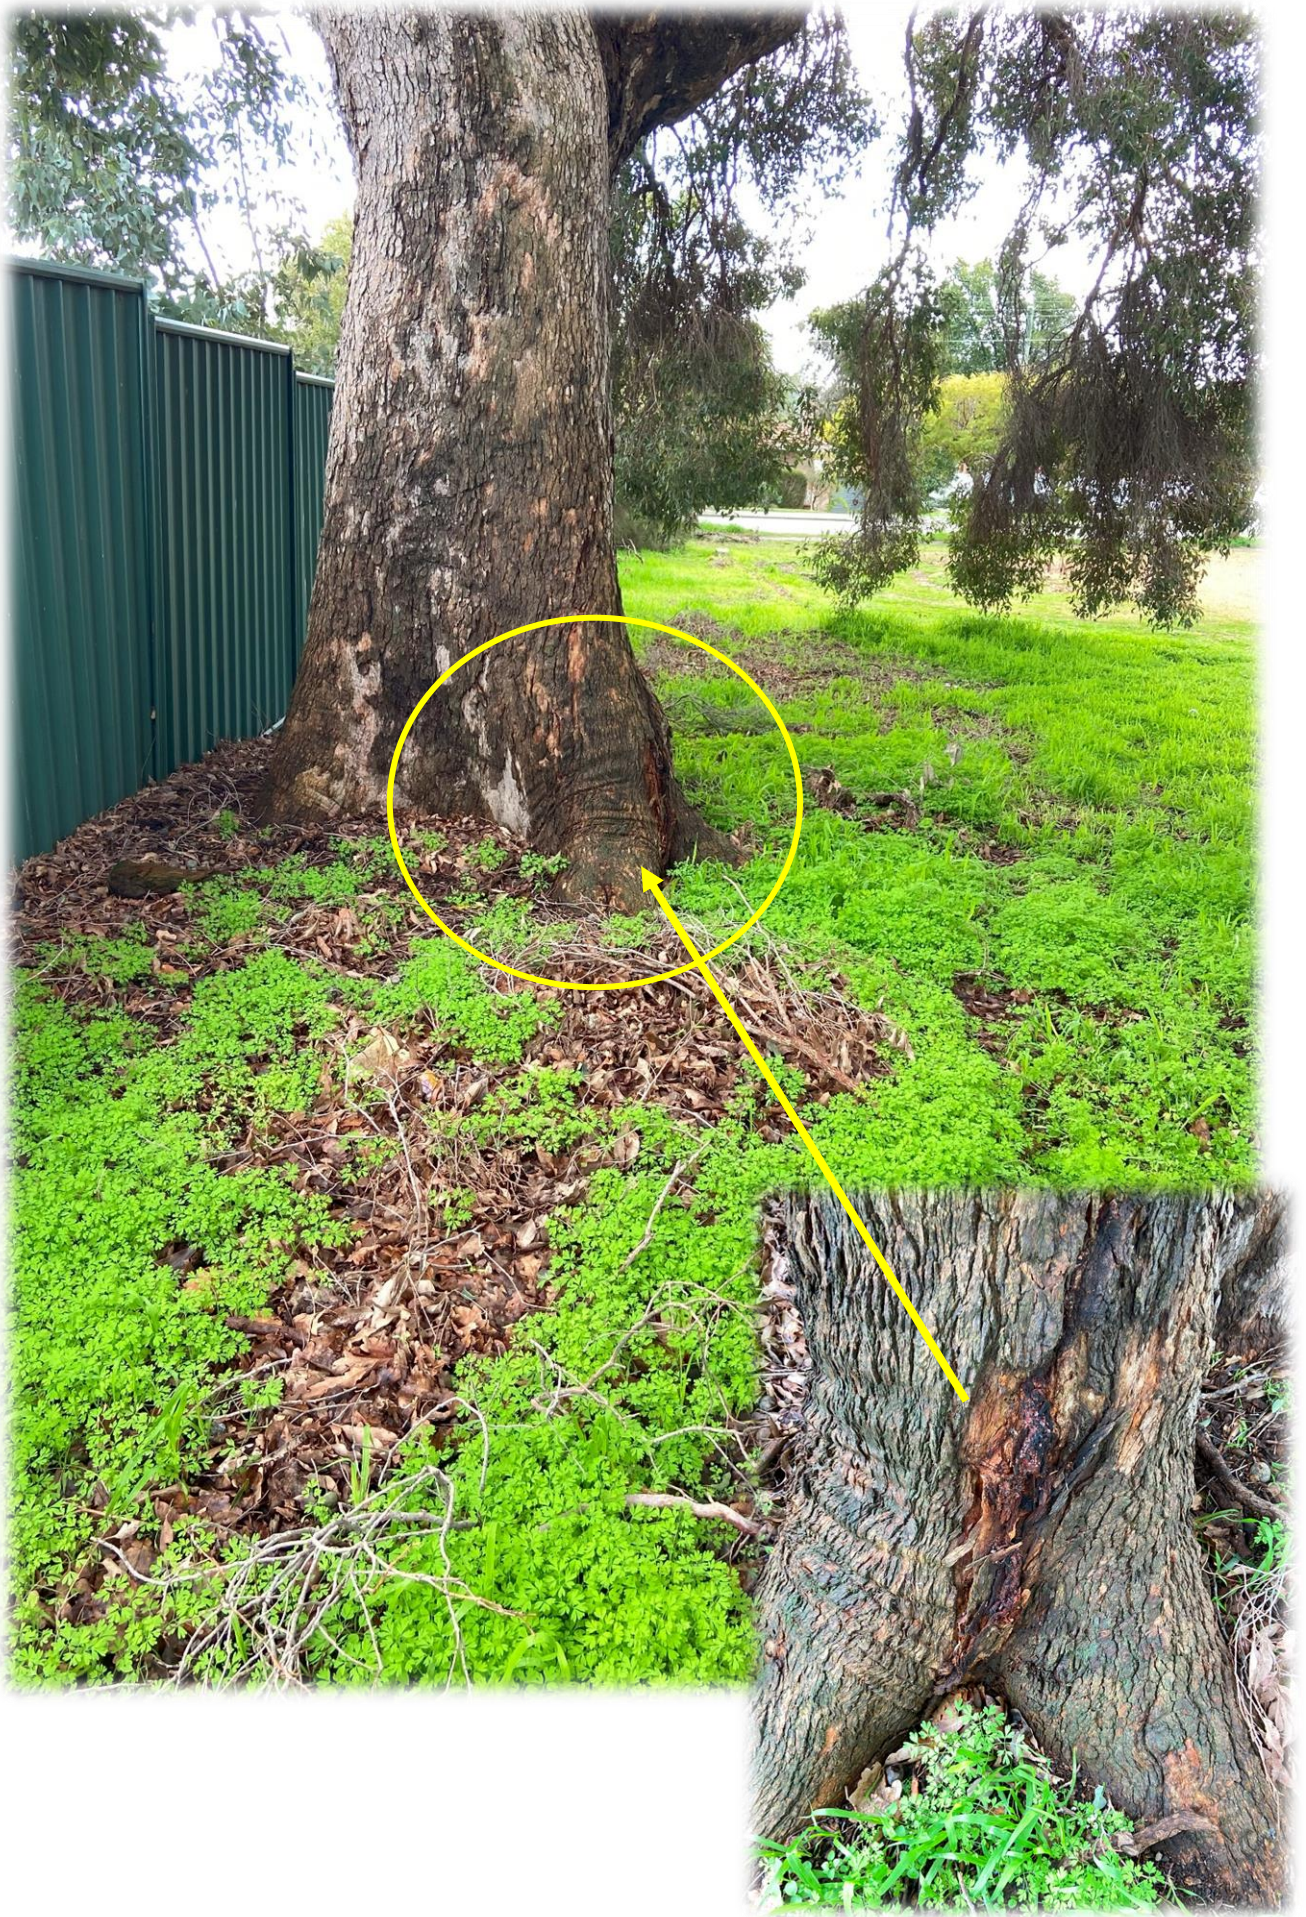
The southeastern buttress root shows a vertical fracture Appendix E, possibly due to flexure or mechanical damage. The wound shows good occlusal, with exudate sealing the wound.

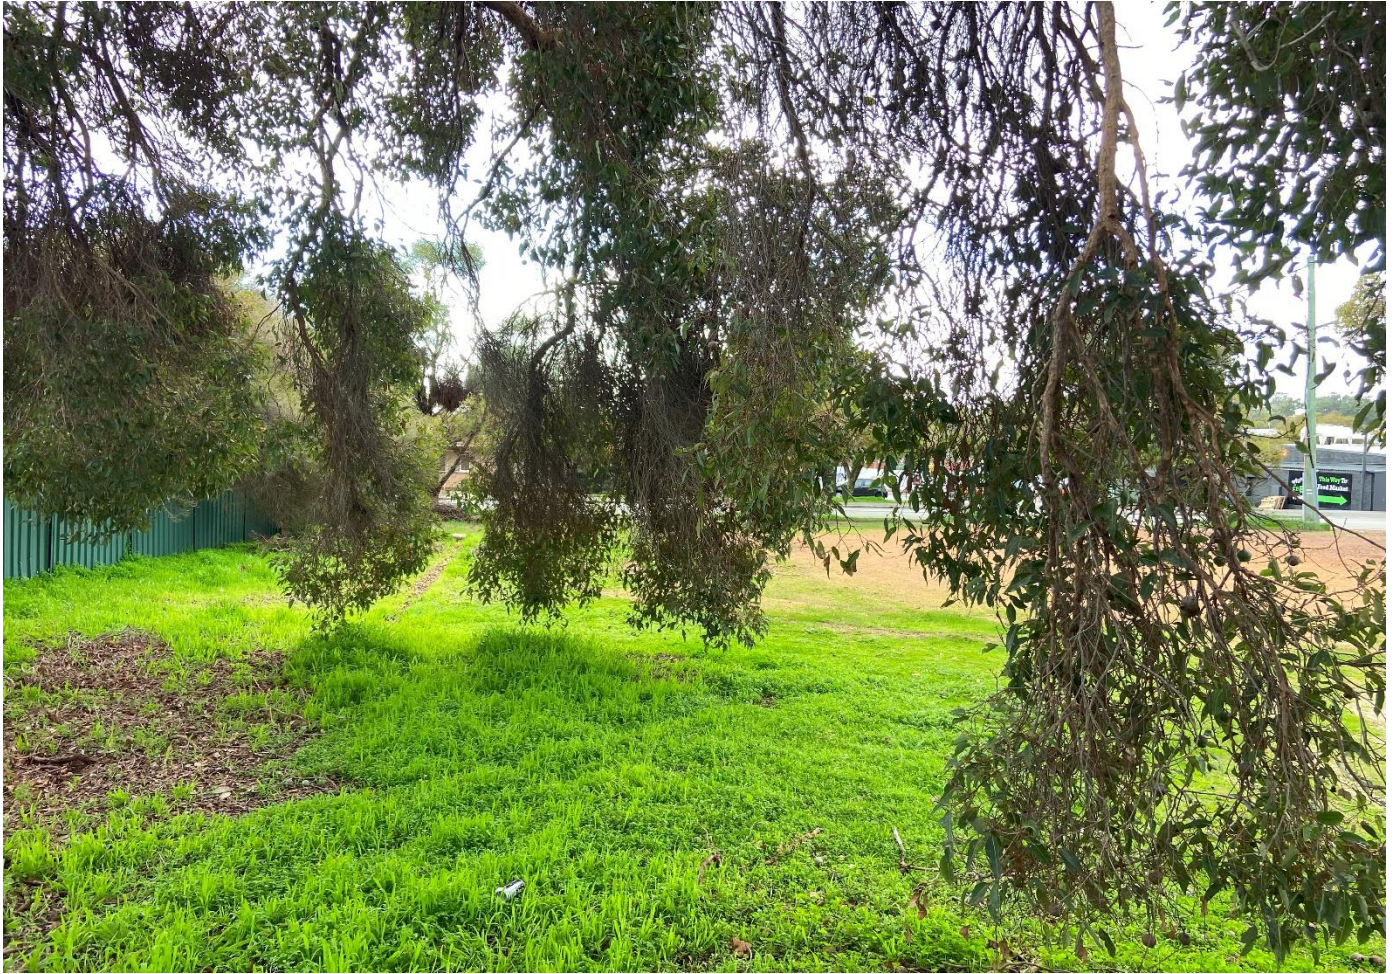
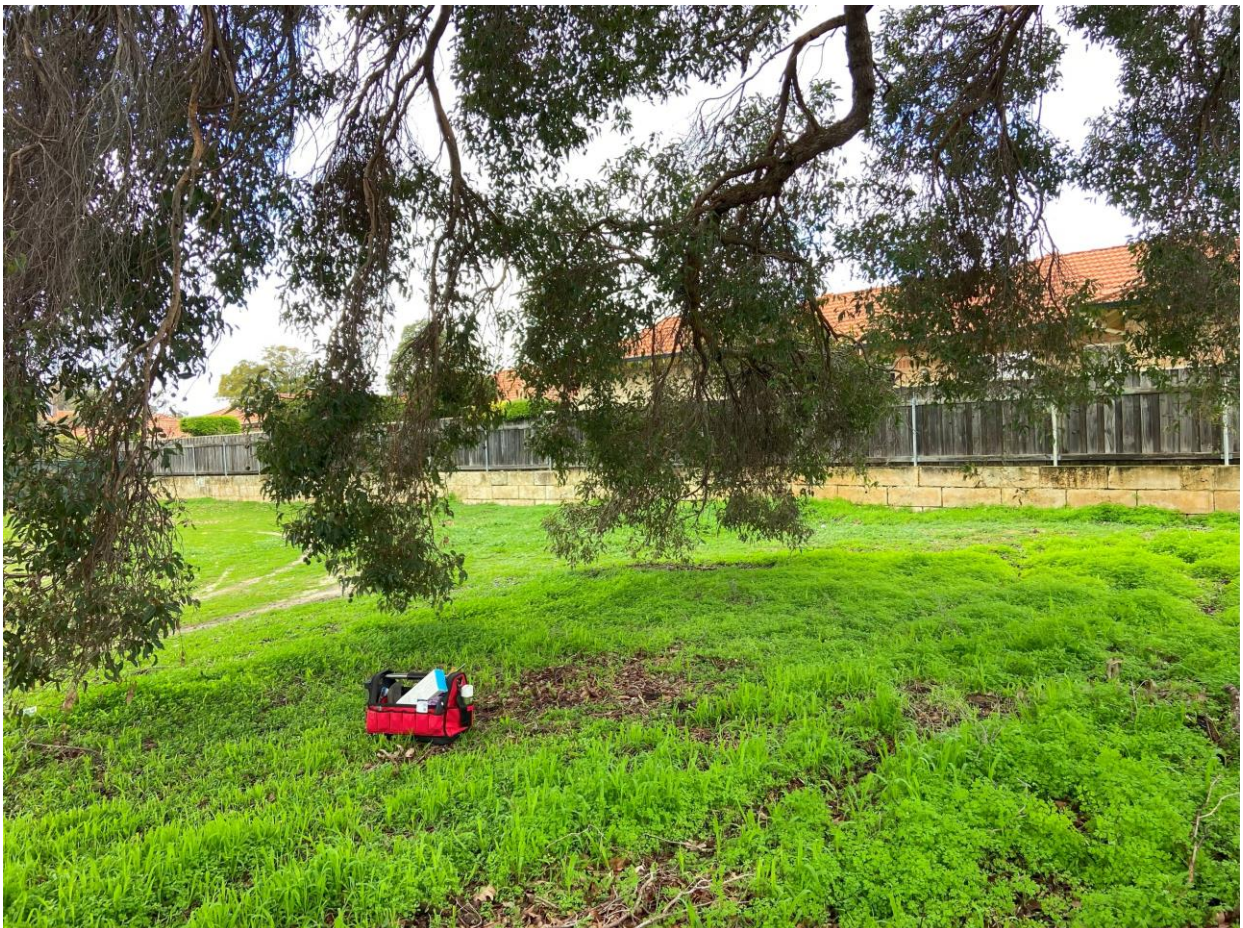
## Appendix F

The tree remains healthy, with a rich green canopy hanging down 0.5m from ground level. The recent rain has caused *Fumaria capreolata* (Fumitory) to shoot up around the base of the tree, probably due to the thick layer of organic matter underneath the canopy, see Appendix E. Approximately 0.3/0.4m of organic matter has mounded up around the tree, enriching the soil that reflects in the lower pH reading. As previously mentioned, the imported soil for the landscaping should be slightly acidic to neutral to avoid additional stress to the tree.

Given the canopy is almost touching the ground, it is recommended that the canopy be uplifted, cutting back to suitable growth points. The recommended height, to allow for vehicles, is 4m.

The canopy hangs lower down and requires lifting to accommodate vehicles, the pruning work should be carried out by a certified arborist to AS4373-2007 standards.
