October 2017  
Final Rev 1

Childcare Centres, Coolinga Road & Marri  
Crescent, Lesmurdie

Prepared For:  
Pachamama Pty Ltd

Parking and Traffic  
Management Plan Report

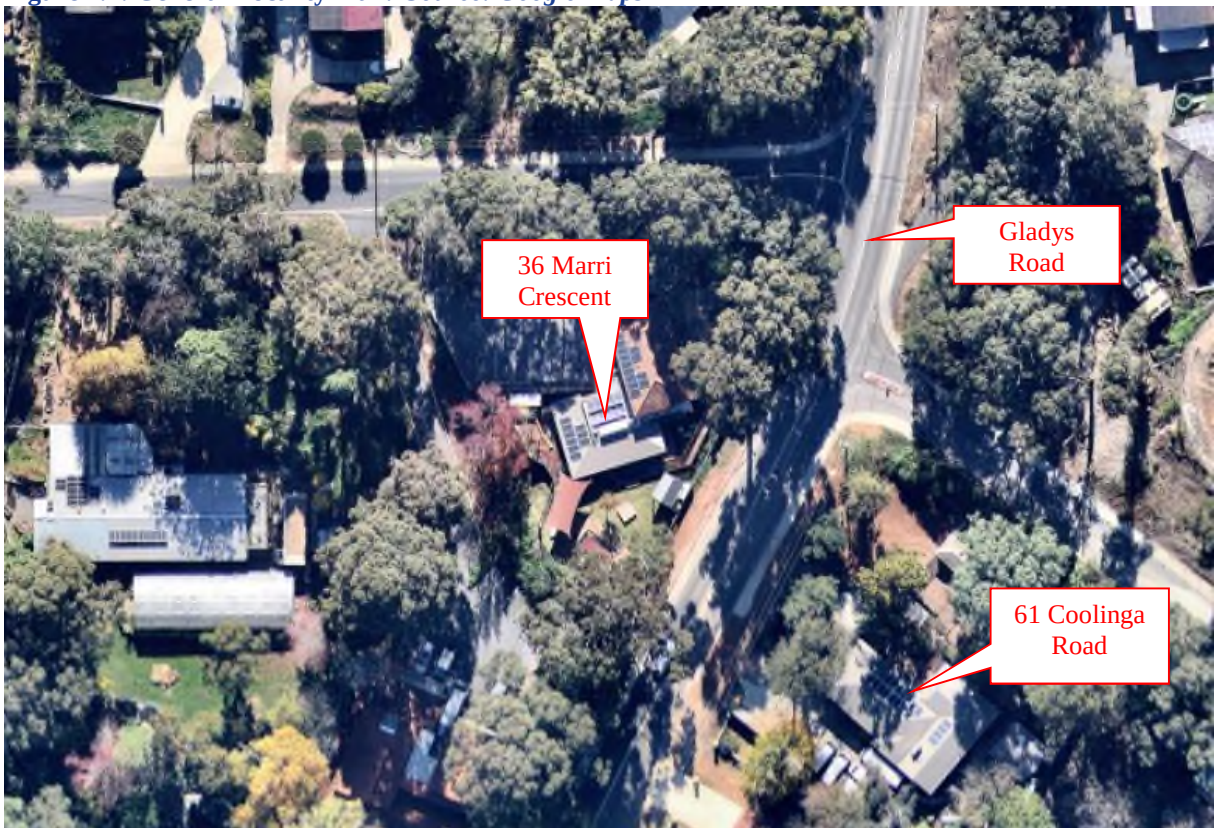
**Figure 2.2: Site Location.** Source: Nearmap

The two existing Child Care Centres are located at 36 Marri Crescent and 61 Coolinga Road, Lesmurdie. The general locality is shown in **Figure 2.1**, with more detail in **Figure 2.2**.

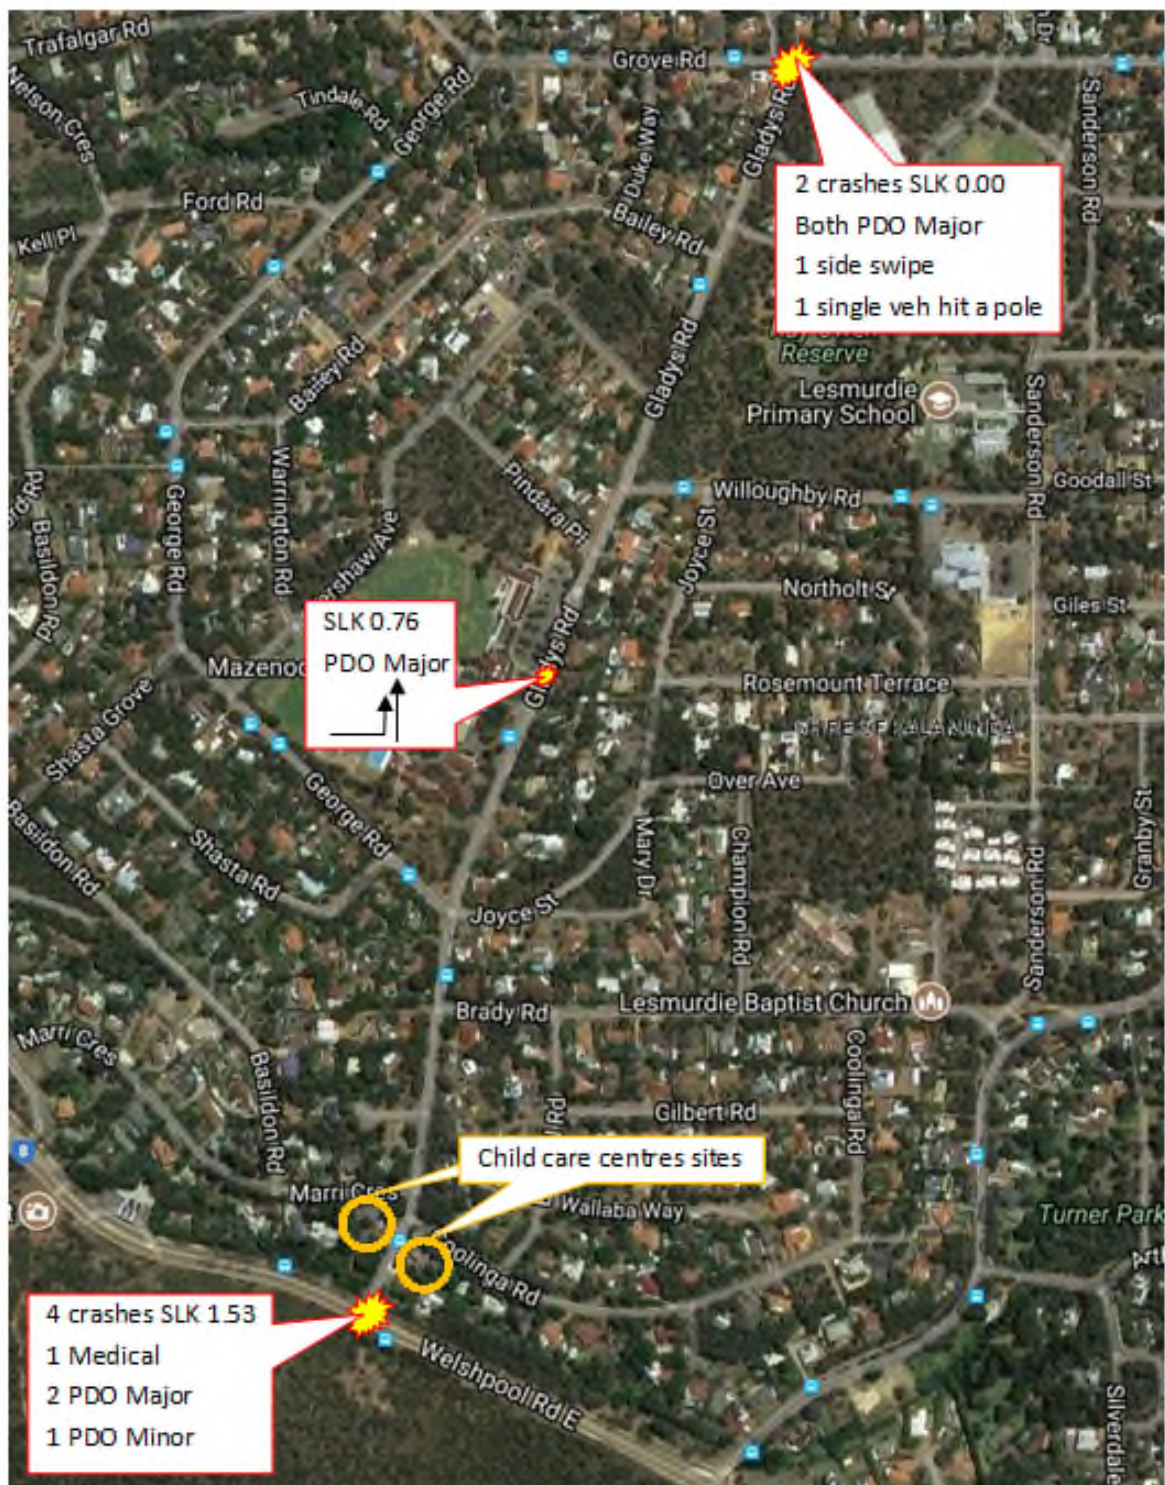
Figure 2.4: Crash Locations

A search of the MRWA CARS database showed no recorded crashes along Coolinga Road and seven crashes along Gladys Road in the last 5-year recorded period, from 2012 to 2016. No crashes were recorded on Marri Crescent in this period. Details of the crash history are included in **Appendix D**. Crash locations are shown in **Figure 2.4**, which shows the crashes concentrated at the intersections at either end of Gladys Road with one crash near Mazenod College. There were no crashes in the vicinity of the child care centres.

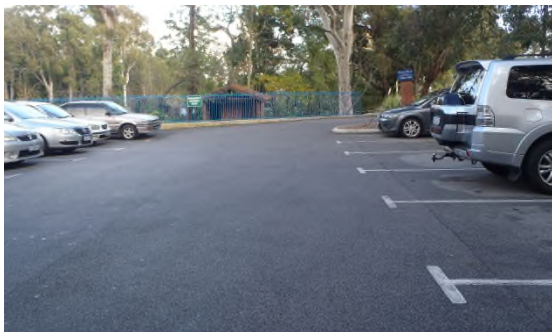
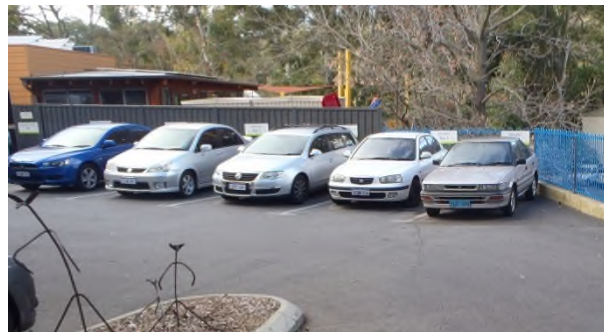
The car park provides 13 parking bays, split between staff bays and customer bays, with the designated use of each clearly marked. See **Photos 1 & 1a**.

**Photos 1 & 1a: Staff and customer bays are clearly marked in the car parking area.**

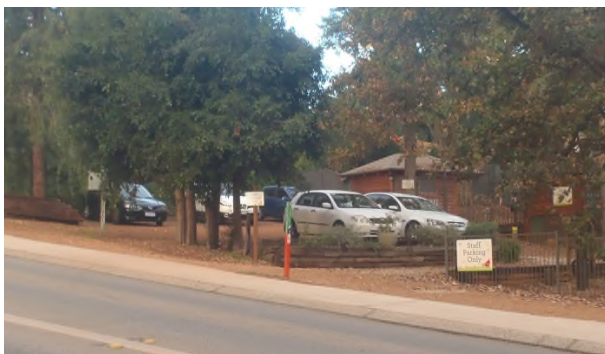
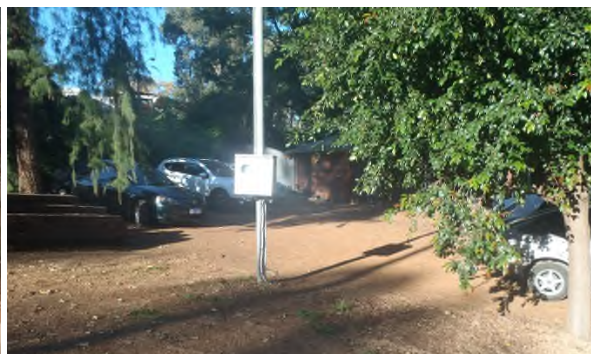
The northern parking area is designated as providing parking for staff vehicles only. The area is unsealed and the bays are therefore unmarked, but it currently accommodates eight staff vehicles. Six vehicles were observed on the day of the surveys whilst we are advised that a further two vehicles are also often present. See **Photos 2 & 2a**.

**Photos 2 & 2a: Space is provided for 7 staff vehicles.**

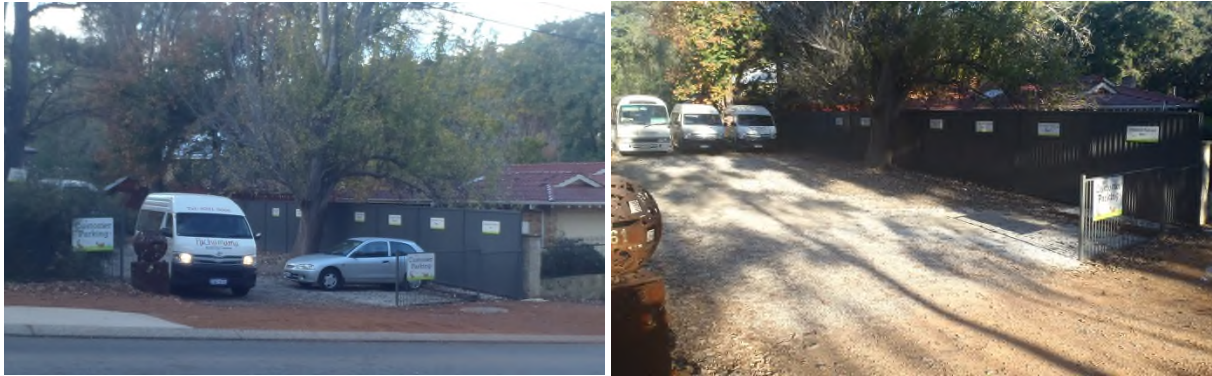
The southern parking area is designated for 'Customer Parking', but is also able to accommodate some of the Centre's vans. As with the northern area, this parking area is unsealed and the bays are therefore not formally line-marked, however they are marked with signs on the end fence.

**Photos 3 & 3a** show six parking bays marked, including one designated 'disabled'. However, during the surveys only a maximum of three of the bays were observed as being occupied at any one time.

**Photos 3 & 3a: Six 90° bays are marked, with 3 shuttle buses also accommodated.**

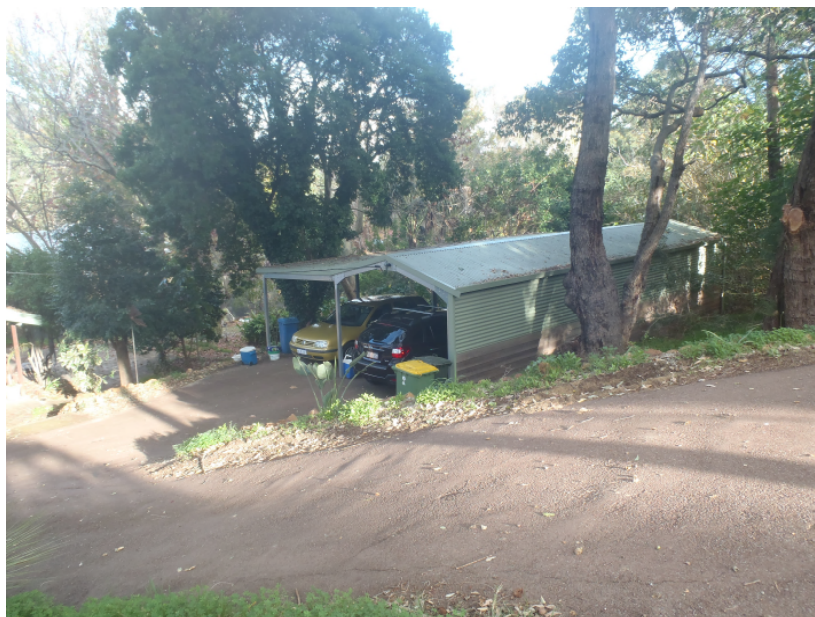
Other staff members were seen to park their vehicles at 59 Coolinga Road, which is currently unoccupied. The premises of 59 and 61 Coolinga Road are linked by a gate enabling staff to walk directly between the two properties. See **Photo 4**.

**Photo 4: Staff parking at 59 Coolinga Road**
