**Report on  
Geotechnical Investigation  
24 Valencia Road Carmel WA**

**Project: LG6892016SC\_Rev2 3 December 2018**

**RE: Geotechnical Site Classification for 24 Valencia Road Carmel WA**

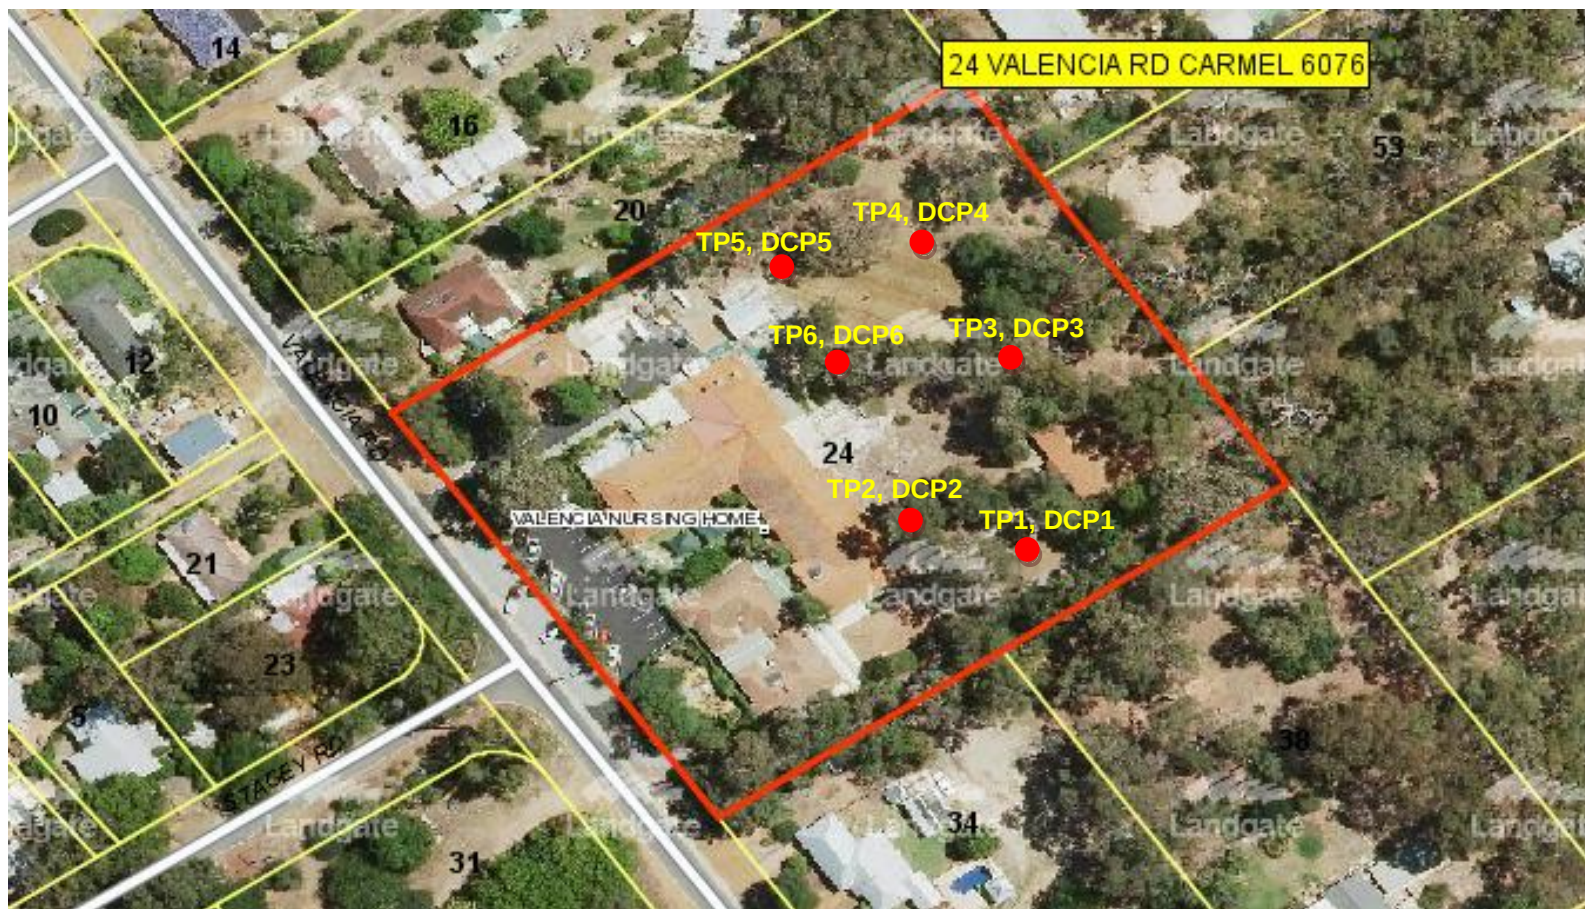
**Site Sketch : Test Pit & DCP Test Locations**

Test Pits (TP1 to TP6) were terminated at the target depth of 2.5 m. Test pit logs are attached in Appendix B. Our engineering visited the site 10 September 2018 and conducted surface probing and DCP tests. Similar findings were observed during our site inspection on 10 September 2018.

Dynamic Cone Penetrometer (DCP1-6) tests were conducted alongside of the test pits. DCP test indicates that the soil density of the site as per Standard Australia HB 160-2006, Table 6.4.6.1 (A) & (B). DCP data are presented in Table 1 and DCP test certificates are attached in Appendix B. It is observed from the DCP test that soil is in very loose to dense and firm to hard condition.

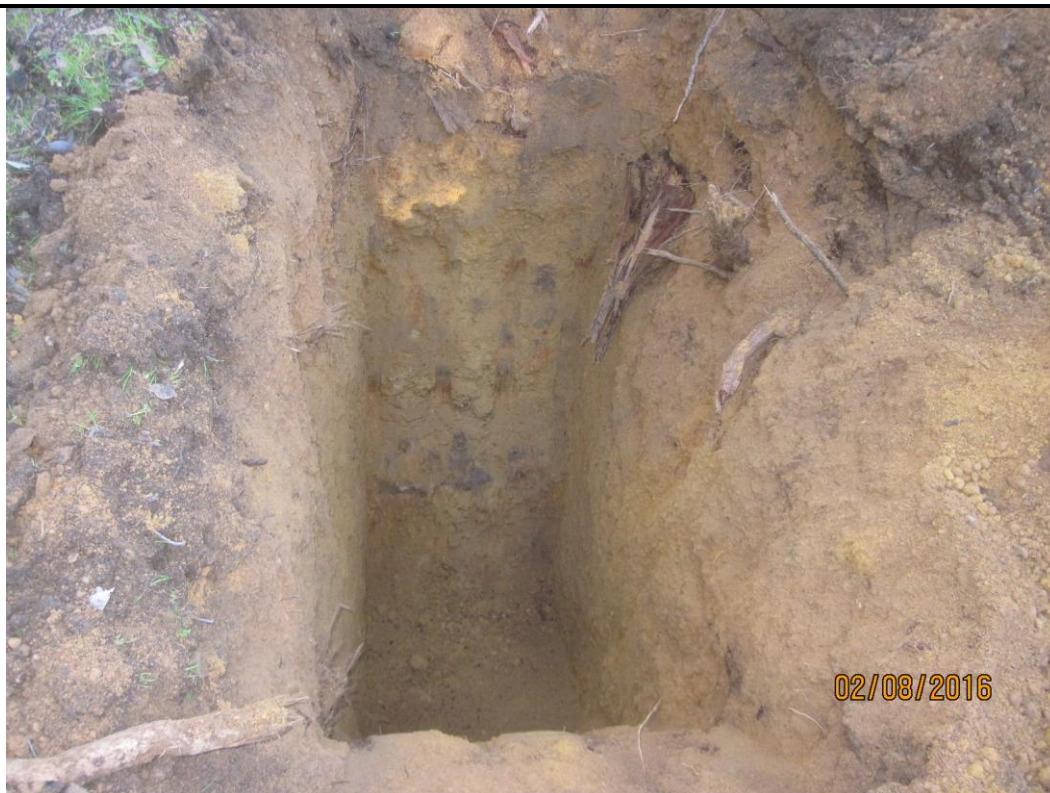
**Photo 5.** Soil Profile of Test Pit location 01 (TP1)

Test pits (TP1 to TP6) revealed similar soil profile and consists of fine to medium grained, fines of low plasticity silty SAND, black, moist, loose to medium dense, followed by sandy clayey GRAVEL, fine to coarse grained, sub rounded gravel up to 30 mm, brown to yellow, yellow to orange mottled red, moist, firm to hard, low to medium plasticity, fine to medium grained sand to a depth of 2.5 m.

The depth of silty sand varies from 0.1 m to 0.5 m followed by sandy clayey Gravel. The depth of topsoil for this site can be considered up to 0.1 m. However, it can vary over the site. Ground water table was not observed at any of the test pits.

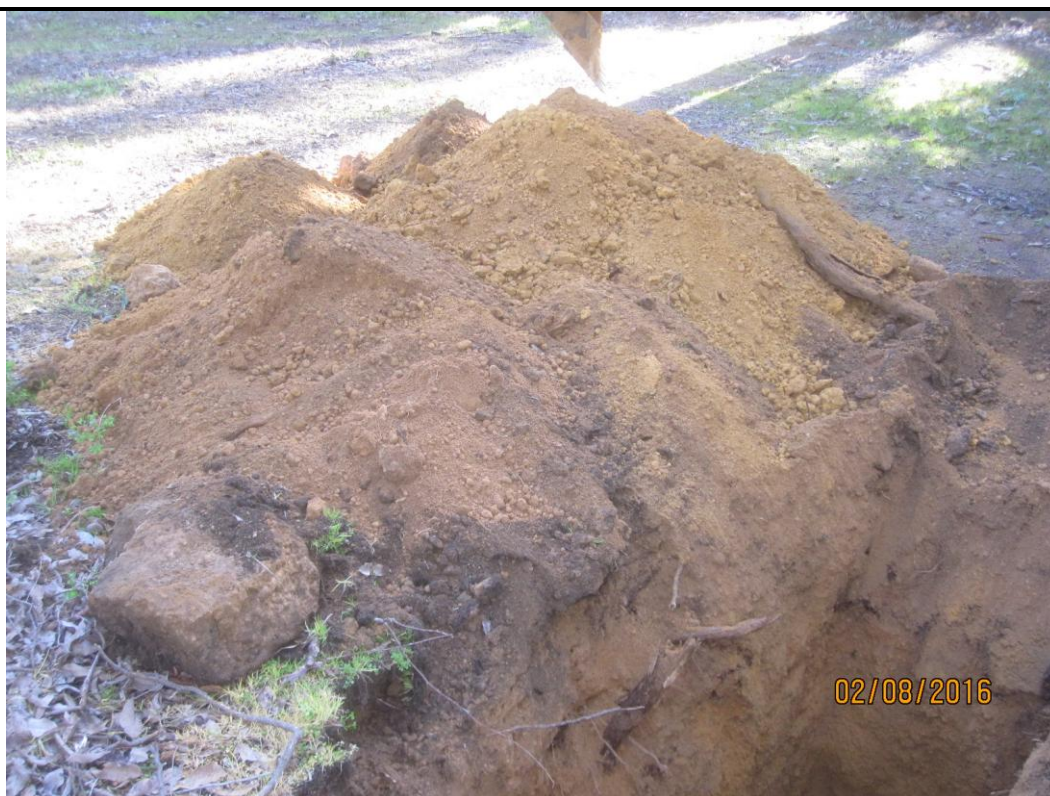
**Photo 6.** Soil from Test Pit location 01 (TP1)

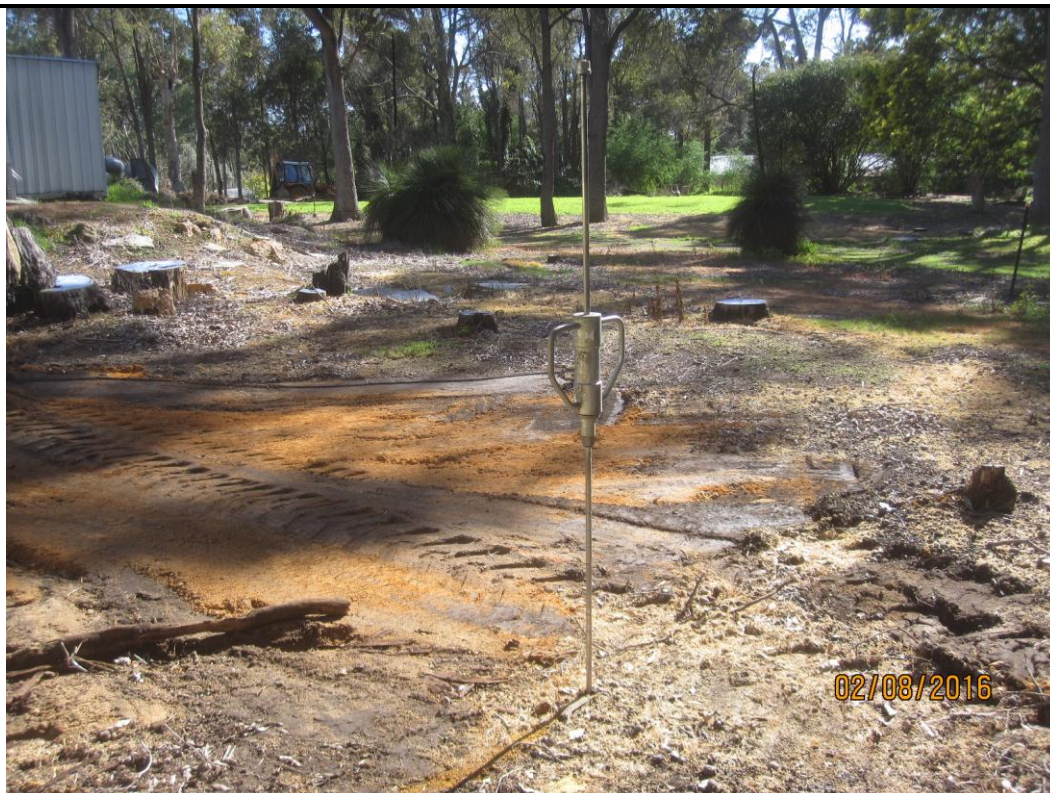
**Photo 9.** Test Location DCP2, Conducting Dynamic Cone Penetrometer Test

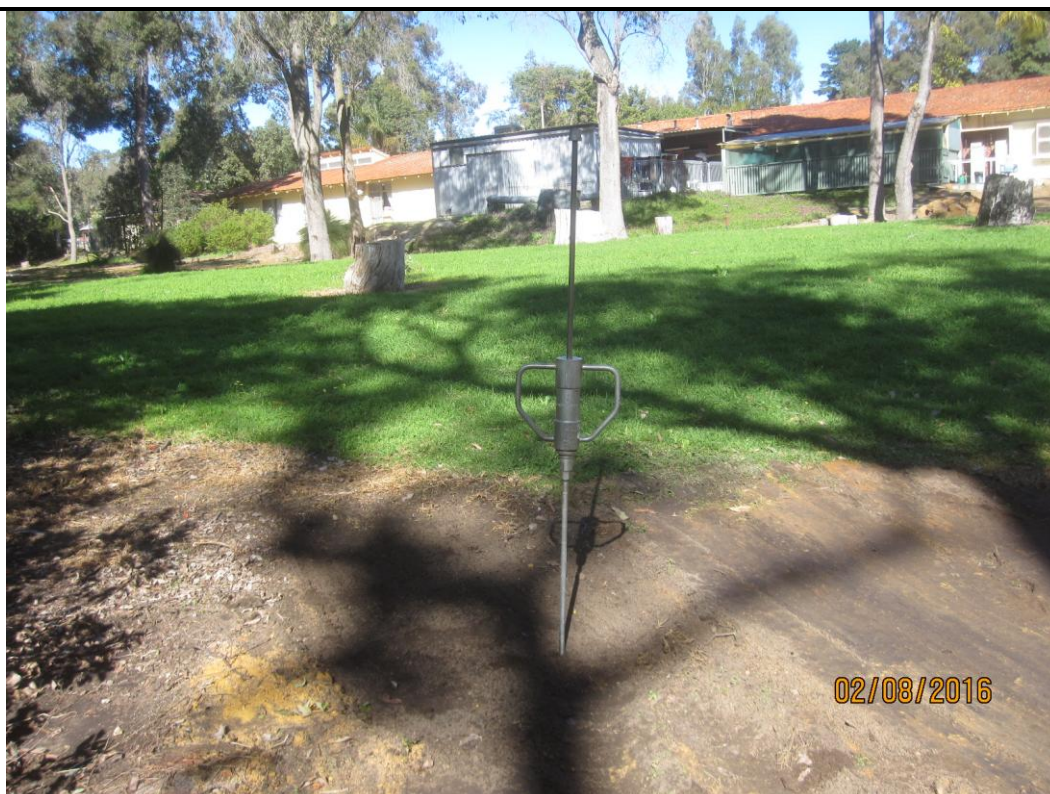
**Photo 10.** Test Location DCP4, Conducting Dynamic Cone Penetrometer Test
