## **Environmental Summary Report**

**Lot 500 Gavour Road, Wattle Grove**

Rev 0

September 2025

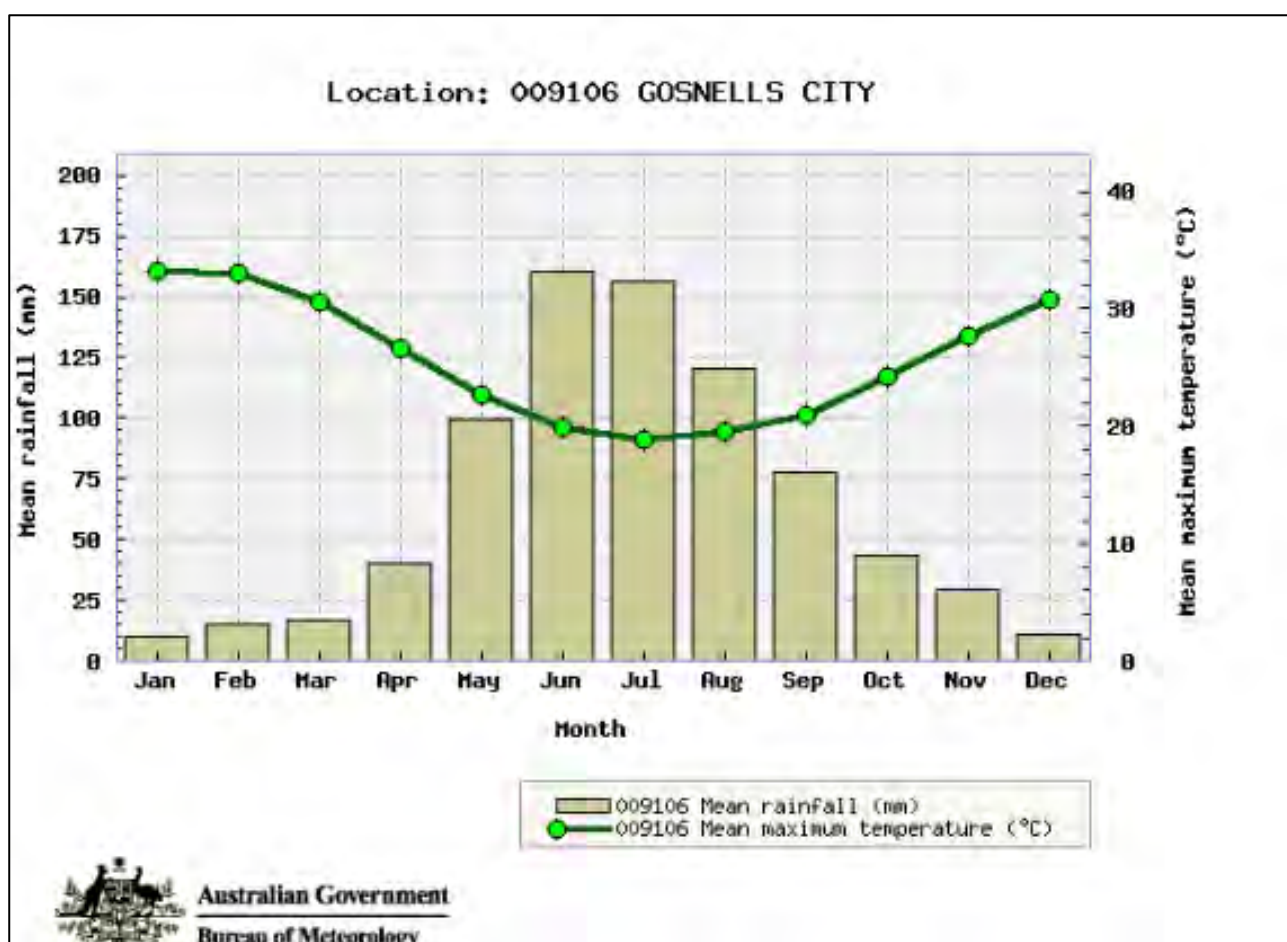
**Plate 2-1: Mean Rainfall and Mean Maximum Temperature – Gosnells Station**

Gosnells experiences an annual mean rainfall of 776.0 mm, with highest mean rainfall experienced in June (160.5 mm) and lowest mean rainfall experienced across warmer months. Mean maximum temperatures are highest in January and February (average of 33.0°C; highest recorded temperatures in February of 46.0°C) and mean minimum temperatures are recorded in July (average of 8.9°C; lowest recorded temperature 0.5°C) (BoM, 2025; Plate 2-1).

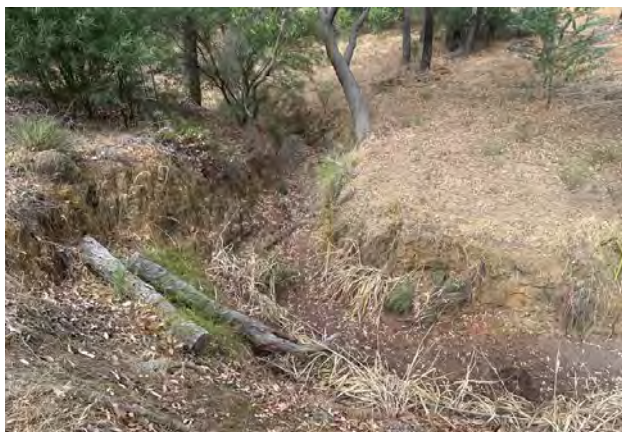
**Plate 2-6: Eastern embankment of Crystal Brook**

Notably, where the vertical banks of the Crystal Brook form, the soils appear clayey in nature (predominantly in eastern portion of creekline), becoming flatter as soils are less clayey and have more structure (western portion of creekline) (Strategen, 2014). Examples of where banks showcase this geology and topography are shown below (Plate 2-6 and Plate 2-7).

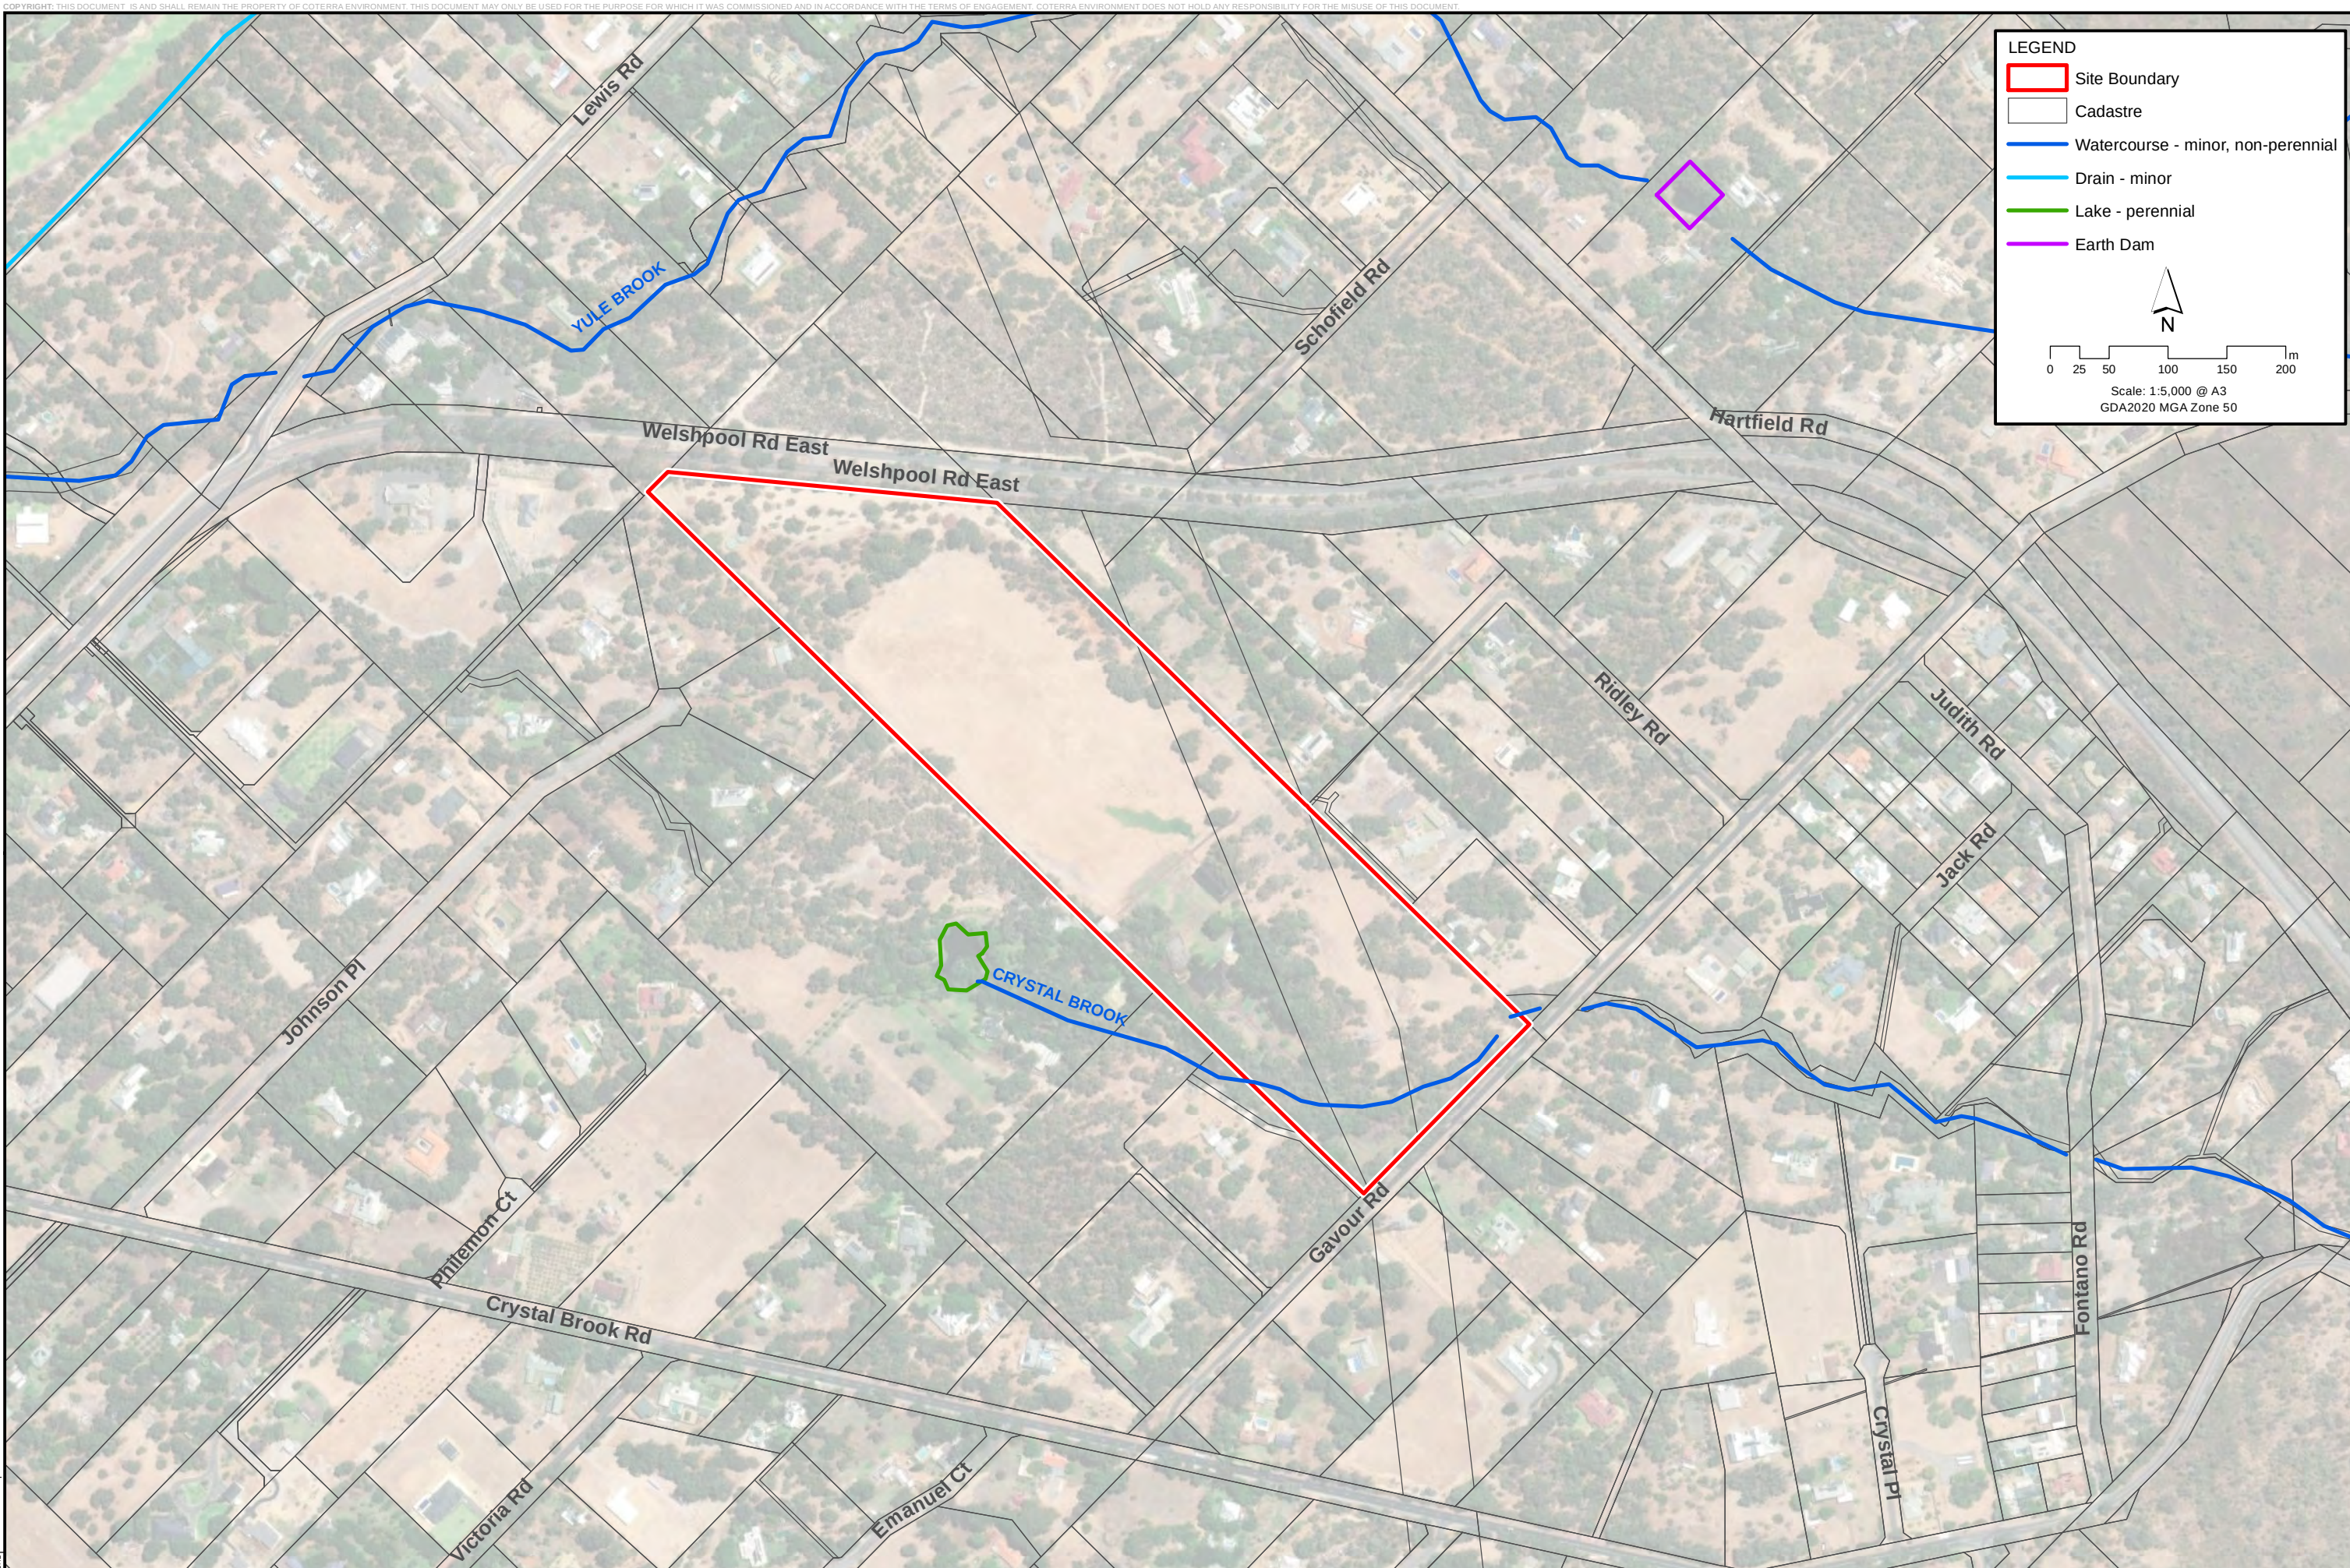
Figure 3

**HYDROLOGY AND WATERWAYS**

There are no mapped wetlands within the site, with the closest Conservation Category Wetland (CCW) being located approximately 850 m west of the site at its closest point (Landgate, 2025; Figure 3).

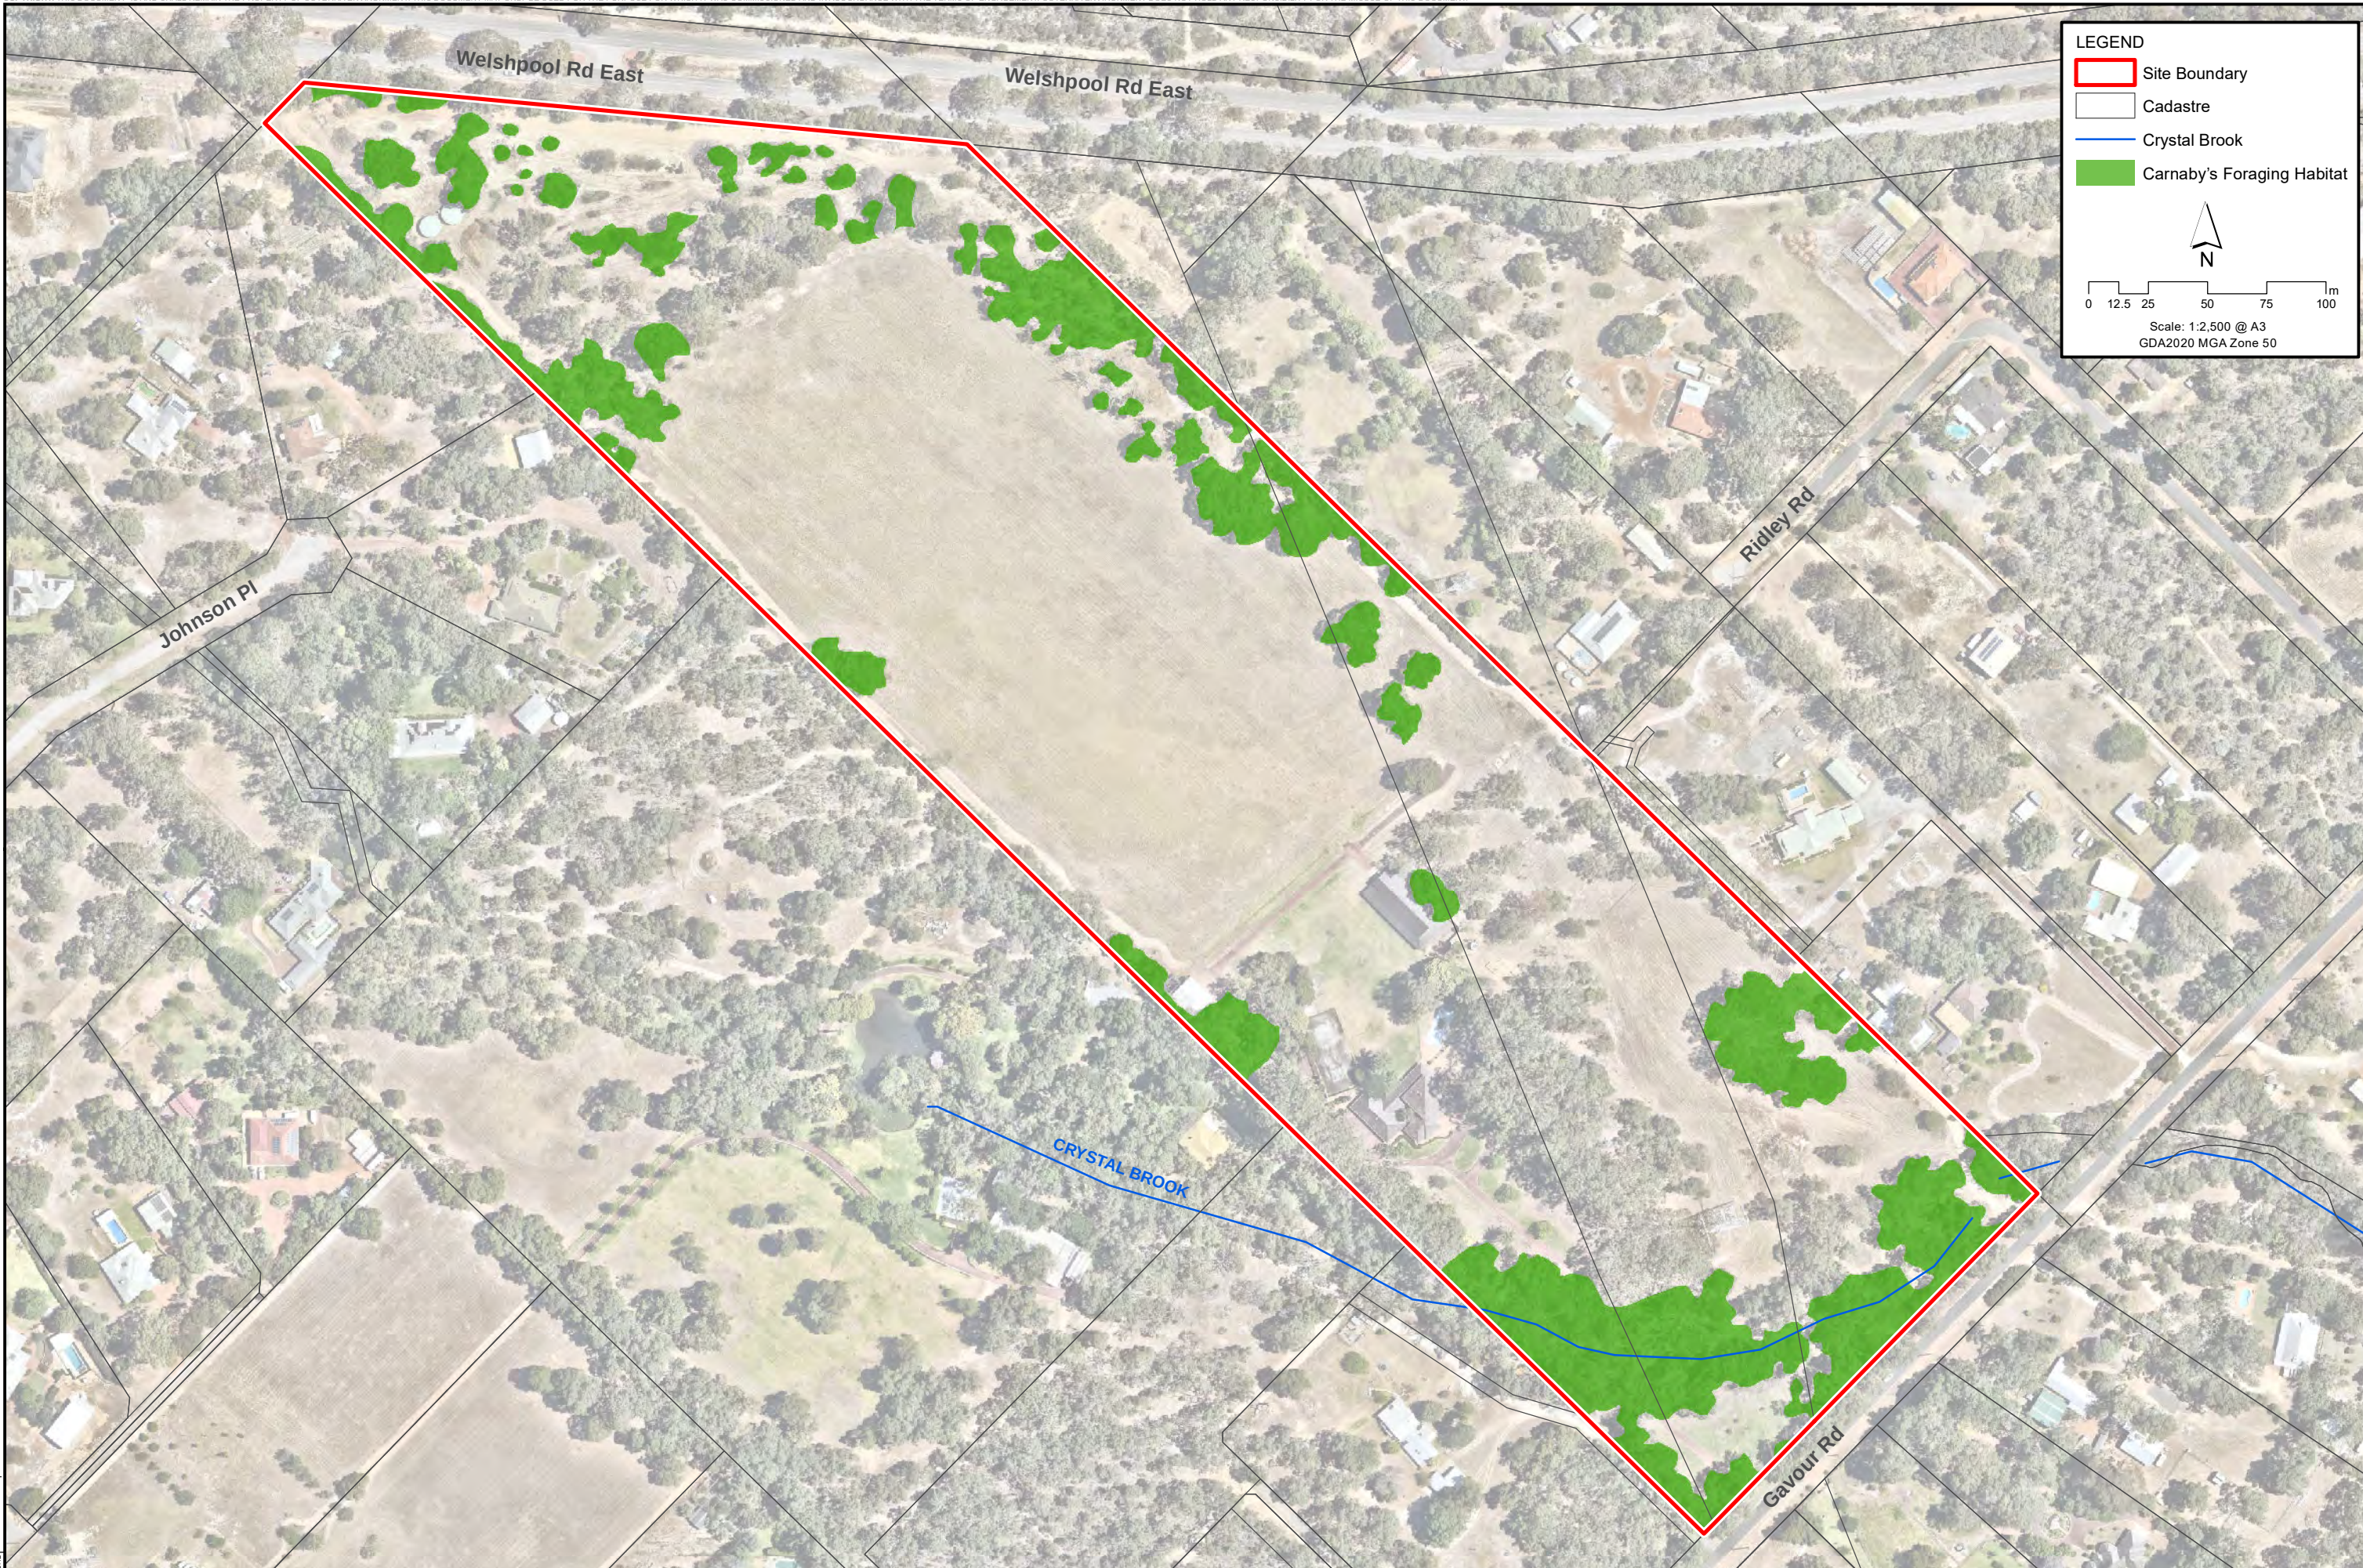
Figure 4

However, given the extent of time that has passed since the 2018 survey, and the lack of native vegetation understorey within the site due to ongoing fire mitigation measures, PGV Environmental undertook an assessment in May 2024 which mapped the dominant tree types (native and non-native) within the site (Figure 4), along with the following corresponding tree codes, (PGV, 2025):

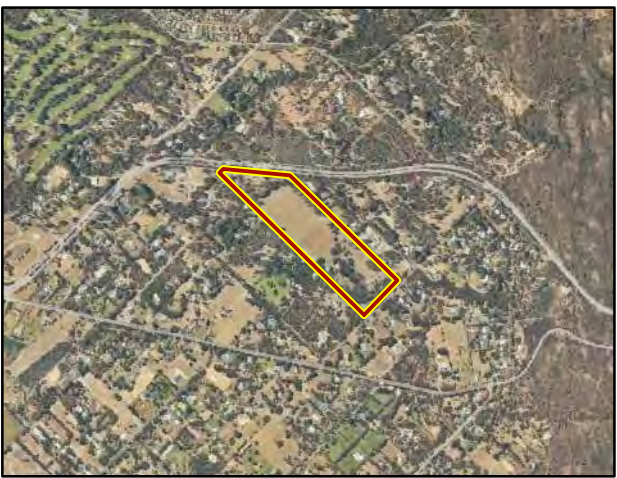
| Job No | J2101290 | Fig No | FIGURE 1 |

The approximate test locations are shown on Figure 1, Site and Location Plan. Photographs of the site taken during the fieldwork are presented in Appendix A, Site Photographs.

This report presents the outcomes of Galt Geotechnics Pty Ltd's (Galt's) geotechnical study for the proposed retirement village on Lot 500 Gavour Road, Wattle Grove (the "site"). The location of the site relative to the surrounding area is shown on Figure 1, Site and Location Plan.

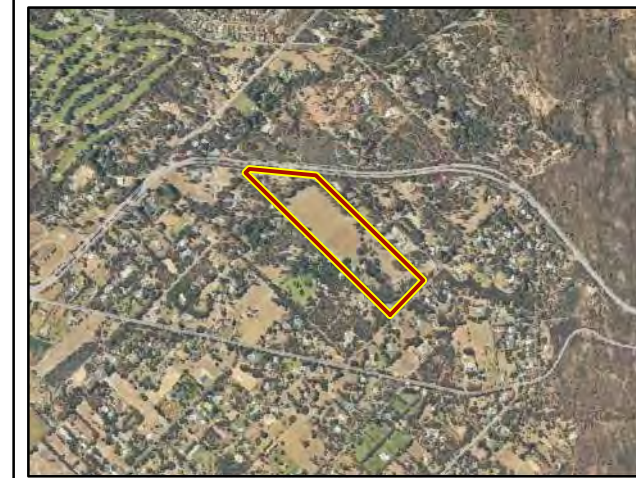
| Job No | J2101290 | Fig No | FIGURE 2 | Rev | <b>A</b> |

We have assessed the site classification in accordance with AS 2870-2011 “Residential Slabs and Footings”. Two areas have been delineated, and are shown on Figure 2, Site Classification Plan. The northern area as shown is considered to be “Class A”, and the balance of the site considered to be “Class S”.

- Notes:**
1. Soil descriptions below 3.0 m are based on interpretation of CPT data in accordance with Robertson et al (1986).
  2. An approximate delineation of these zones is given on Figure 2, with the north area being referred to as the “Class A” area and the balance of the site “Class S”, as discussed later in this report.

The result is two distinct areas, with a “mottled” central zone. For the purposes of design, we consider that the sandy area at the north can be treated as “Class A” area (AS2870-2011), while the balance of the site is a “Class S” area. This is shown on Figure 2 and discussed in Section 7.2.

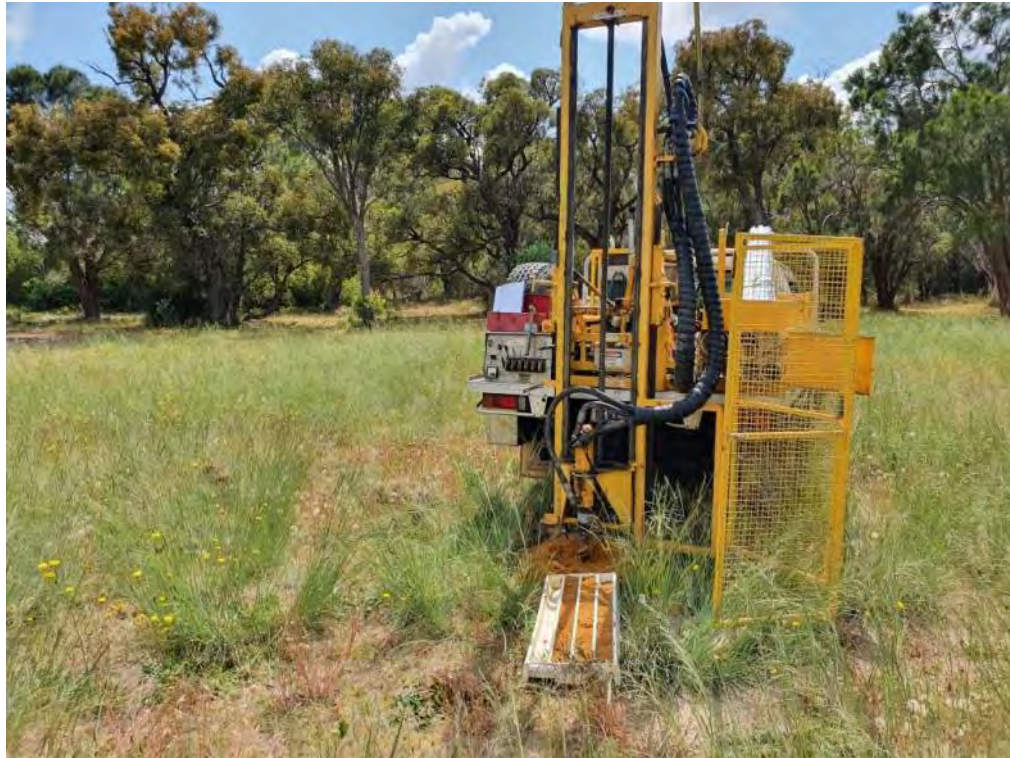
Photograph 3: Borehole drilling at the north of the site

Test locations were selected and positioned by a geotechnical engineer from Galt. The geotechnical engineer conducted the walkover and inspection of the site, observed the CPTs, drilled the auger boreholes and logged the materials encountered, and performed the penetrometer, permeability and infiltration tests.

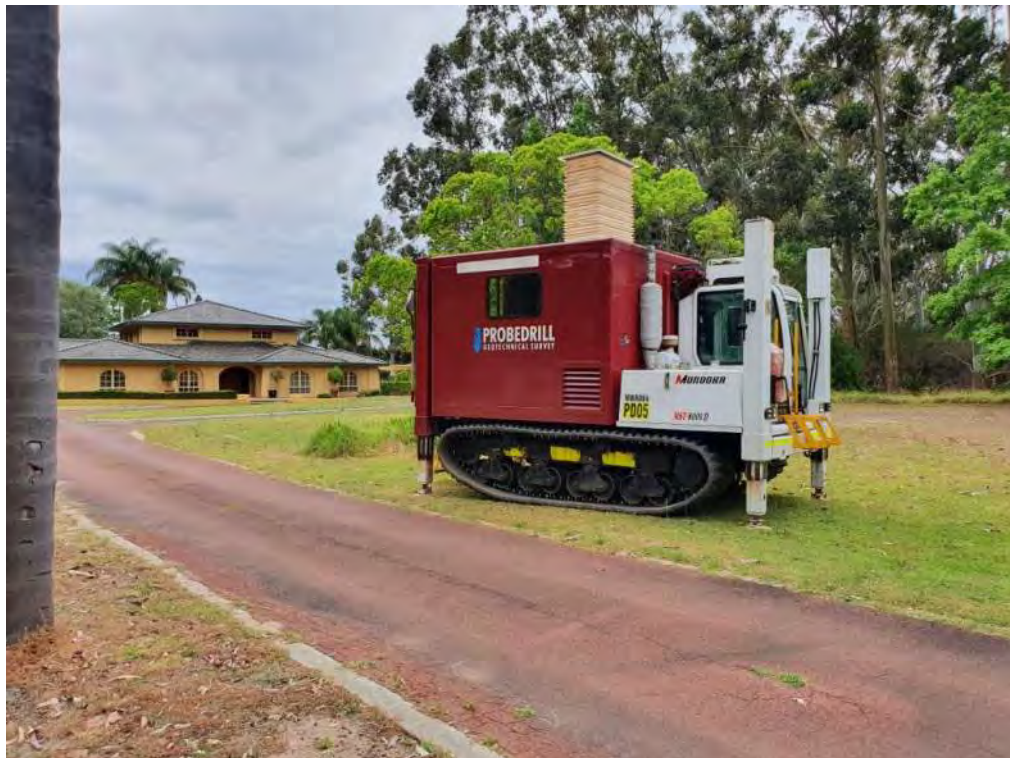
Photograph 4: CPT testing near the centre of the site
