# LOCAL GEOTECHNICS

**Report on**  
**Field Permeability Test**  
**24 Valencia Road, Carmel WA**

Project:  
**LG7722016FPT**  
**REV\_1**

Client: **Burswood Care Pty Ltd**

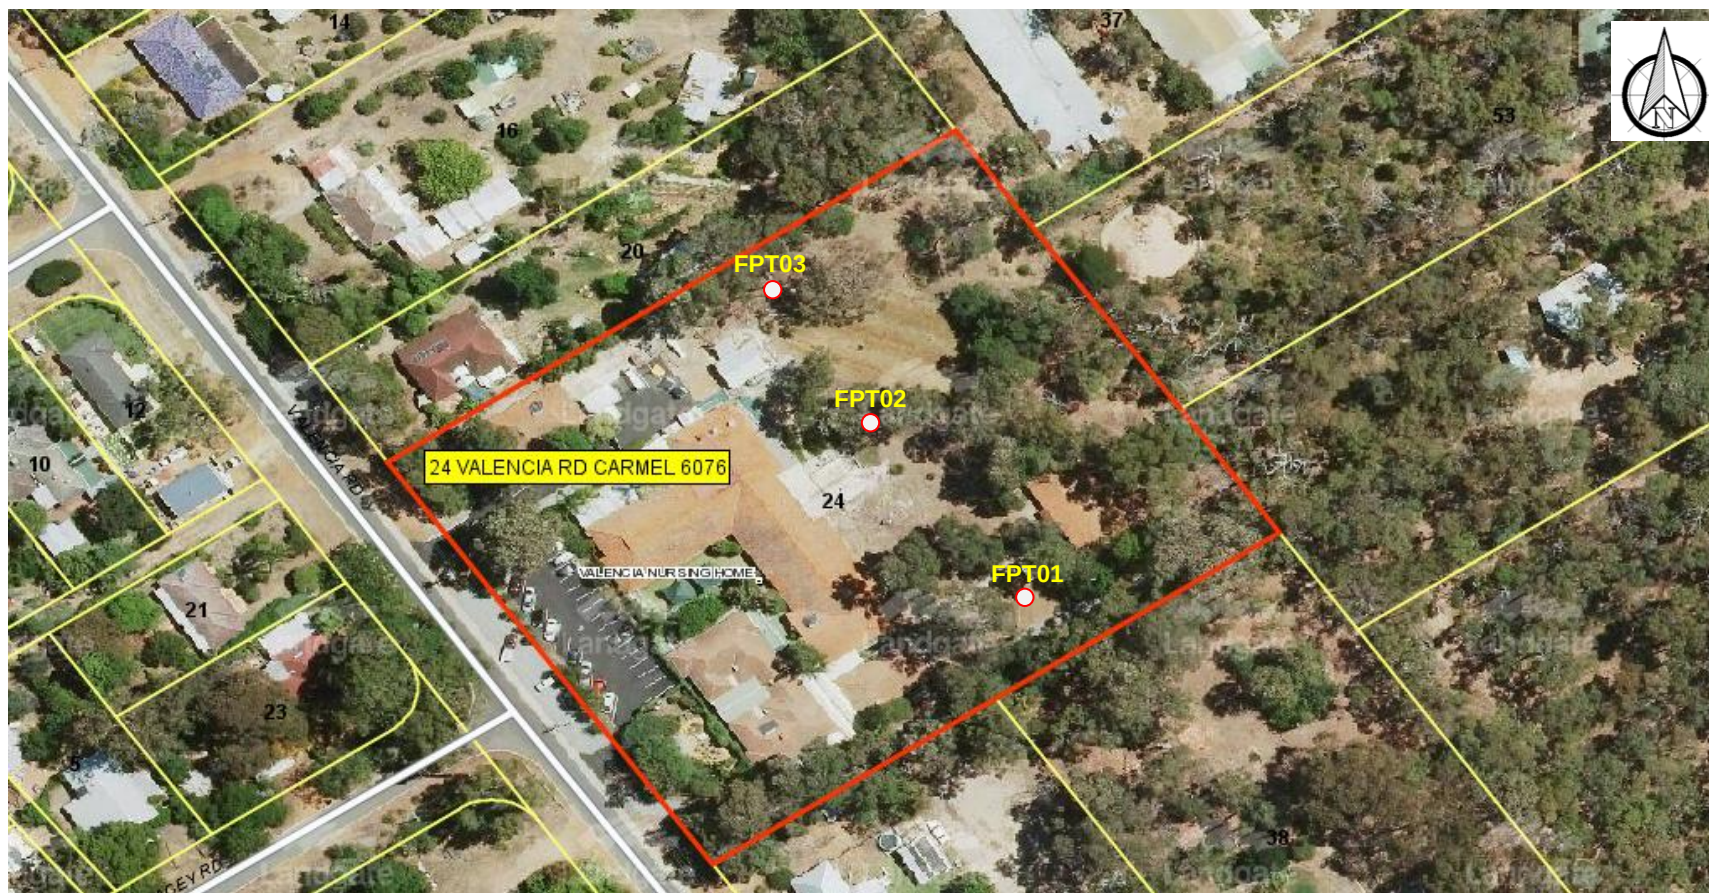
**Site Sketch : Field Permeability Test Locations**

The field works consists of field observation, conduction of three (03) field permeability tests by using Guelph Permeameter and taking photographs. The field permeability test locations are denoted as FPT01, FPT02 and FPT03.

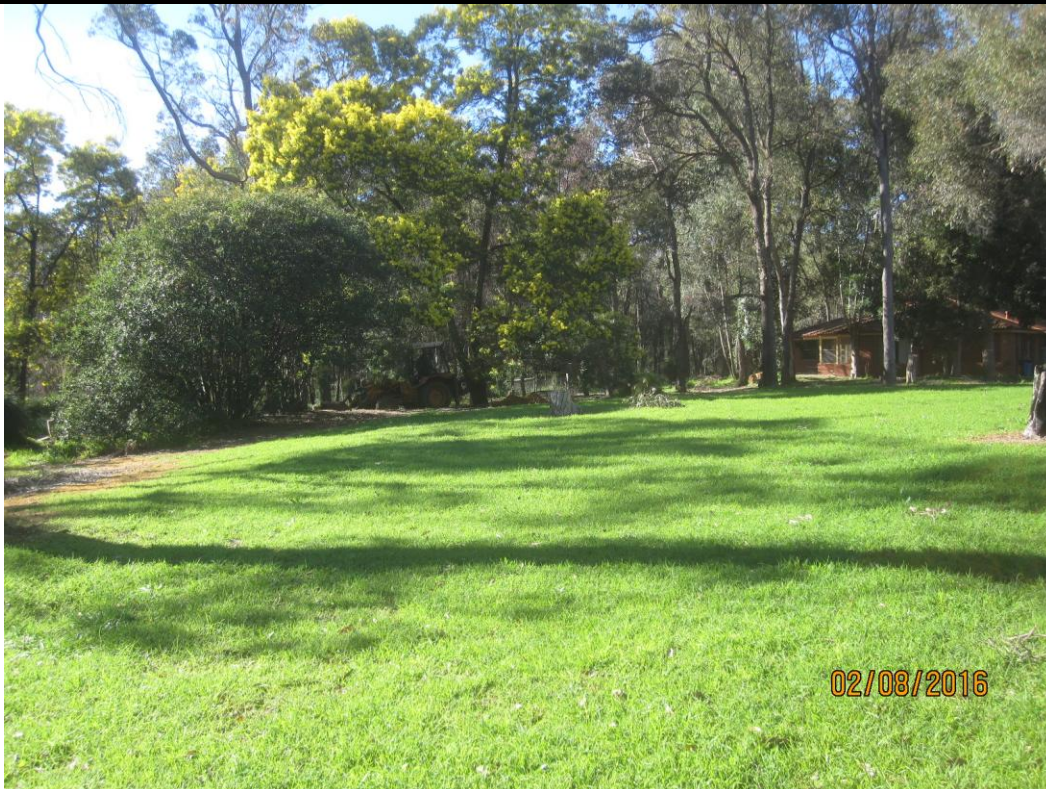
**Photo 3.** Existing leach drain area at site

The site is located at 24 Valencia Road, Carmel WA. There is an existing nursing home at front of the site which will remain. There is a house near to the south-east corner of the site. There are few small to large size trees at the site and the site is covered with grasses. There are few leach drains were found at site. The topography of the area is hilly and the site level is found with slope from western towards eastern side. The site photos taken during the permeability test are shown in Appendix C.

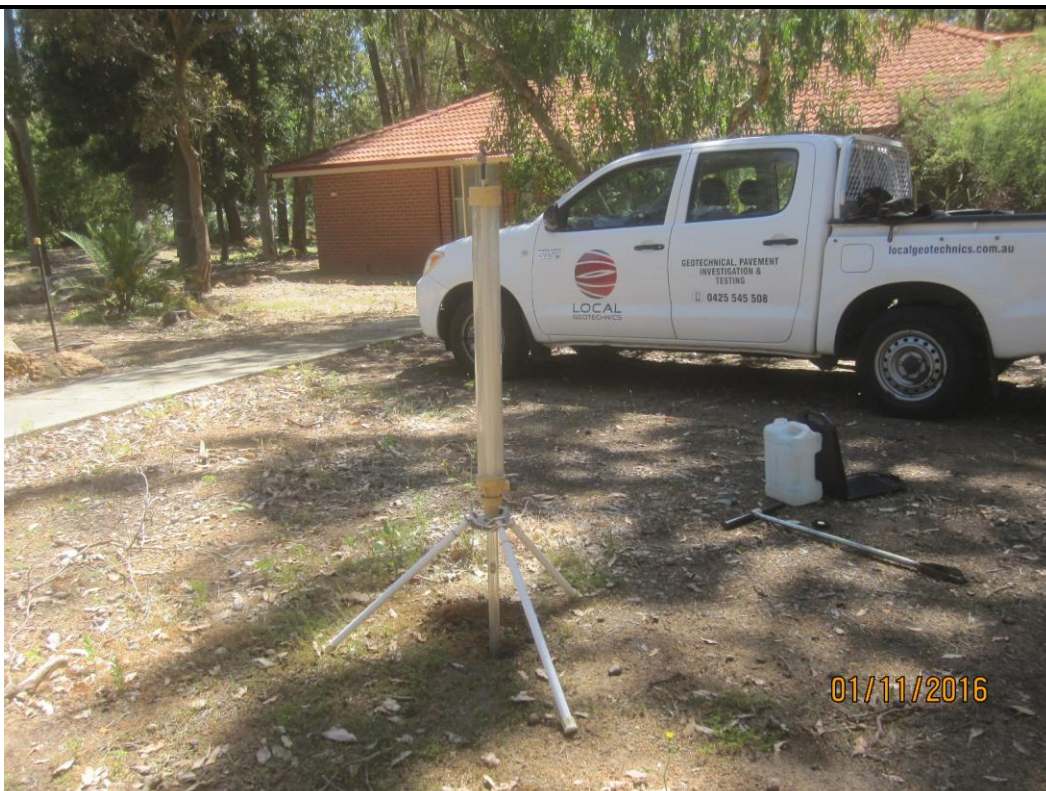
**Photo 4.** Infiltration Test at Location FPT01

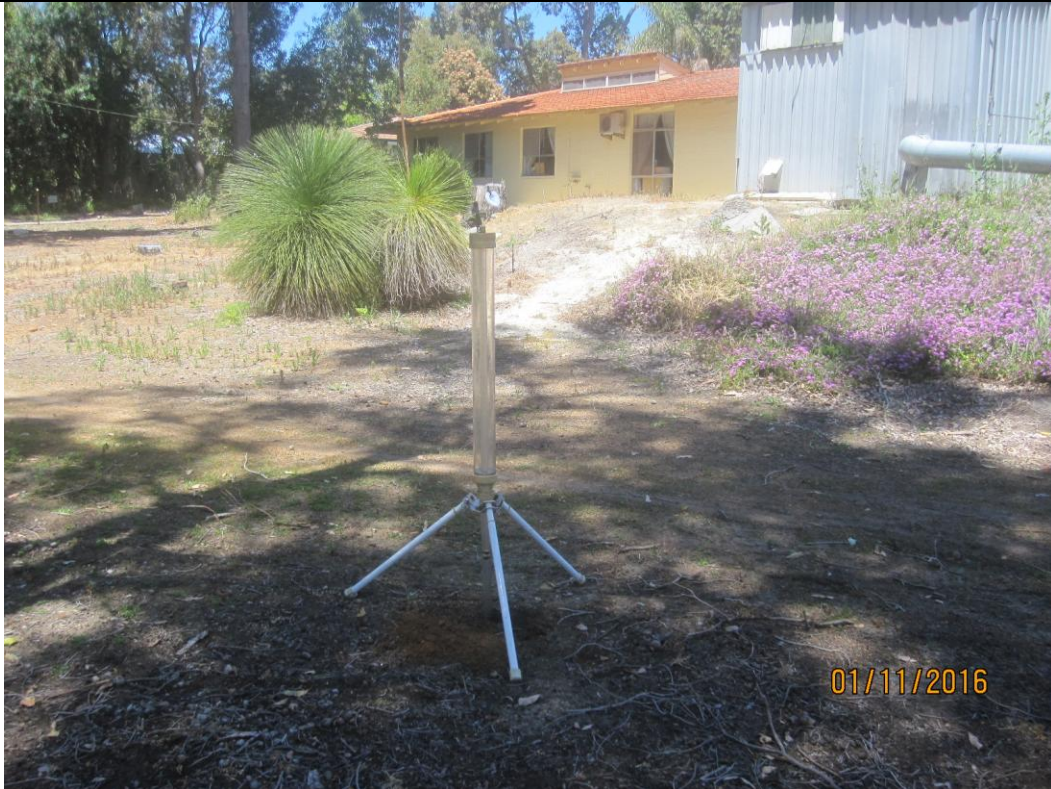
**Photo 5. Infiltration Test at Location FPT02**

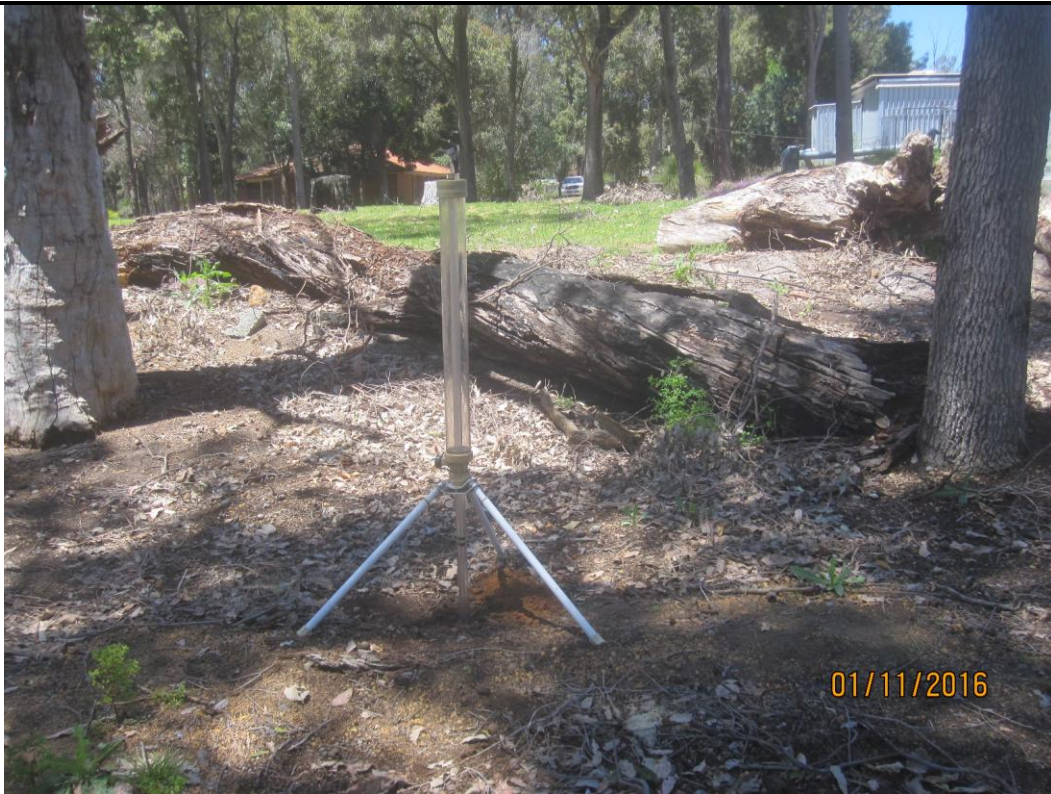
**Photo 6. Infiltration Test at Location FPT03**
