## MEMORANDUM

| <b>Date</b> | 21 September 2017 | <b>Title</b> | Lot 28 Lewis Rd, Wattle Grove - Bed and Banks Permit Application Report |
| <b>Ref.</b> | PHA17001/02 | <b>Distribution</b> | Department of Water and Environmental Regulation |

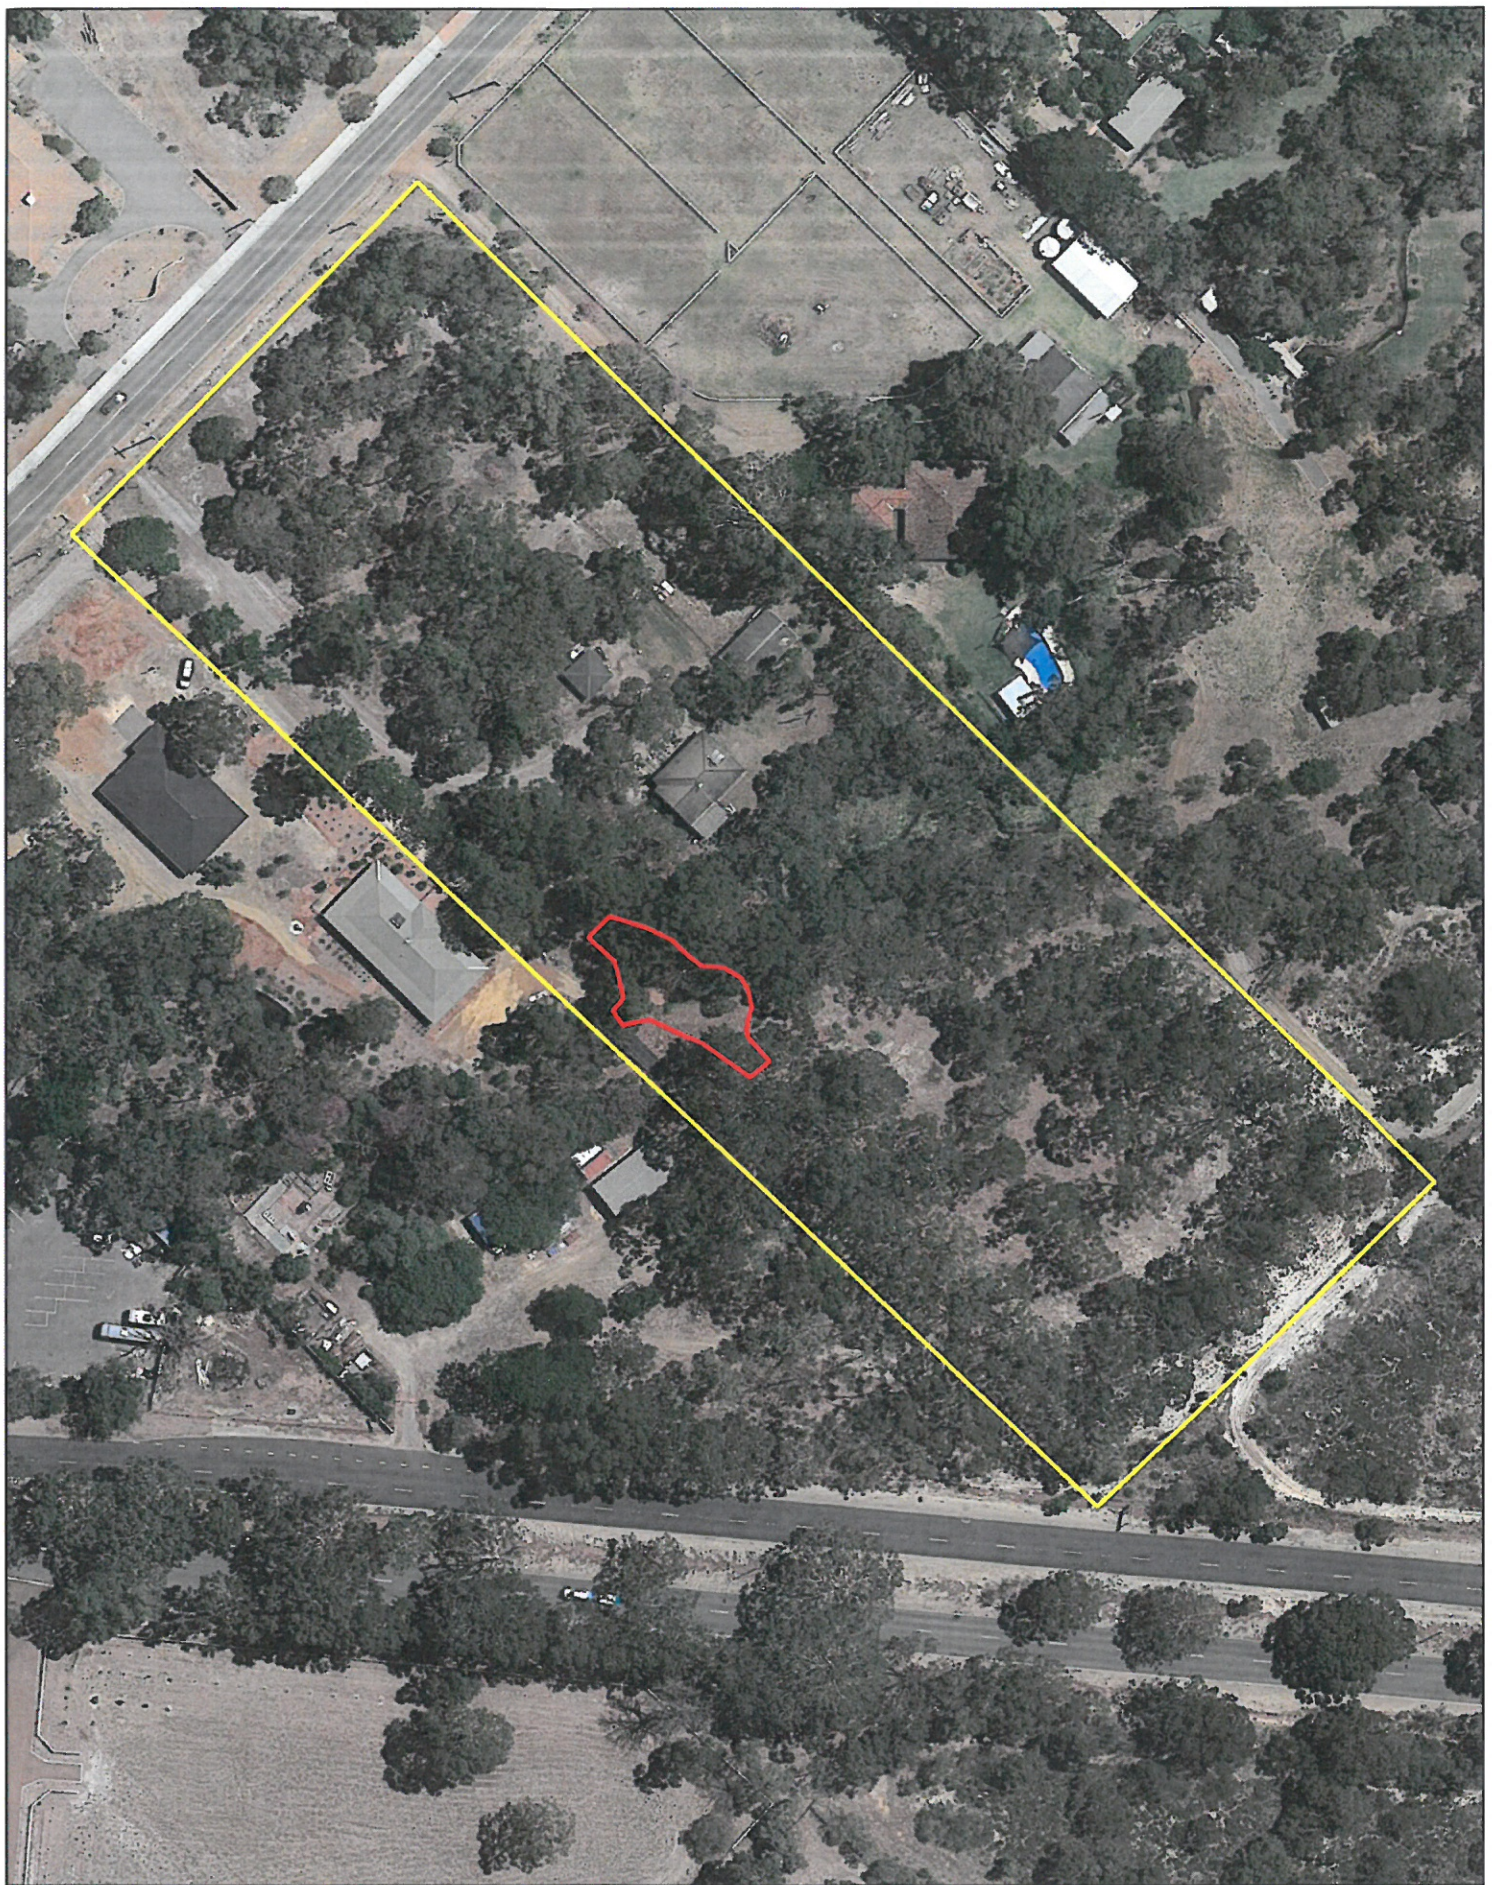
**Figure 1 - Lot 28 Lewis Road,  
Wattle Grove**

An area of Lot 28 Lewis Road, Wattle Grove (**Figure 1**) is proposed for the construction and operation of a building that will serve the purposes of a place of worship, a sanctuary and a community centre. A perennial stream, Yule Brook, flows through the property, and it is proposed that a formal crossing be constructed by installing a culvert, to enable vehicular access to the rear of the property, for both users of the facilities and emergency vehicles, should the need arise.

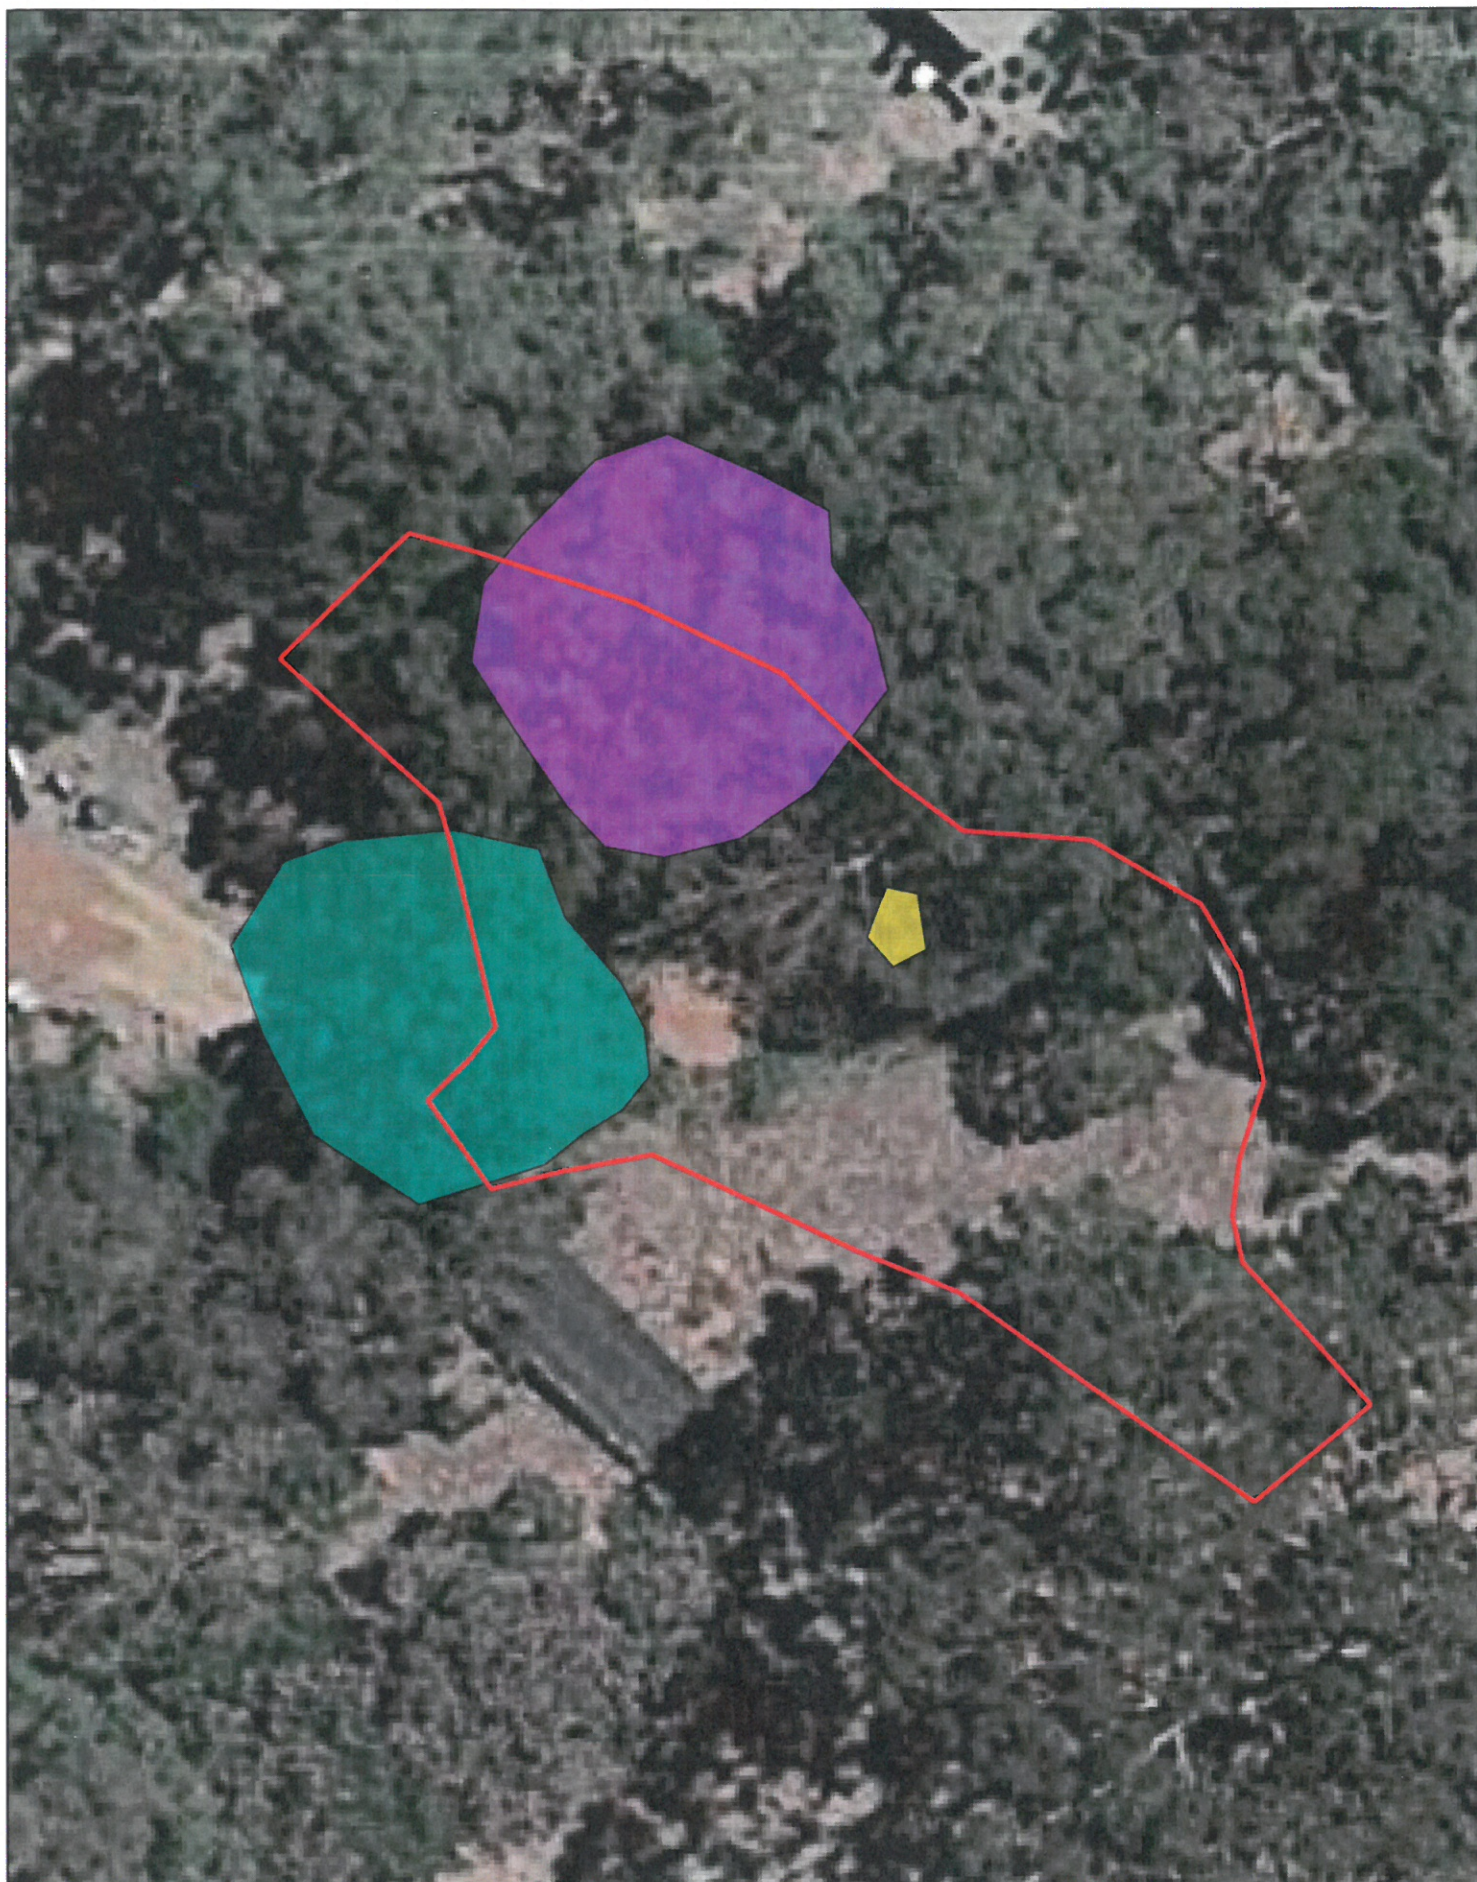
**Figure 2 - Impacted Native Vegetation**

On the west bank, there are two mature marri (*Corymbia calophylla*) trees present, in positions shown in **Figure 2**, which for both trees, is largely inside the clearing footprint (if not inside the impact zone, the trees' root systems would be compromised to the degree that their survival would be unlikely). These trees are both approximately 13 m tall, and the tree closest to the stream (on the far right in **Plate 3**) has a diameter at breast height (DBH) less than 50 cm. The other Marri tree within the proposed clearing footprint (positioned approximately in the centre of **Plate 3**) has a DBH of 58.5 cm. Given that this tree's DBH is greater than 50 cm, it is considered a habitat tree (potential future breeding tree) for Black-cockatoos. Neither tree supports any visible hollows.

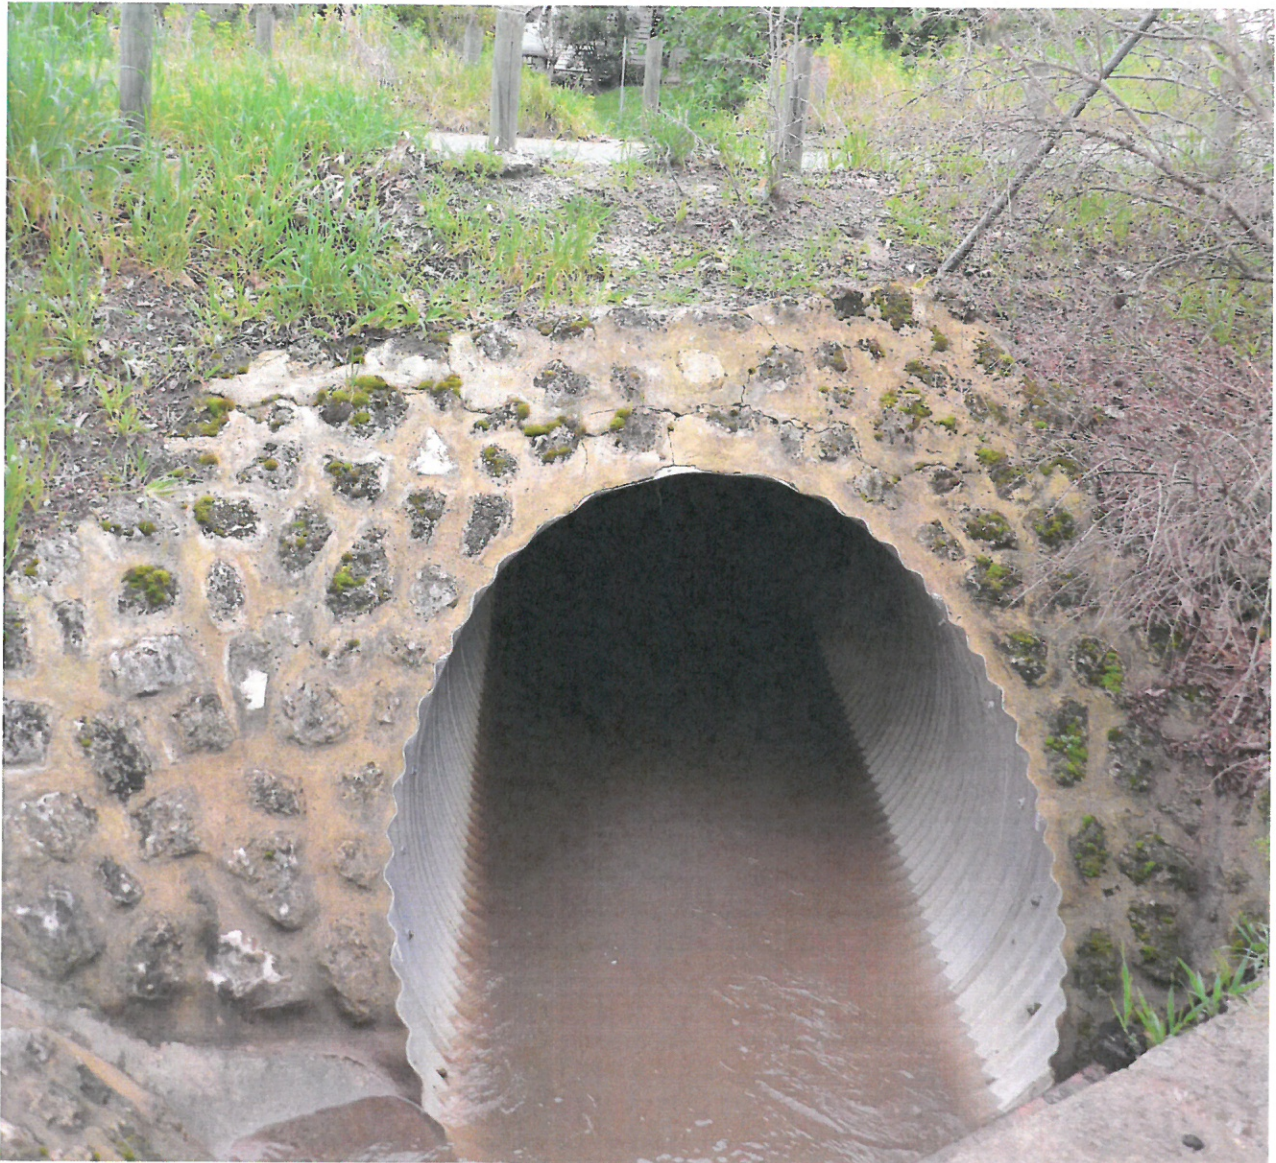
The proposed installation of a culvert and construction of vehicular crossing over Yule Brook will comprise of a 3.5 m wide road with batters up to 9 m wide on each side, and a 1,800 mm diameter halcoil corrugated pipe, tapered to be longer on the base. The batters will be backfilled with local fill, stoned pitched and concreted in order to stabilise them. There is an existing culvert of identical design at a crossing of Yule Brook on a neighbouring property, as shown in **Plate 1**.

**Plate 1: Existing culvert on neighbouring property**

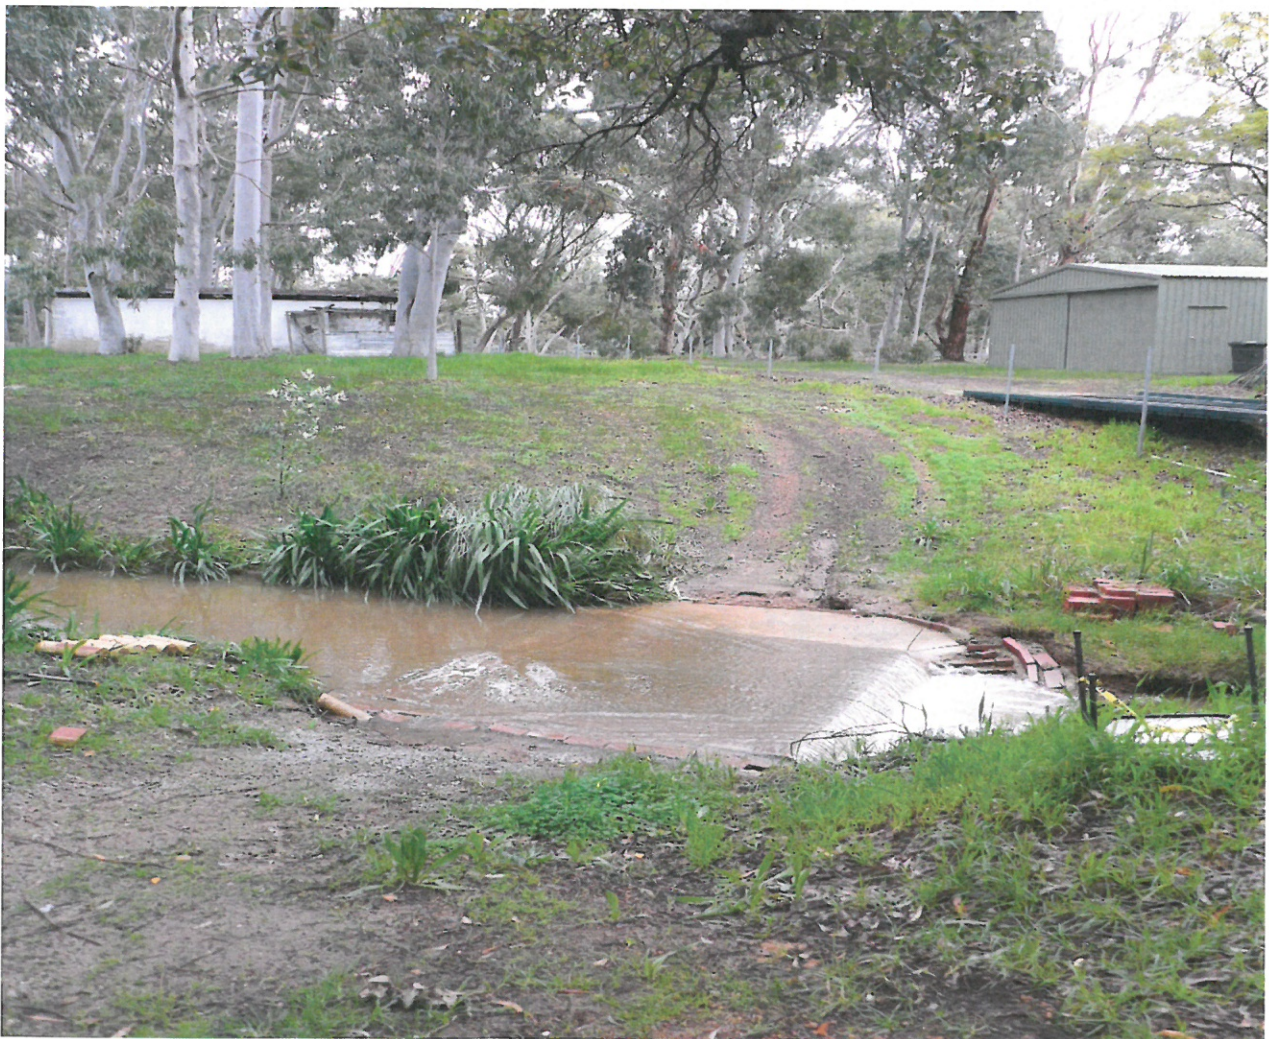
The area on Lot 28 Lewis Road, proposed to be cleared for installation of a culvert and construction of vehicular crossing over Yule Brook supports no intact native vegetation, with just a few isolated native trees and shrubs on the west bank. The vegetation on the east bank comprises mainly introduced grasses and other weeds, including *Watsonia meriana*, *Plantago debilis*, *Trifolium* sp. and *Cenchrus clandestinum*, with non-endemic (planted) Lemon-scented Gums further up the bank (**Plate 2**).

**Plate 2: Vegetation present at location proposed for culvert and vehicular crossing, with an eastern-facing view**

A small revegetation program is also planned as part of the project. Once the culvert is constructed, during a suitable season, some planting of native species (trees, shrubs and rushes/sedges) will be carried out, along with soil stabilization (mulch and/or matting), as and if appropriate.

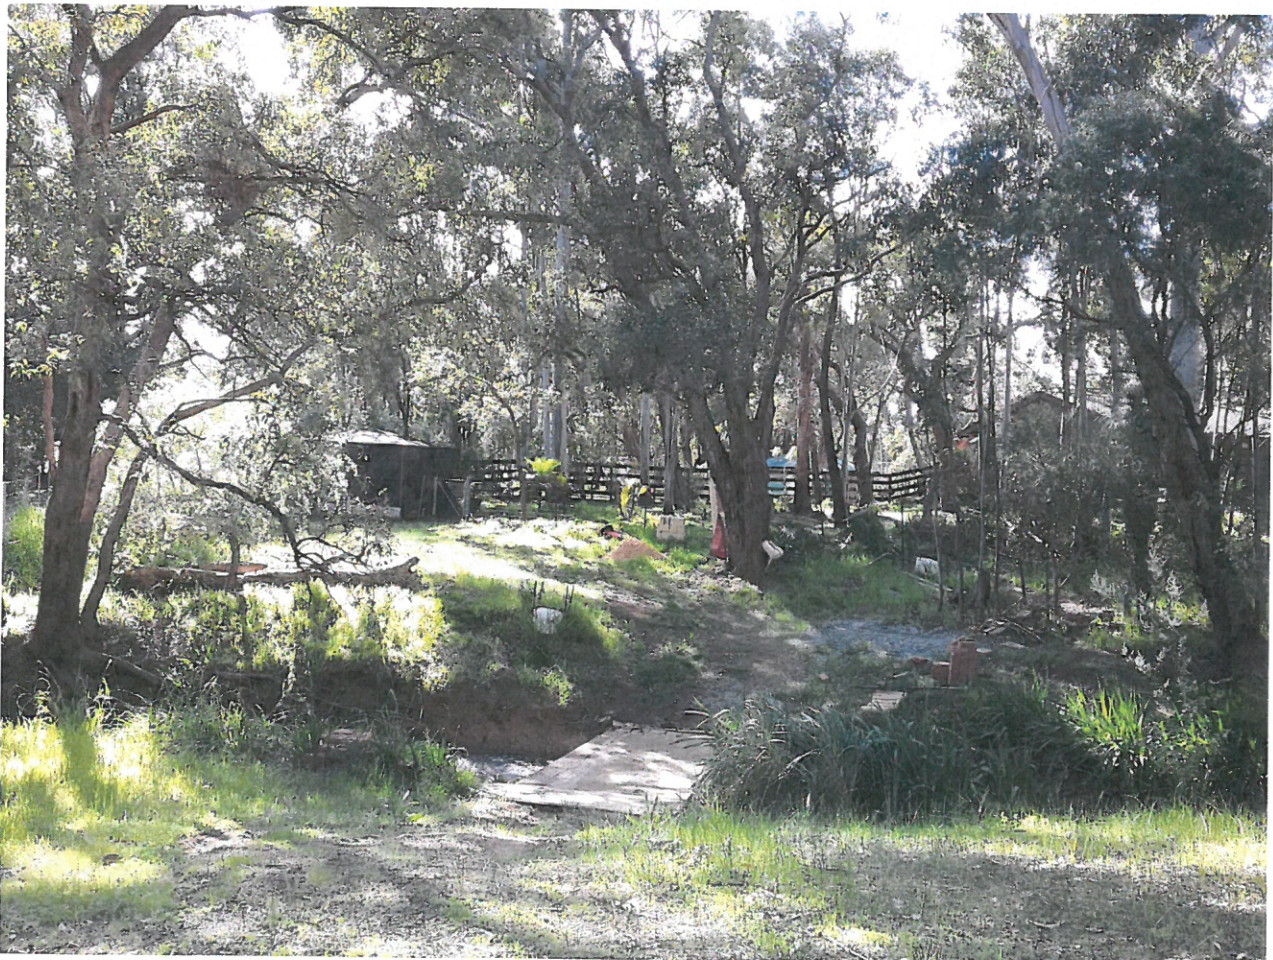
**Plate 3: Vegetation present at location proposed for culvert and vehicular crossing, with a western-facing view**

Also visible in **Plate 3** (directly to the left of the large dead Eucalypt trunk) is a single, mature *Kingia australis*, and in the immediate foreground of this, a single, juvenile *Trymalium floribundum* shrub. Along with the two Marri trees, these plants comprise the only native species within the proposed clearing footprint necessary for the construction of the proposed culvert, in accordance with the current design.

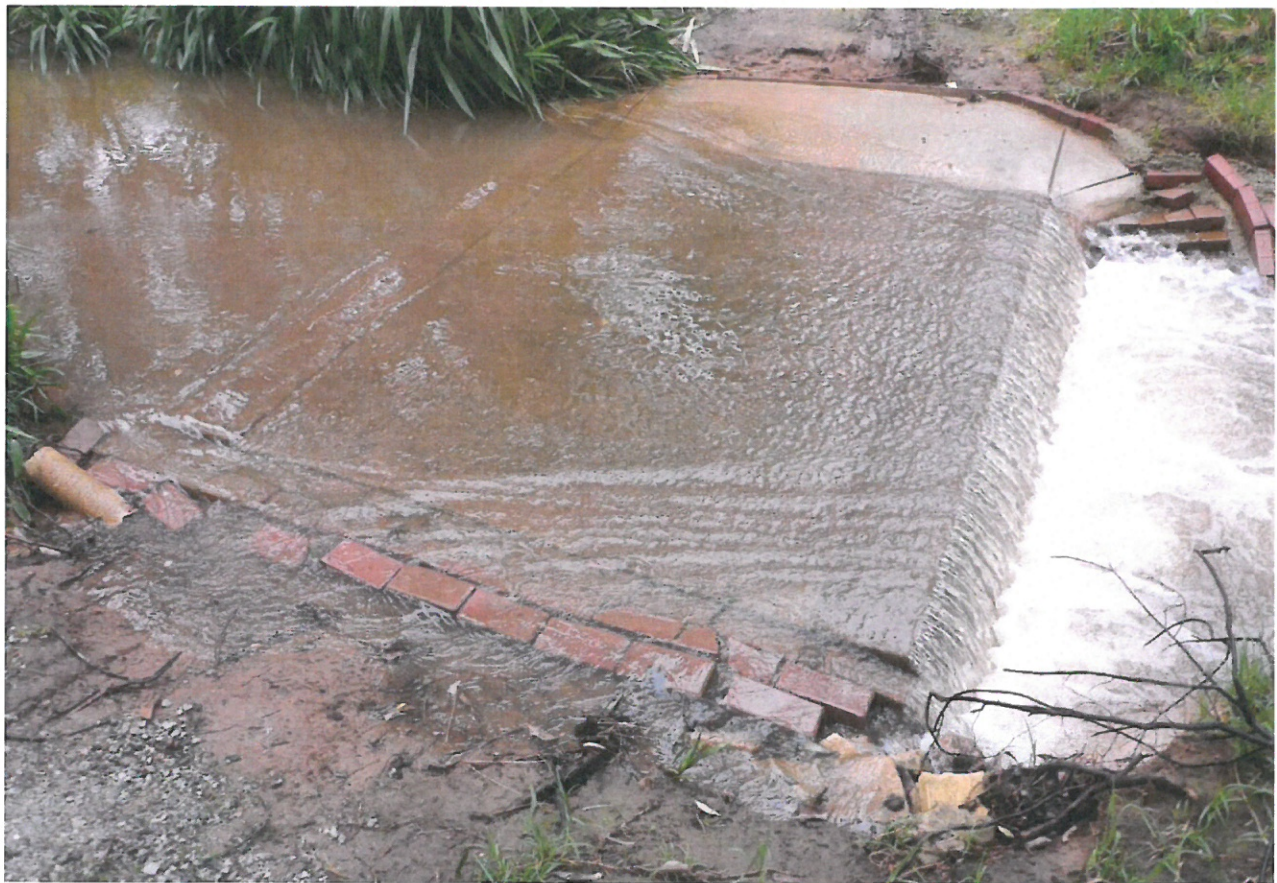
There is currently a concrete structure with underlying pipe on the bed of the creek at the existing crossing which will be removed prior to installation of the culvert and vehicular crossing (**Plate 4**). The downstream edge of this structure is creating a weir effect concentrating high velocity flows which are causing erosion in the creek bed. Additionally, the pipe is inadequate for winter stream volumes (**Plate 5**). Removal of this structure will benefit the integrity of the stream bed and maintaining stream flows.

**Plate 4: Bed of creek showing concrete structure**

The concrete base with underlying pipe currently present on the creek bed will be removed with minimal excavation to level for stabilisation of the bed.

Aprons will be constructed on the ends of the culvert base (upstream and downstream edges of the culvert on the bed), where they fall on the stream bed, to prevent any dam or weir effect and erosion.

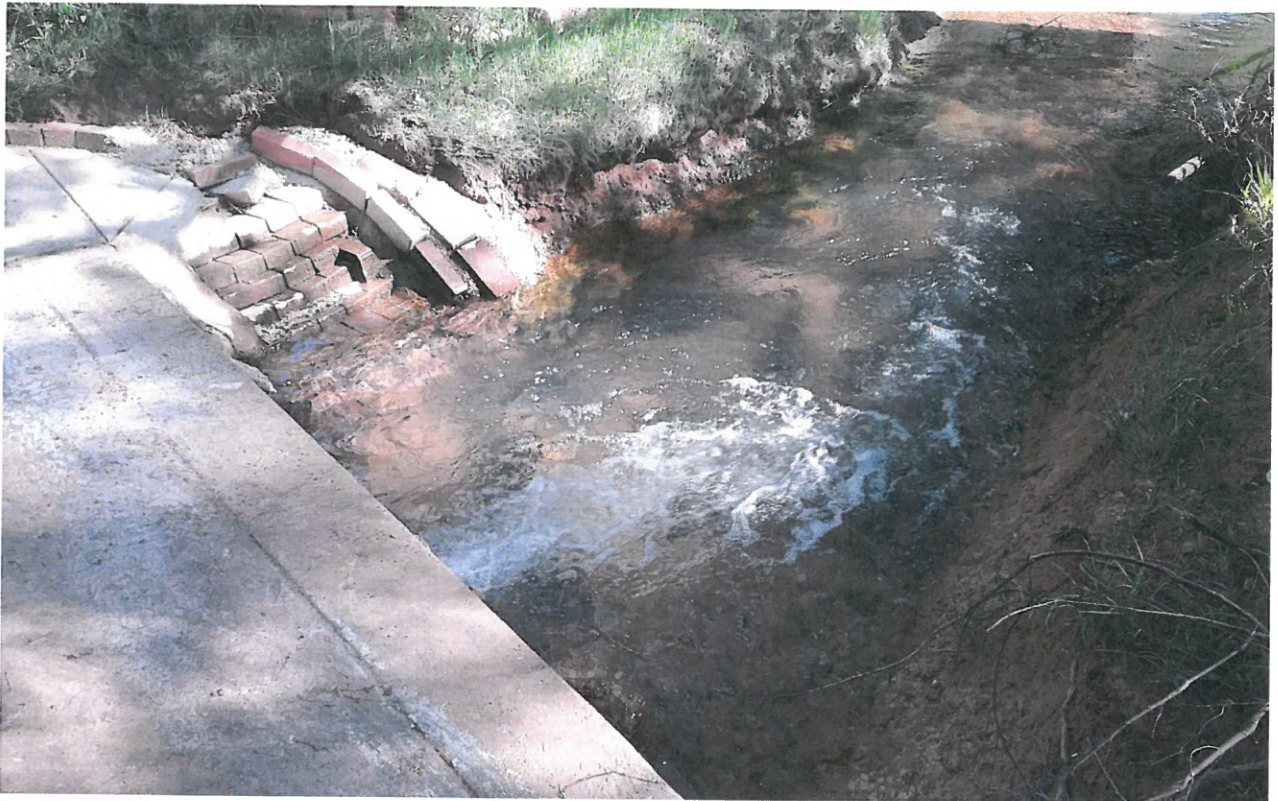
**Plate 5: Choked stream flows exiting the existing pipe**

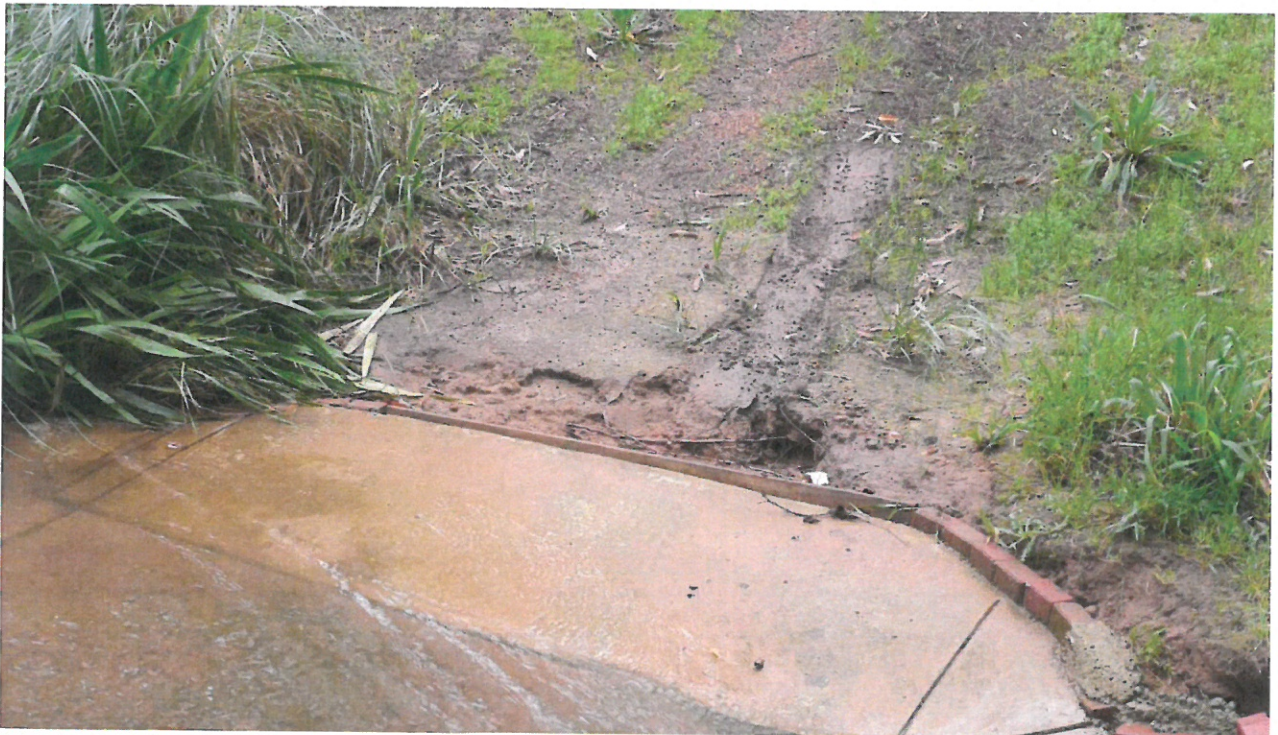
There is also some erosion present on the eastern bank resulting from vehicle access (**Plate 6**), and formalising a crossing over the brook will prevent any further such erosion.

**Plate 6: Erosion from vehicle access on eastern bank**
