# **Biophysical Assessment and Foreshore Management Plan**

**Lot 500 Gavour Road, Wattle Grove**

Rev 0

September 2025

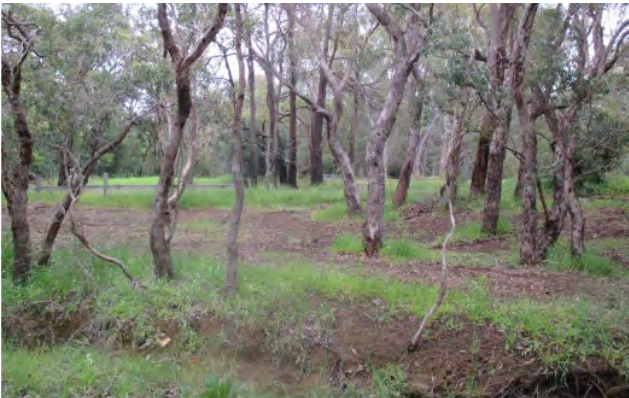
| Vegetation units | Example Site Photograph |
|---|---|
| <p><b>Unit 5: <i>Corymbia calophylla</i> (<i>Eucalyptus rudis</i>) open woodland over degraded/cleared</b> - Open woodland of <i>Corymbia calophylla</i> (<i>Eucalyptus rudis</i> variably present) over a historically cleared understorey.</p> <p><b>Condition:</b> Degraded, <b>Area:</b> 2.91 ha</p> | |

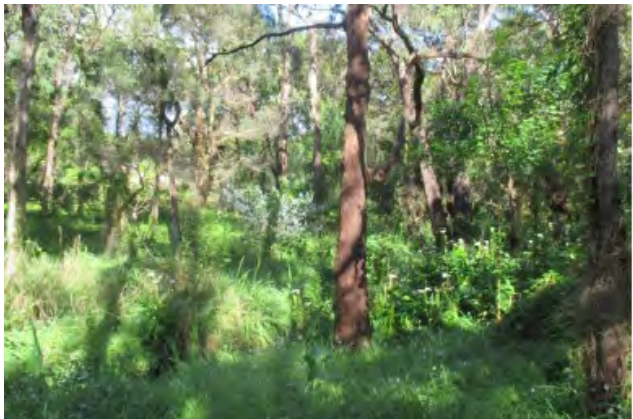
| Vegetation units | Example Site Photograph |
|---|---|
| <p><b>Unit 7: <i>Corymbia calophylla</i> woodland over dense garden planting</b> - <i>Corymbia calophylla</i> woodland over a dense tall understorey and ground layer of exotic plantings. A creek runs through a portion of the unit but is not associated with a separate vegetation unit. The Declared Pest <i>Zantedeschia aethiopica</i> (Arum Lilly) is present within this unit.</p> <p><b>Condition:</b> Completely Degraded, <b>Area:</b> 1.51 ha</p> | |

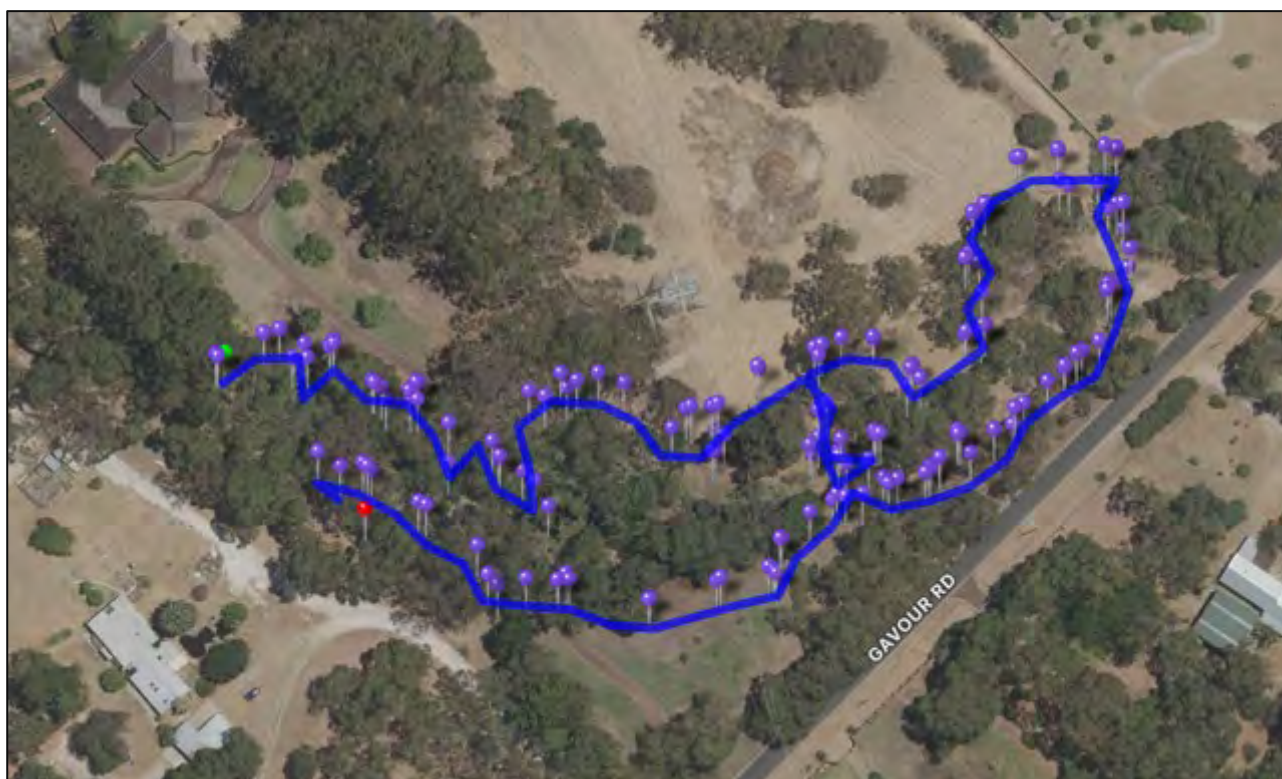
**Plate 3-1: Coterra Environment Site Inspection Track Log and Photo Points**

The biophysical assessment was informed by a targeted site visit by Coterra Environment scientists, desktop data assessment, as well as incorporation of relevant technical studies undertaken for the site. The Coterra Environment site inspection assessed the ground conditions and topographic elevations of the site nearby the creekline, as well as recording vegetated areas along the creekline. Track logs for the site inspection are provided below (Plate 3-1).

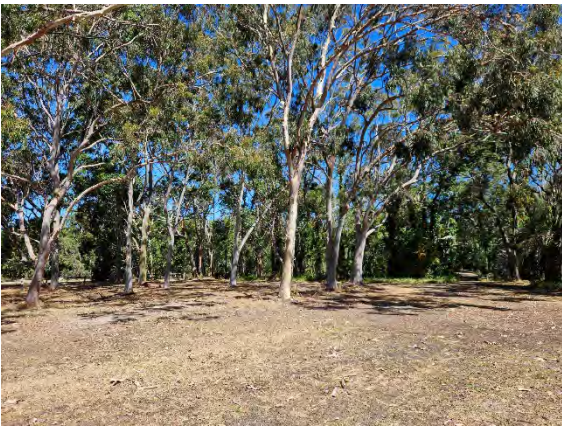
| Biophysical Criteria | Description | Site Assessment and Example Characteristic Photograph and/or Mapping |
|---|---|---|
| Vegetation | Fringing and upland vegetation associated with, or influencing, the waterway. | <p>Vegetation within the site consist of a mix of planted and naturally generated endemic and non-endemic species. Relevant considerations to determining the extent of the management area included the extent of <i>Corymbia calophylla</i> (marri), <i>Eucalyptus rudis</i> (flooded gum) and <i>Melaleuca</i> spp. growing in association with the Crystal Brook and foreshore area, as these species are known to grow in association with wetlands and drainage lines (Figure 2).</p> <p>Of note, <i>E. rudis</i> is not mapped as a dominant tree type in any other location within the site other than within the management area.</p> <p>At least 41 weeds occur within the foreshore area, and there is no distinct pattern of these species that delineate the creekline or management area, reflective of the site's current land use and associated landscaping (Table 4-2).</p> <p><b>Plate 3-2: <i>Eucalyptus rudis</i> along creekline</b></p> |

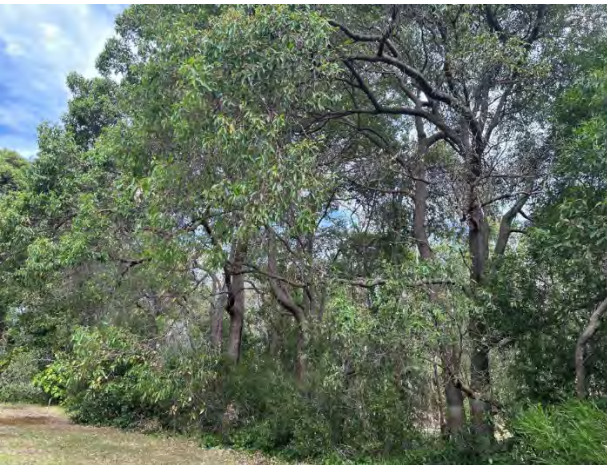
| Biophysical Criteria | Description | Site Assessment and Example Characteristic Photograph and/or Mapping | |
|---|---|---|---|
| Soil Type | Soil types that define extent of foreshore vegetation. | <p>The vegetation mapped in the 'CcEr' tree unit is in approximate correlation with the Forrestfield F4 Phase, and does not occur elsewhere on site (DPIRD, 2025). It is noted that the DPIRD mapping is broad scale and boundaries may vary on-ground.</p> <p><b>Plate 3-4: Example of CcEr Vegetation Unit</b></p> | <p><b>Plate 3-5: CcEr Vegetation Unit and Forrestfield F4 Phase Mapping</b></p> |

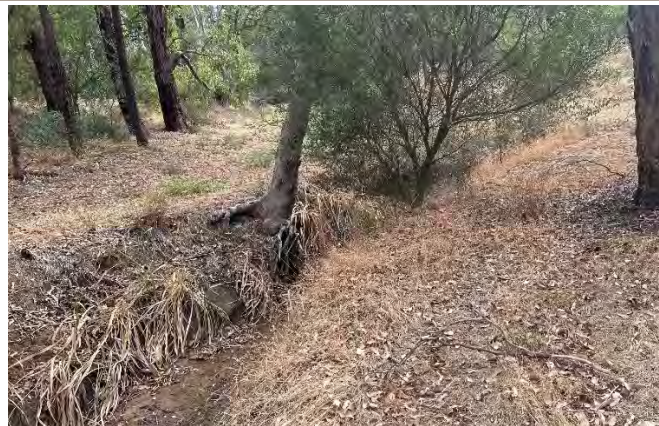
| Biophysical Criteria | Description | Site Assessment and Example Characteristic Photograph and/or Mapping | |
|---|---|---|---|
| Erosion | Soil types prone to erosion. | <p>The DPIRD maps Forrestfield F4 Phase as containing 60% of the map unit has a very high to extreme water erosion hazard (DPIRD, 2025). Other soils on site (Forrestfield D Range F2 phase and Forrestdale (D Range) F1 Phase) both have 0% of the map unit with a very high to extreme water erosion hazard (DPIRD, 2025).</p> <p><b>Plate 3-6: Erosion occurring within Forrestfield F4 Phase</b></p> | |

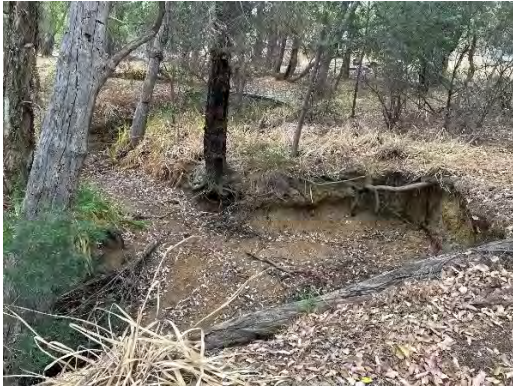
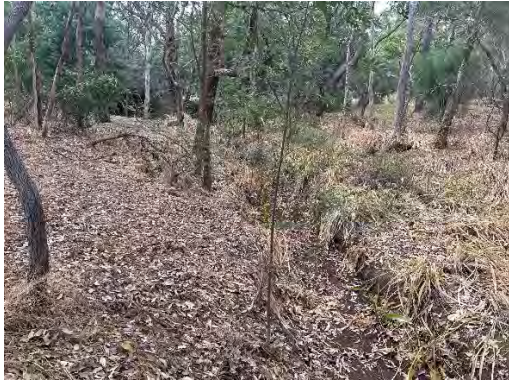
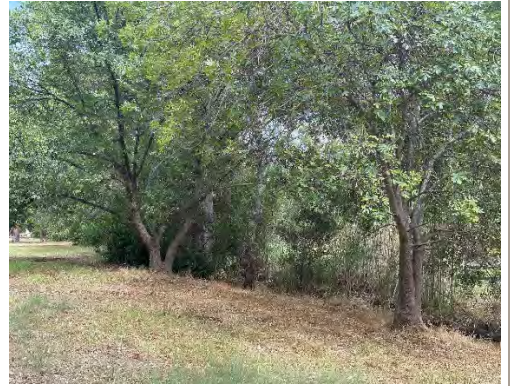
| Biophysical Criteria | Description | Site Assessment and Example Characteristic Photograph and/or Mapping |
|---|---|---|
| Topography | Landscape features including slope, shape and composition of the landforms that influence, or are influenced by the waterway. | <p>Notable site topographic features that were considered when defining the management area include:</p> <ul style="list-style-type: none"> <li>Existing waterway is defined by an incised channel that is approximately 1 to 2 m below ground level</li> <li>Beyond the defined channel, topography is generally broad and flat and not indicative of a defined floodplain area</li> <li>Some discrete areas sloped down towards the waterway and could indicate the foreshore boundary. These areas are all captured within the 30 m management area</li> </ul> <div> </div> <p><b>Plate 3-7: Deeper Point in channel</b>      <b>Plate 3-8: Shallower Point in channel</b>      <b>Plate 3-9: Example Sloping Landscape</b></p> |

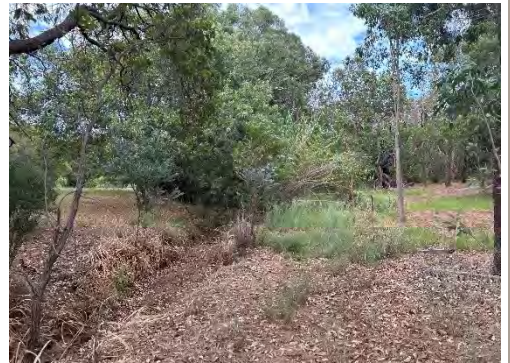
| Biophysical Criteria | Description | Site Assessment and Example Characteristic Photograph and/or Mapping |
|---|---|---|
| Function | The foreshore function, i.e., flood protection, recreation or habitat conservation. | <p>The function of the management area would serve to both conserve the Crystal Brook waterway, as well as provide a passive recreational space for the proposed development. The tree canopy in this location provides excellent shade opportunities.</p> <p>Defining the management area will assist with preserving the habitat in this area for conservation significant fauna such as large trees for black cockatoos, or low shrubs for Quenda, where practical.</p> <div> </div> <p><b>Plate 3-10: Tree Canopy along the Creekline</b></p> |

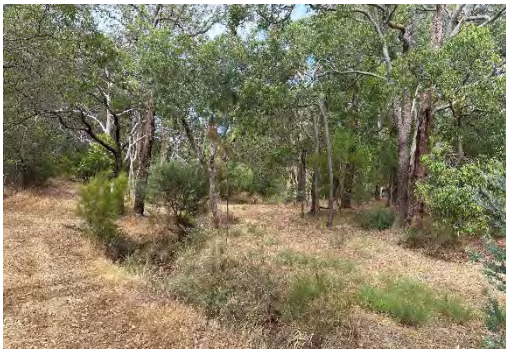
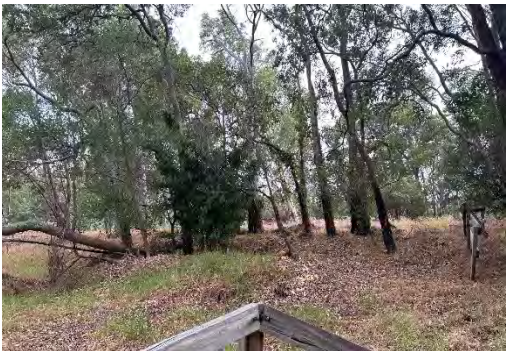
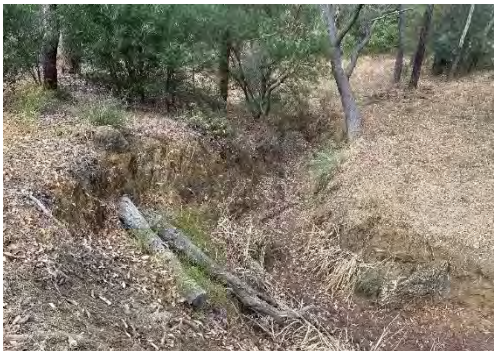
| Biophysical Criteria | Description | Site Assessment and Example Characteristic Photograph and/or Mapping |
|---|---|---|
| Habitat | Habitats such as river pools, woody debris, riffles and riparian vegetation. | <p>The following habitat has been identified within the management area:</p> <ul style="list-style-type: none"> <li>• Limited aquatic habitat, due to creekline being highly modified from its original condition, for creekline species such as frogs</li> <li>• Dense fringing vegetation (grasses and shrubs) that provide habitat for bandicoots</li> <li>• Large trees which provide habitats for birds, notably black cockatoos</li> <li>• No other conservation significant fauna are expected to occur within the site</li> <li>• Fallen logs and litter possibly provide fauna habitat</li> </ul> <p>The vegetation associated with the waterway may provide a corridor for fauna movement between adjacent vegetated areas of habitat value.</p> <div style="display: flex; justify-content: space-around;"> </div> <div style="display: flex; justify-content: space-around;"> <p><b>Plate 3-11: Potential Quenda Habitat</b></p> <p><b>Plate 3-12: Marri trees – Black Cockatoo Habitat</b></p> <p><b>Plate 3-13: Dead logs – Potential Habitat</b></p> </div> |

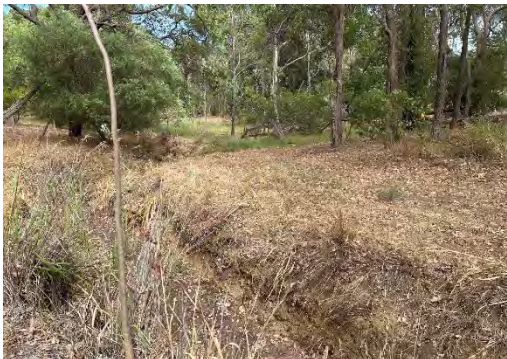
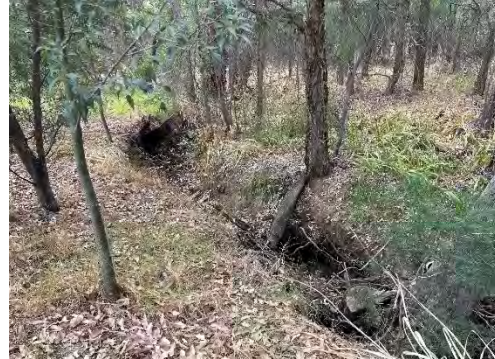
| Biophysical Criteria | Description | Site Assessment and Example Characteristic Photograph and/or Mapping |
|---|---|---|
| Climate | Climatic variations and resultant changes in water levels. | <p>Crystal Brook is mapped by DWER as being a watercourse that is minor and non-perennial, which may be dry for much of the time, with flows being seasonal or intermittent and responsive to rainfall, and considered susceptible to climate variations and water levels.</p> <p>This was confirmed during the Coterra site inspection, undertaken in summer, which noted that the creek was dry.</p> <div style="display: flex; justify-content: space-around;"> </div> <div style="display: flex; justify-content: space-around;"> <p><b>Plate 3-14: : Dry Creekline (Eastern Portion)</b></p> <p><b>Plate 3-15: Dry Creekline (Western Portion)</b></p> </div> |

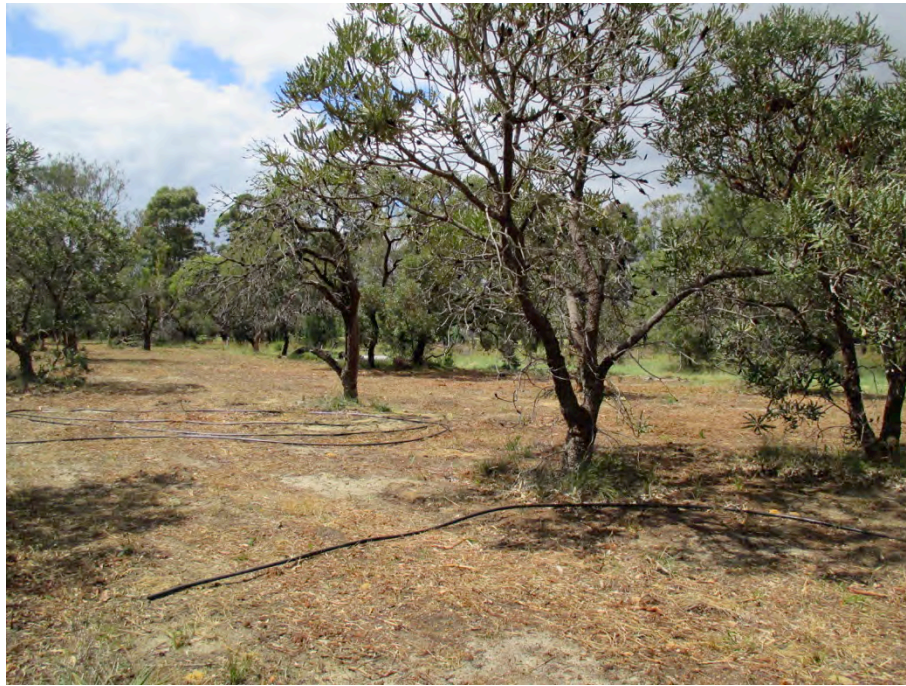
Open woodland of *Banksia menziesii* (approximately 10 trees) with understory of resprouting *Xanthorrhoea* (Plate 1). This vegetation unit occupies 0.32 ha or 2.11% of the Project Area and has a Keighery condition rating of 'Good'. The native understorey within this unit was slashed for fire mitigation purposes approximately four weeks prior to survey.

**Plate 1. Photo of Unit 1 *Banksia menziesii* open woodland.**

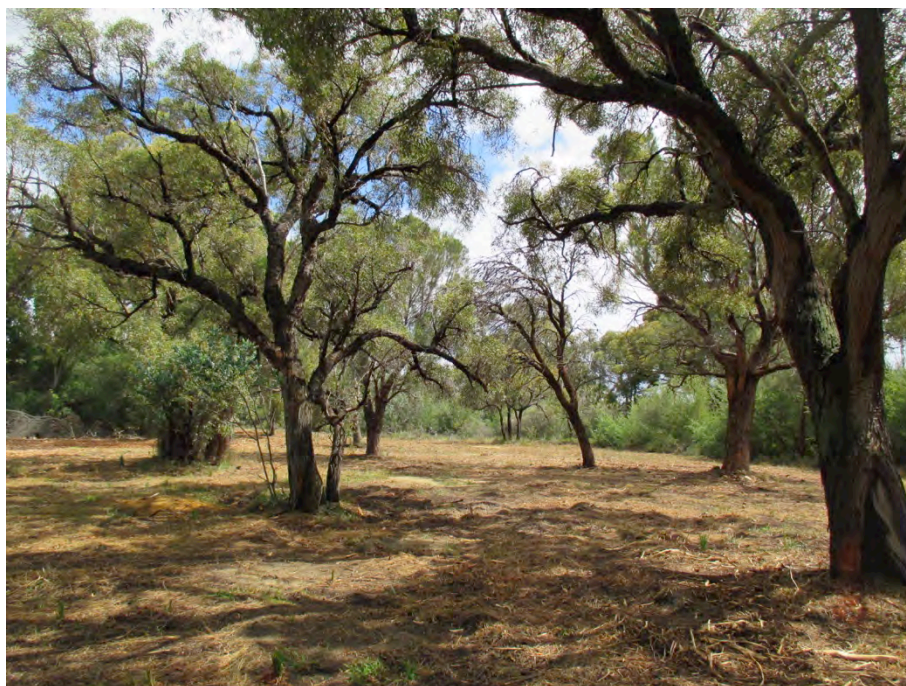
Open woodland of *Eucalyptus marginata* subsp. *marginata* and *Allocasuarina fraseriana* with occasional trees of *Banksia attenuata* (Plate 2). This vegetation unit occupies 0.57 ha or 3.75% of the Project Area and has a Keighery condition rating of 'Good'. The native understorey within this unit was slashed for fire mitigation purposes approximately four weeks prior to survey.

**Plate 2. Photo of Unit 2 *Eucalyptus marginata* subsp. *marginata* and *Allocasuarina fraseriana* open woodland.**

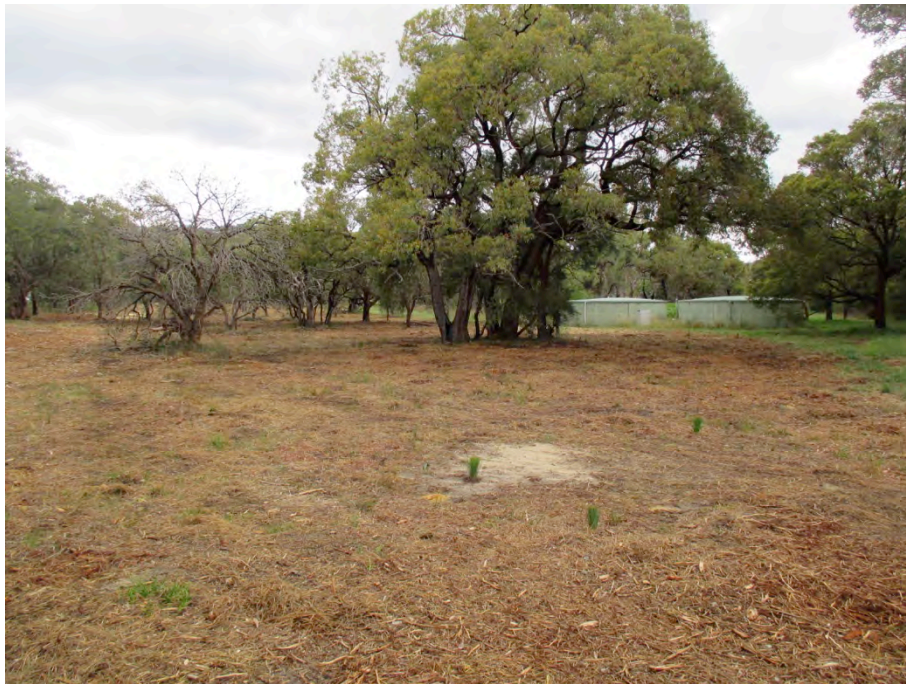
Sparse open woodland of *Corymbia calophylla* with sparse understory of resprouting *Xanthorrhoea* (Plate 3). This vegetation unit occupies 0.27 ha or 1.78% of the Project Area and has a Keighery condition rating of 'Good'. The native understory within this unit was slashed for fire mitigation purposes approximately four weeks prior to survey.

Plate 3. Photo of Unit 3 *Corymbia calophylla* sparse woodland.

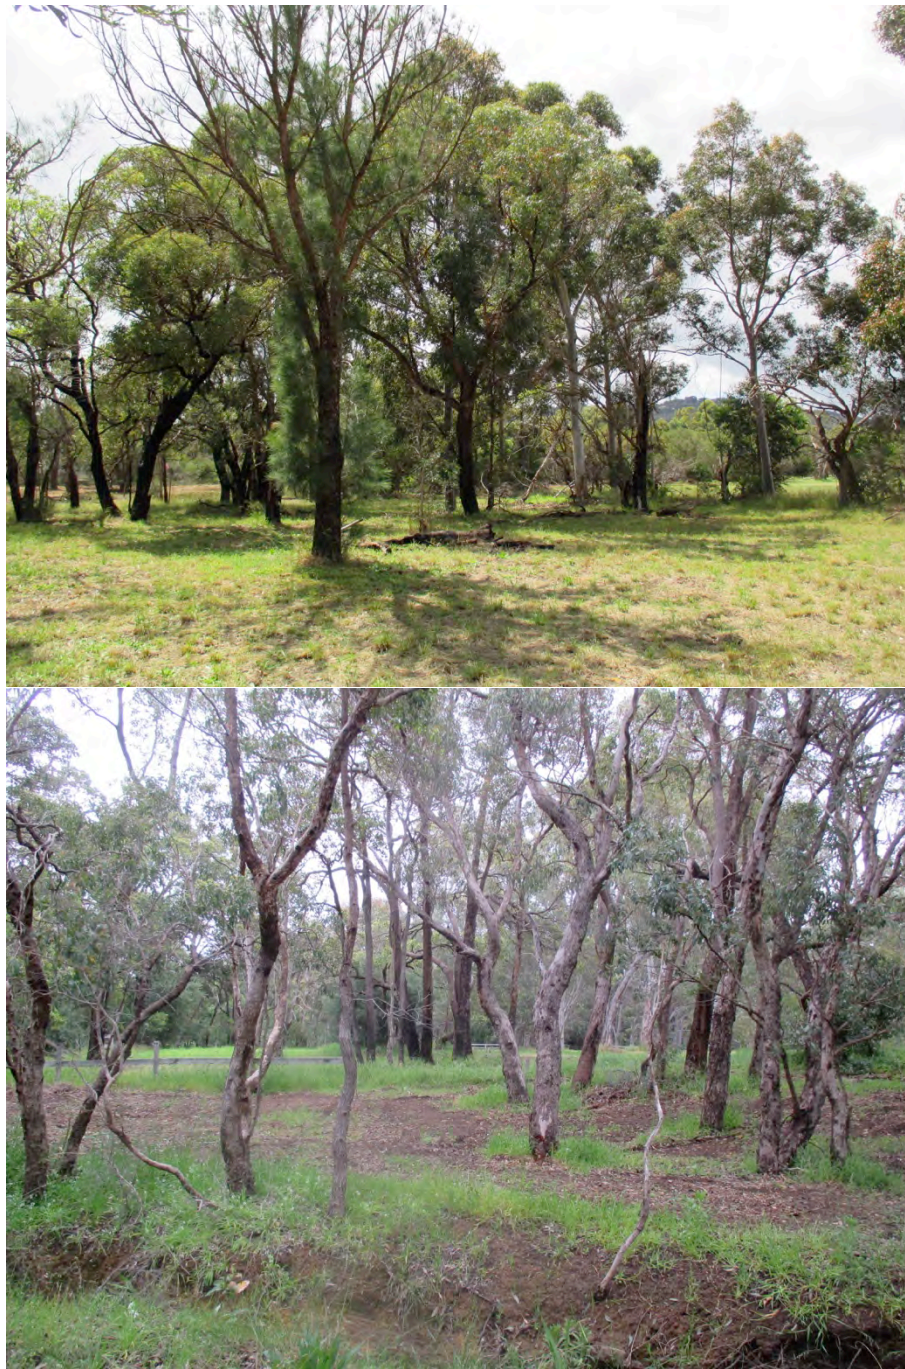
Open woodland of *Corymbia calophylla* (*Eucalyptus rudis* variably present) over a historically cleared understory (Plate 4). This vegetation unit occupies 2.91 ha or 19.14% of the Project Area and has a Keighery condition rating of 'Degraded' with an almost complete absence of understory due to previous land use practices.

**Plate 4. Photos of Unit 4 *Corymbia calophylla* (*Eucalyptus rudis*) open woodland over degraded/cleared.**

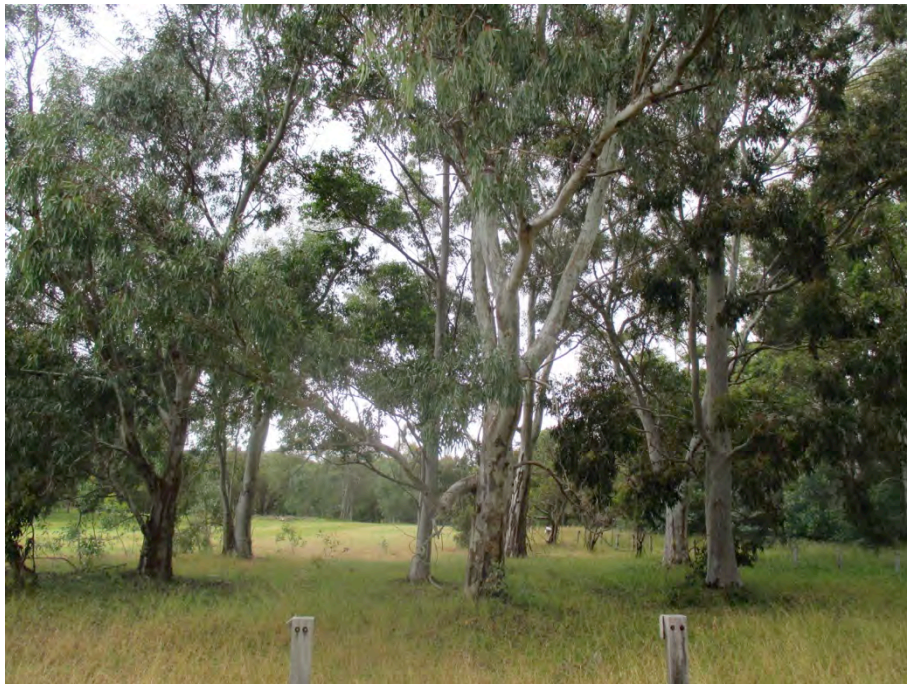
Open woodland of *Corymbia citriodora* (planted) and *Eucalyptus rudis* (remnant) woodland over a historically cleared understorey (Plate 5). This vegetation unit occupies 0.84 ha or 5.53% of the Project Area and has a Keighery condition rating of ‘Degraded’ due to an almost complete absence of understorey due to previous land use practices.

**Plate 5. Photo of Unit 6 *Corymbia citriodora* (planted) and *Eucalyptus rudis* woodland over degraded/cleared.**

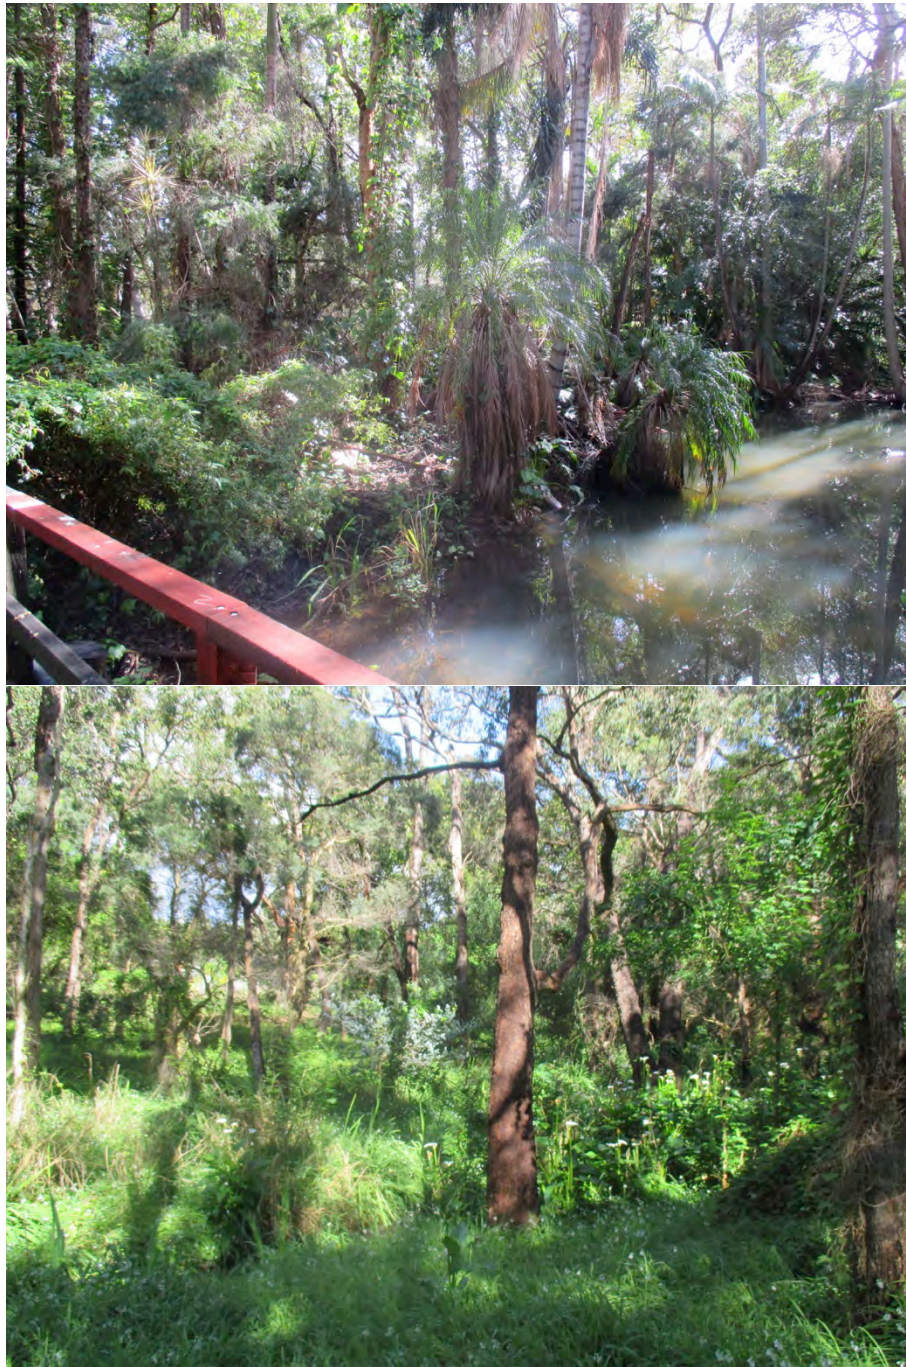
*Corymbia calophylla* woodland over a dense tall understorey and ground layer of exotic plantings (Plate 6). This vegetation unit occupies 1.51 ha or 9.93% of the Project Area and has a Keighery condition rating of ‘Completely Degraded’ from an almost complete absence of understorey due to previous land use practices. A creek runs through a portion of the unit but is not associated with a separate vegetation unit. The Declared Pest *Zantedeschia aethiopica* (Arum Lilly) is present within this unit.

**Plate 6. Photos of Unit 7 *Corymbia calophylla* woodland over dense garden planting.**

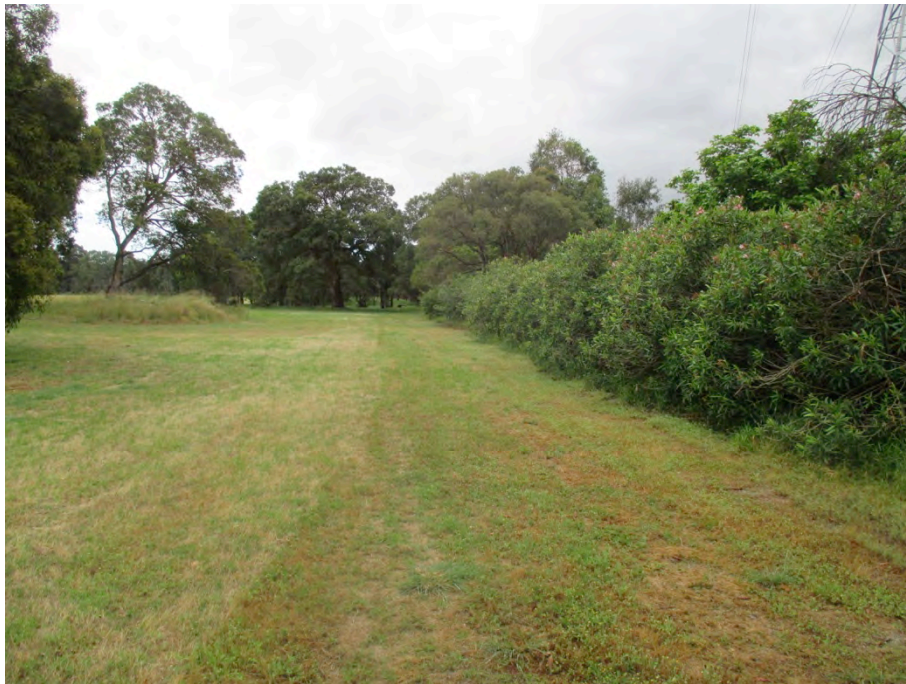
A variable unit representing historically completely cleared areas with mixed plantings of exotic species and non-local native species (Plate 7). This vegetation unit occupies 0.43 ha or 2.83% of the Project Area and has a Keighery rating of ‘Completely Degraded’ due to complete absence of native vegetation.

**Plate 7. Photo (right of view) of Unit 8 Mixed native and exotic plantings.**

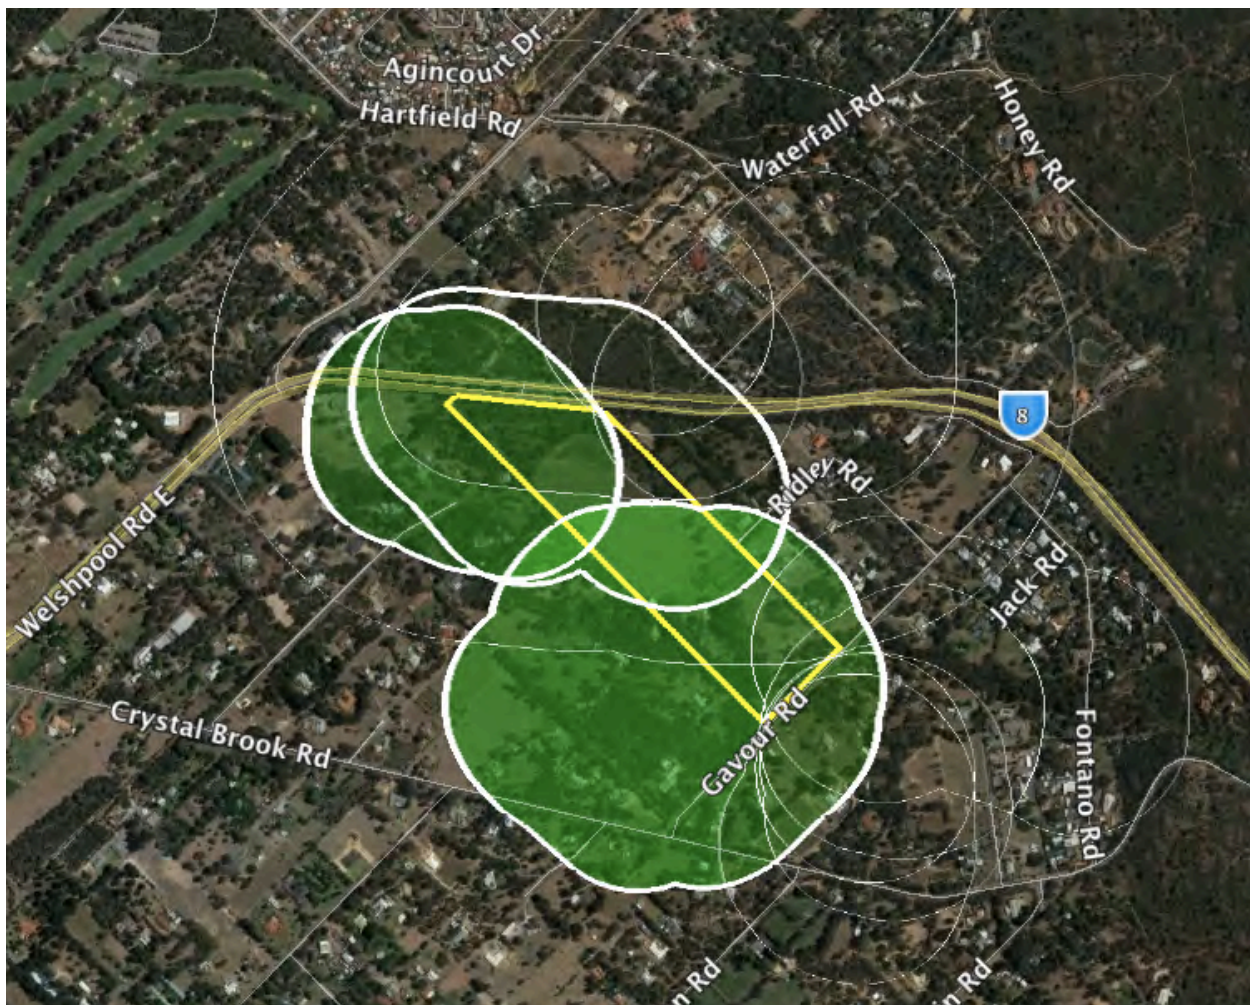
## **Appendix 4: TEC/PEC records of the Project Area**

- 1 x record of '*SCP20a, Banksia attenuata woodland over species rich dense shrublands*' TEC (Western Australia)
- 8 records of '*Banksia Dominated Woodlands of the Swan Coastal Plain IBRA Region*' PEC (WA) and TEC (National)

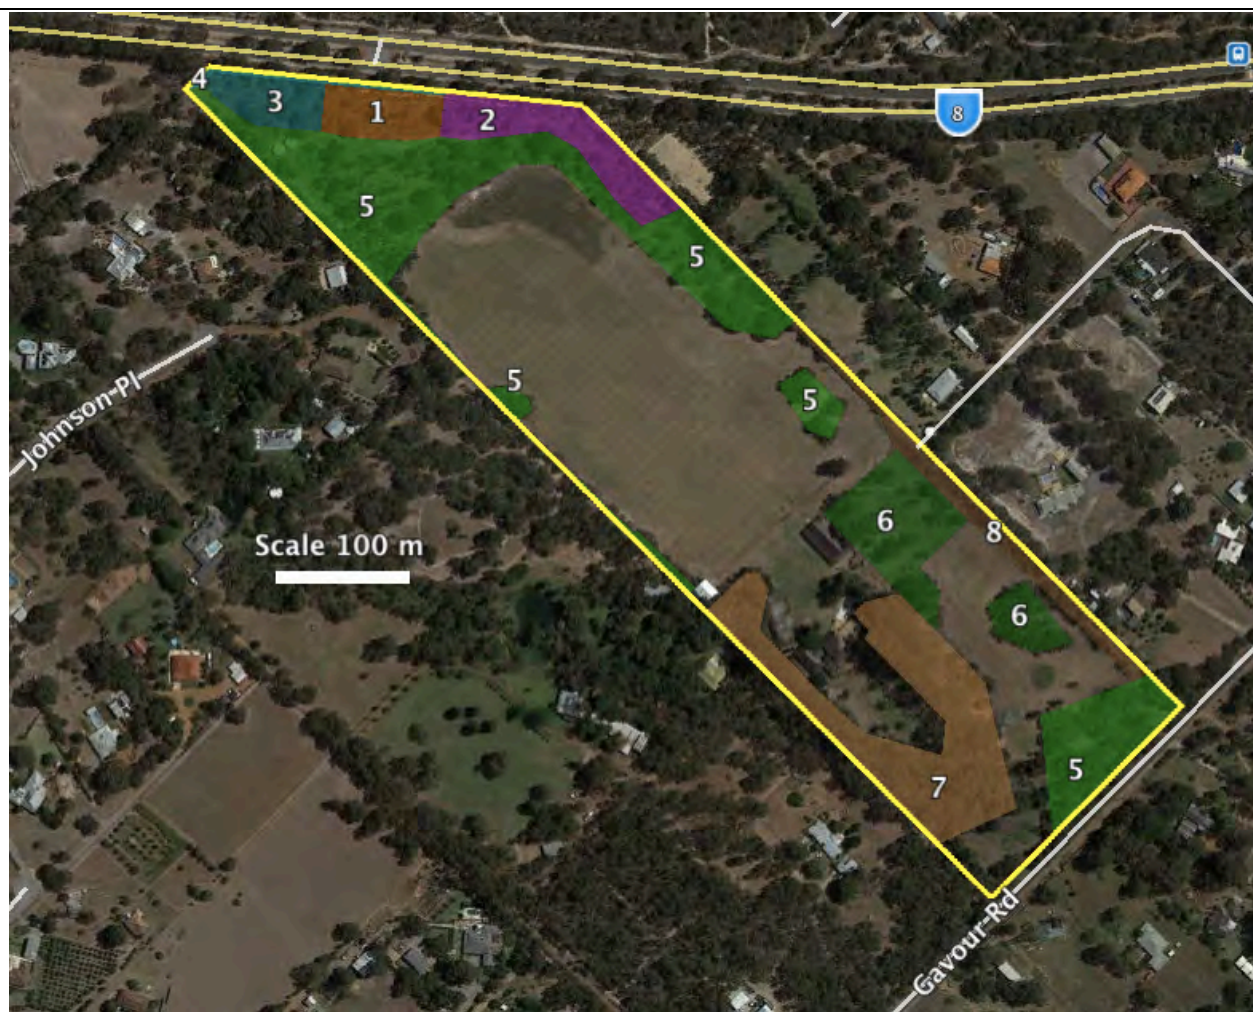
## **Appendix 5. Vegetation Structural Units map.**

- Unit 1: *Banksia menziesii* open woodland
- Unit 2: *Eucalyptus marginata* subsp. *marginata* and *Allocasuarina fraseriana* open woodland
- Unit 3: *Corymbia calophylla* sparse woodland
- Unit 4: *Corymbia calophylla* open woodland
- Unit 5: *Corymbia calophylla* (*Eucalyptus rudis*) open woodland over degraded/cleared
- Unit 6: *Corymbia citriodora* (planted) and *Eucalyptus rudis* woodland over degraded/cleared
- Unit 7: *Corymbia calophylla* woodland over dense garden planting
- Unit 8: Mixed native and exotic plantings
