hydo  
Wattle Grove South Local Water Management Strategy  
**Stormwater Management Plan: Precinct A, B & C**  
**Figure 14a**

hydo  
 Wattle Grove South Local Water Management Strategy  
**Post Development Monitoring Program**

Project 96730.01  
November 2020

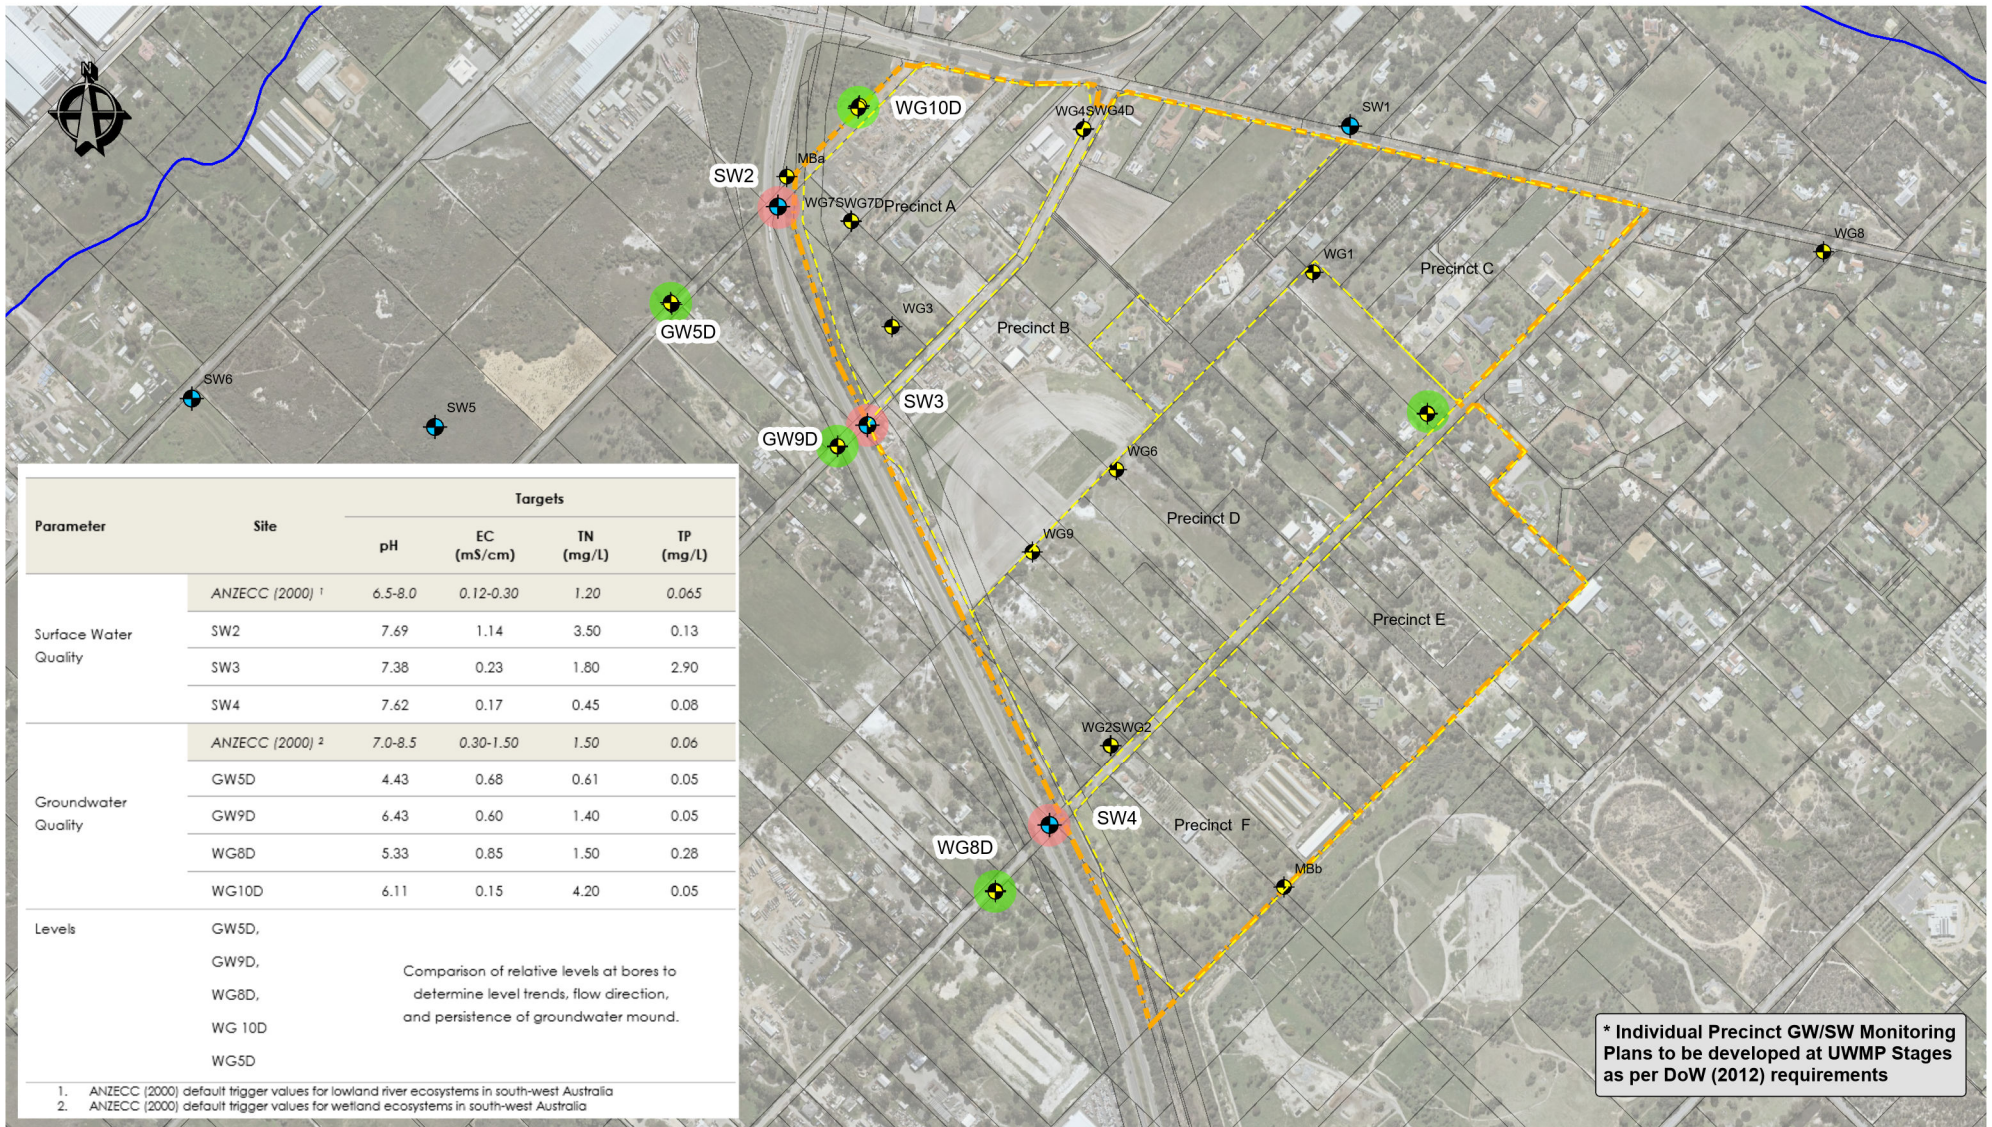
**Figure 15**

Site  
 Precinct Areas  
 Groundwater Monitoring Bores  
 Surface Water Monitoring Sites

Key Assessment Sites to be monitored for all precincts:

Groundwater Sites  
 Surface Water Sites

| Local Water Management Strategy Item | Deliverable | ✓ | Comments |
|---|---|---|---|
| Recommended future monitoring plan including timing, frequency, locations and parameters, together with arrangements for ongoing actions | | <input checked="" type="checkbox"/> | Chapter 9, Table 12, Figure 15 |

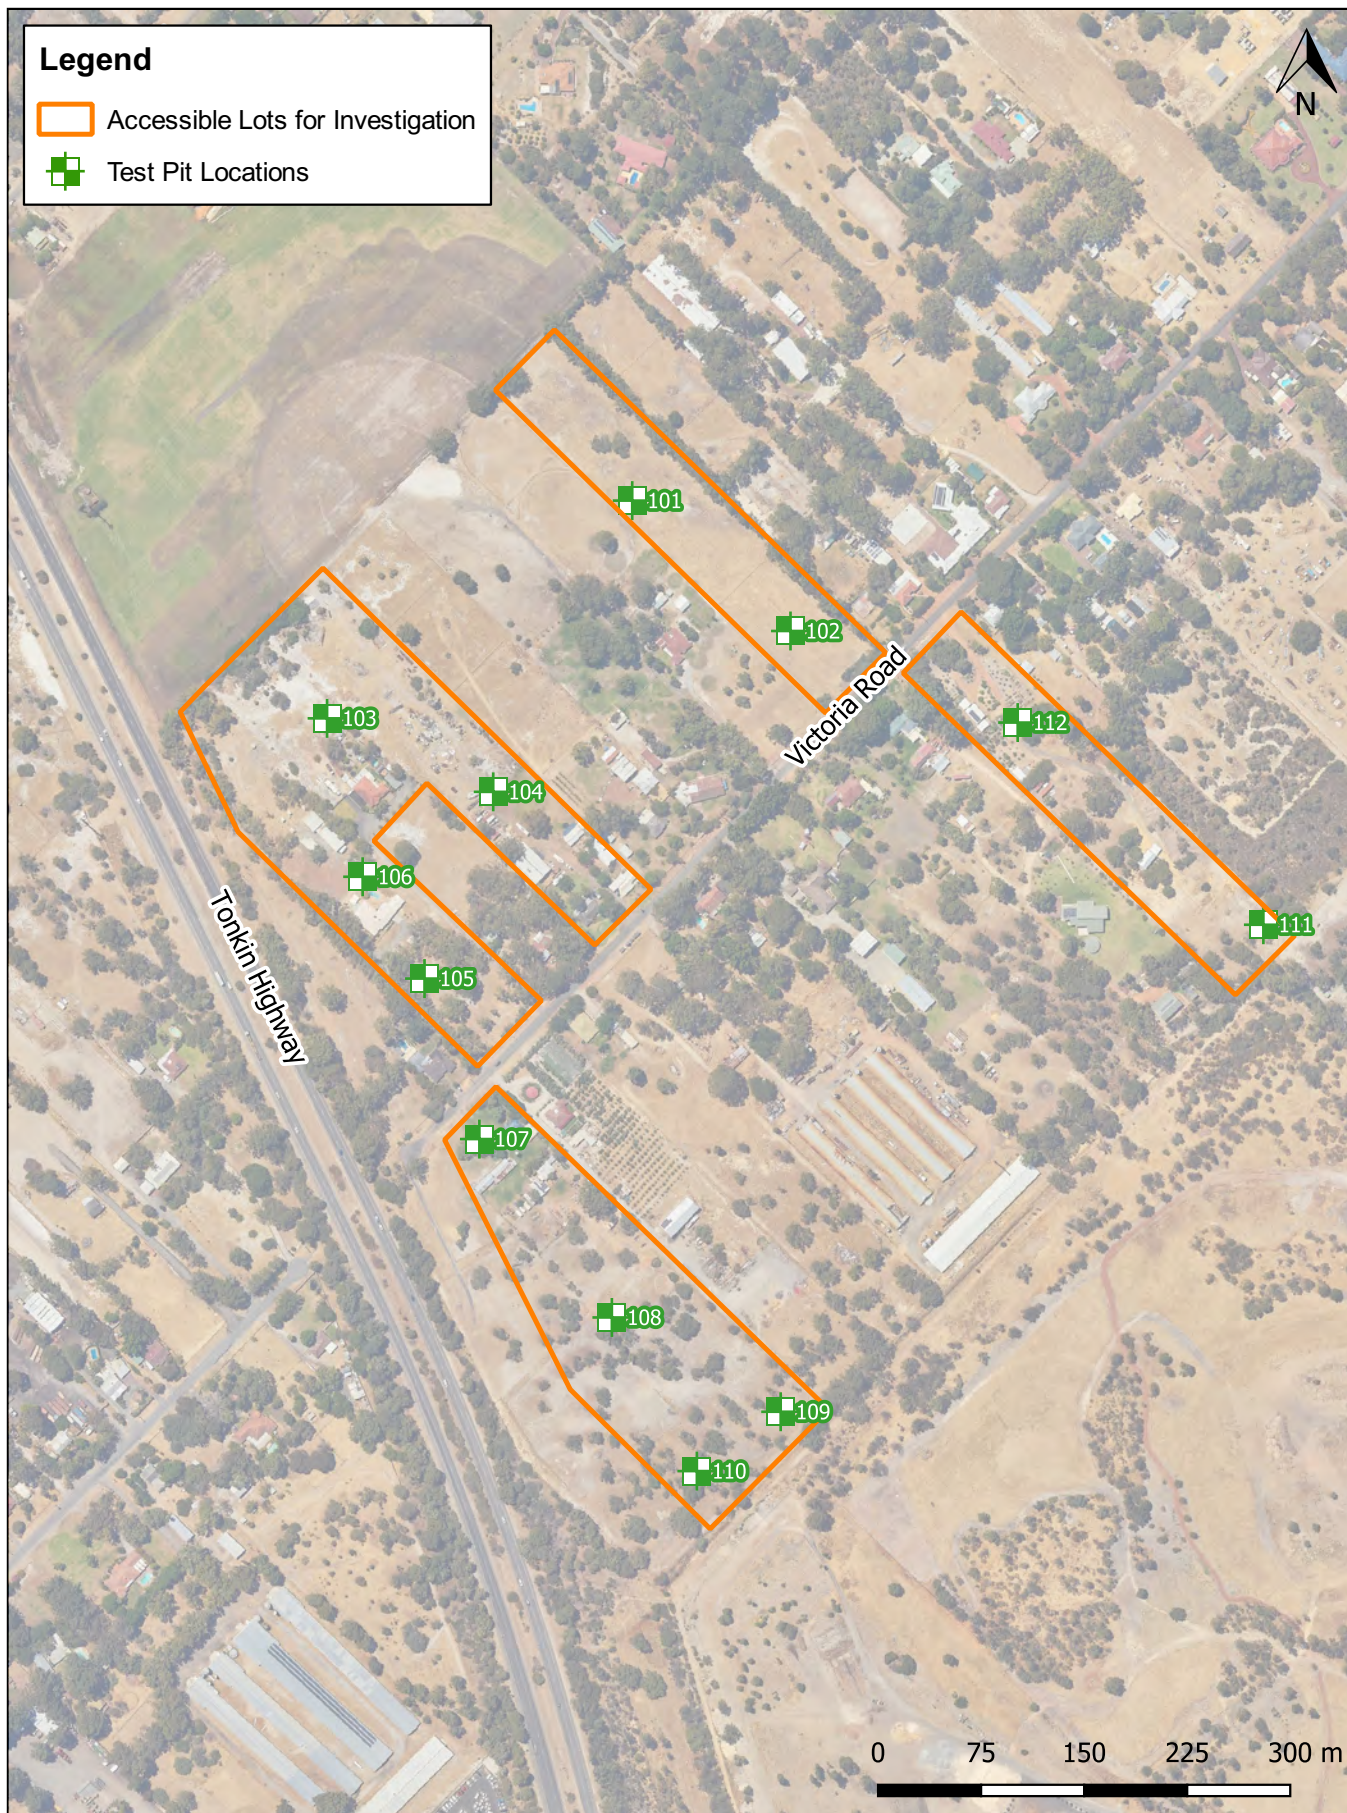
Drawing 1  
Results of Field Work

| <b>Douglas Partners</b><br><small>Geotechnics Environment Groundwater</small> | <b>Test Pit Locations</b> | PROJECT: 96730.04 |

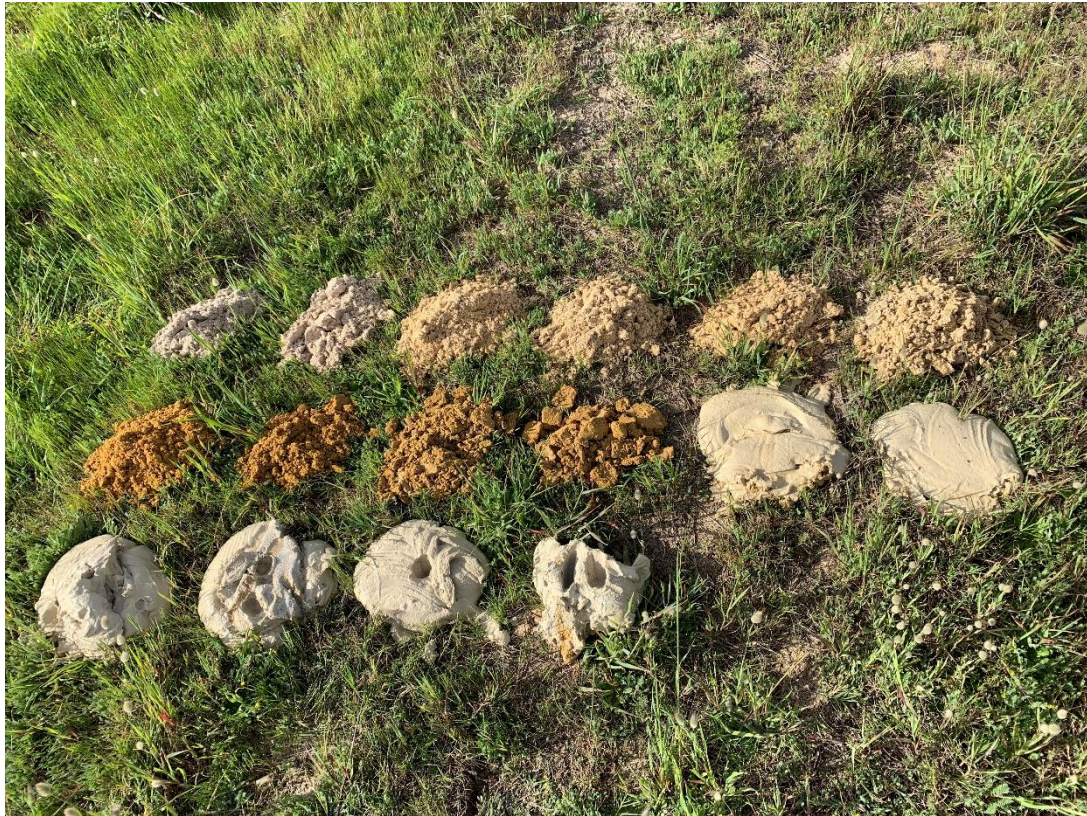
**Figure 1: Samples collected at 0.5 m intervals during drilling**

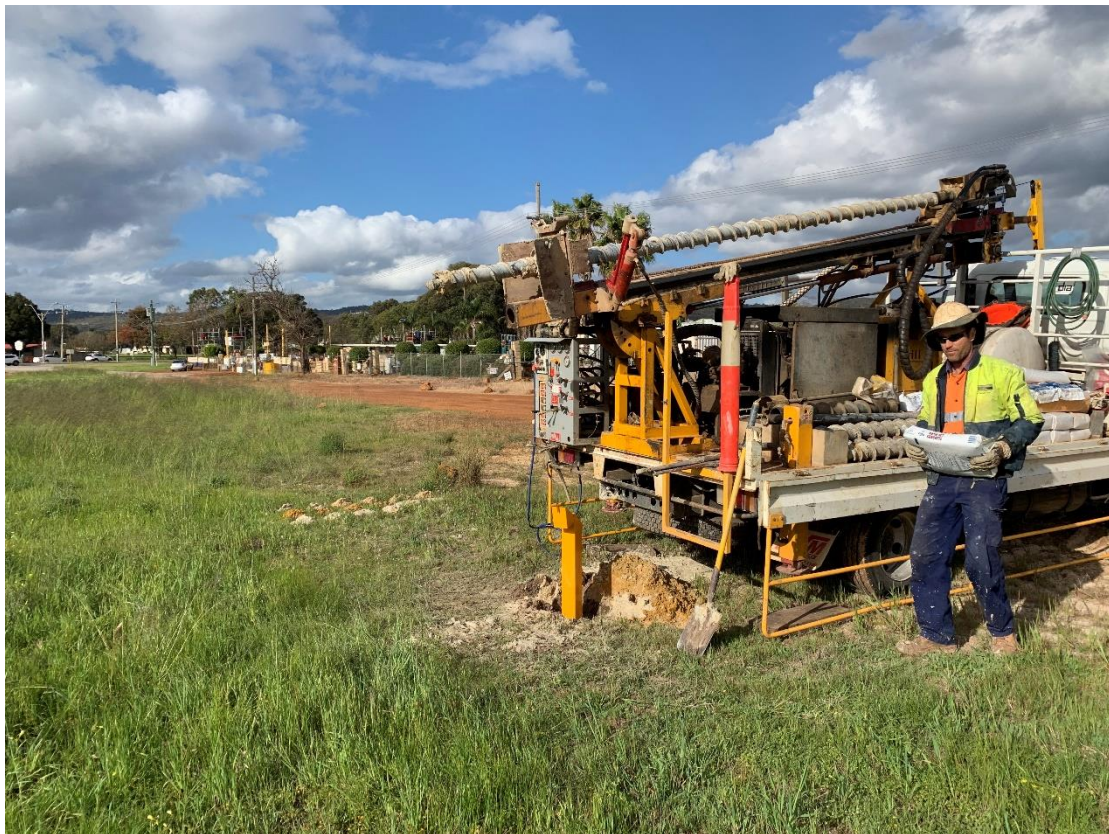
**Figure 2: Drill rig on location**

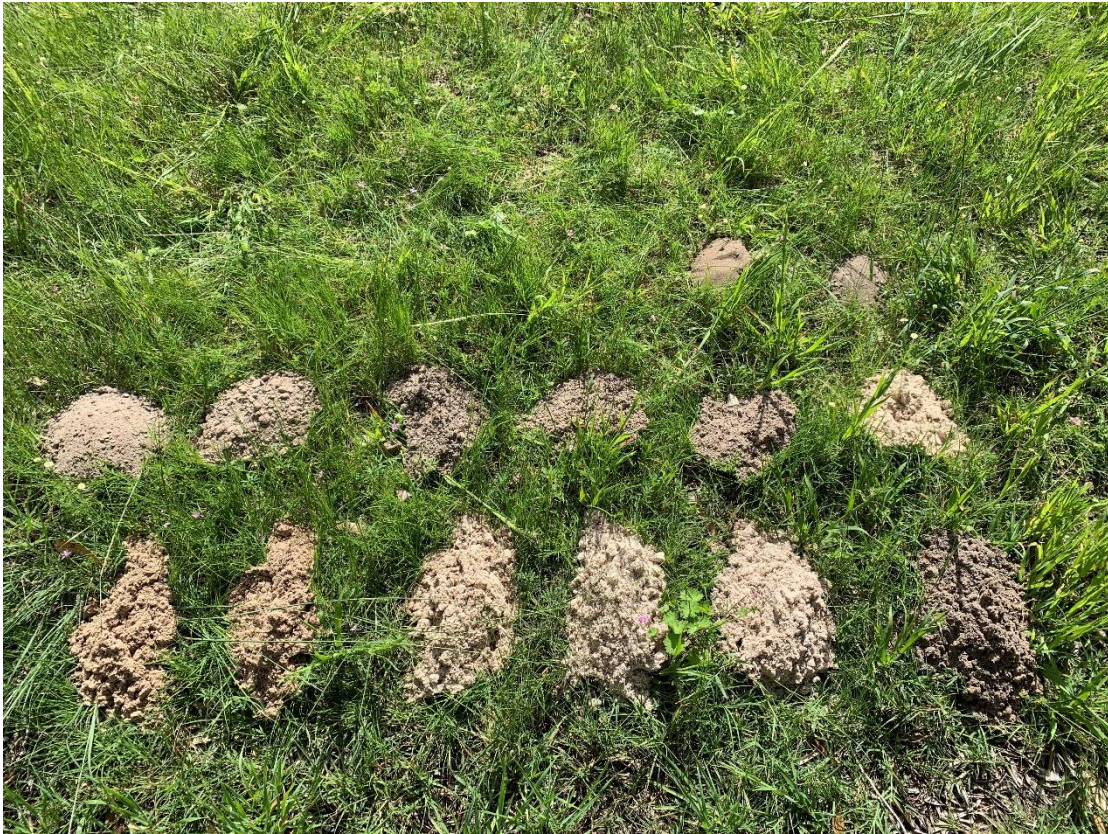
**Figure 1: Samples collected at 0.5 m intervals during drilling**

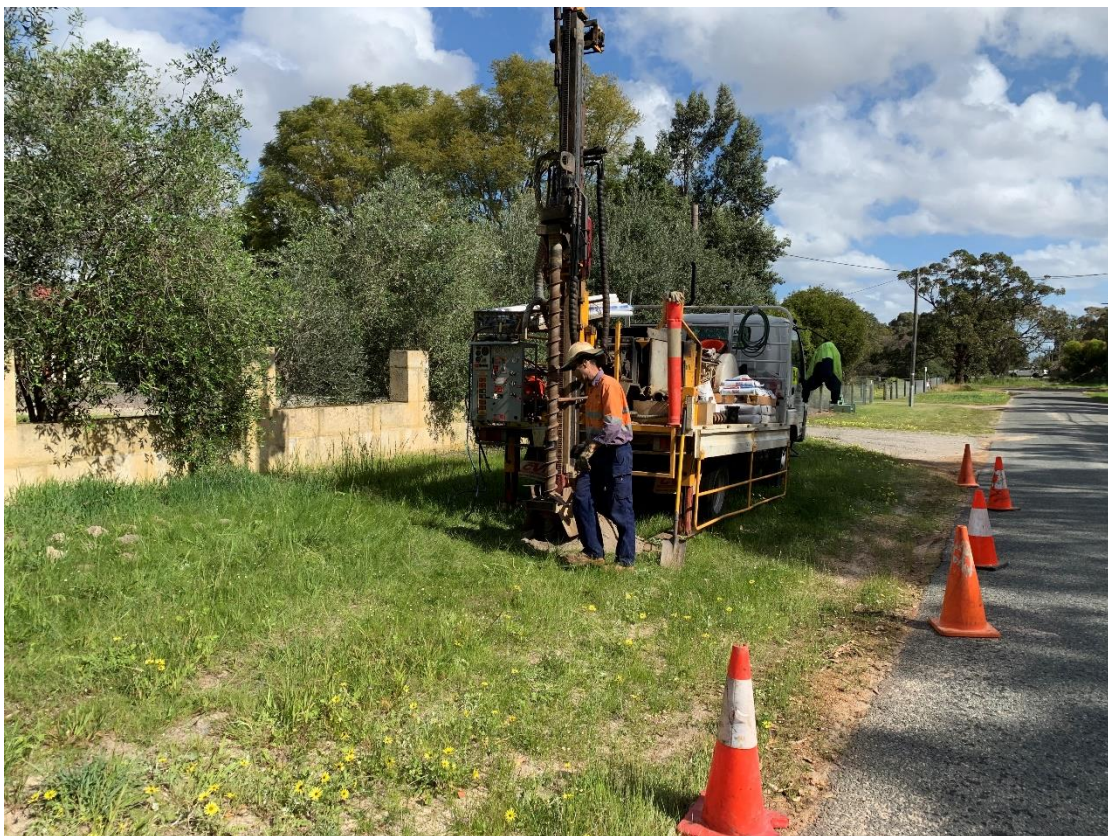
**Figure 2: Drill rig on location**

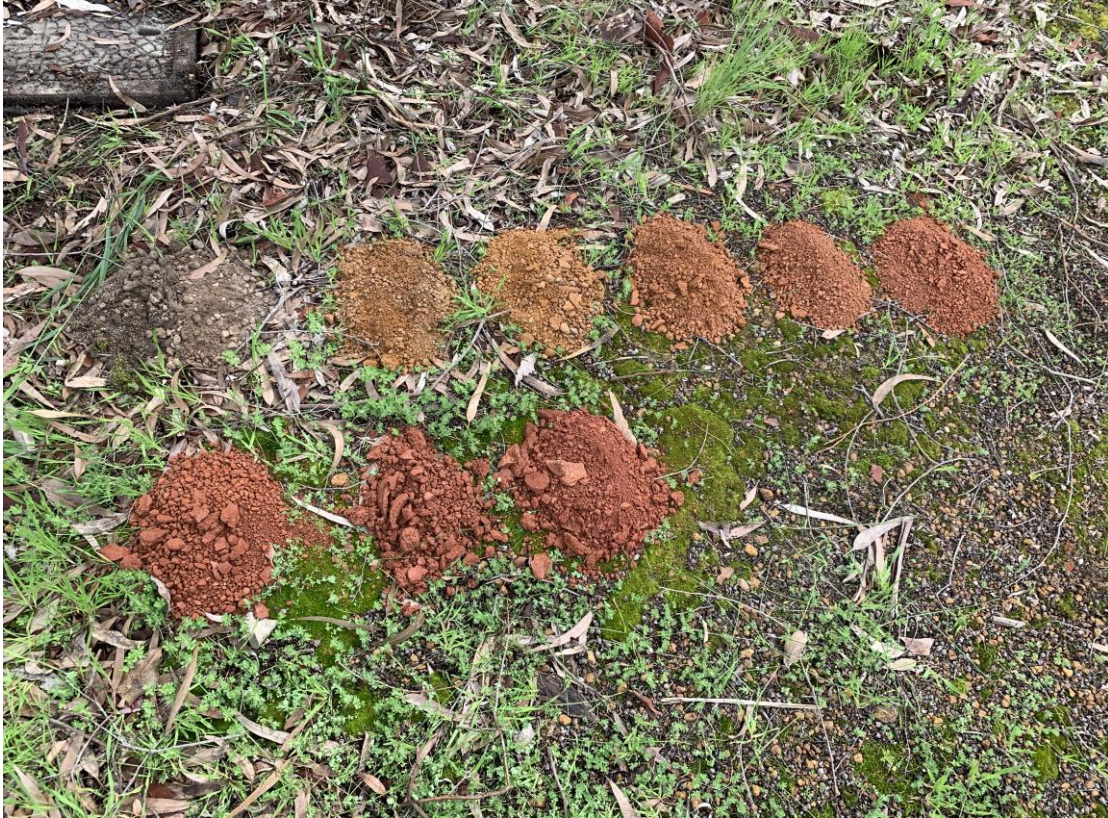
**Figure 1: Samples collected at 0.5 m intervals during drilling**

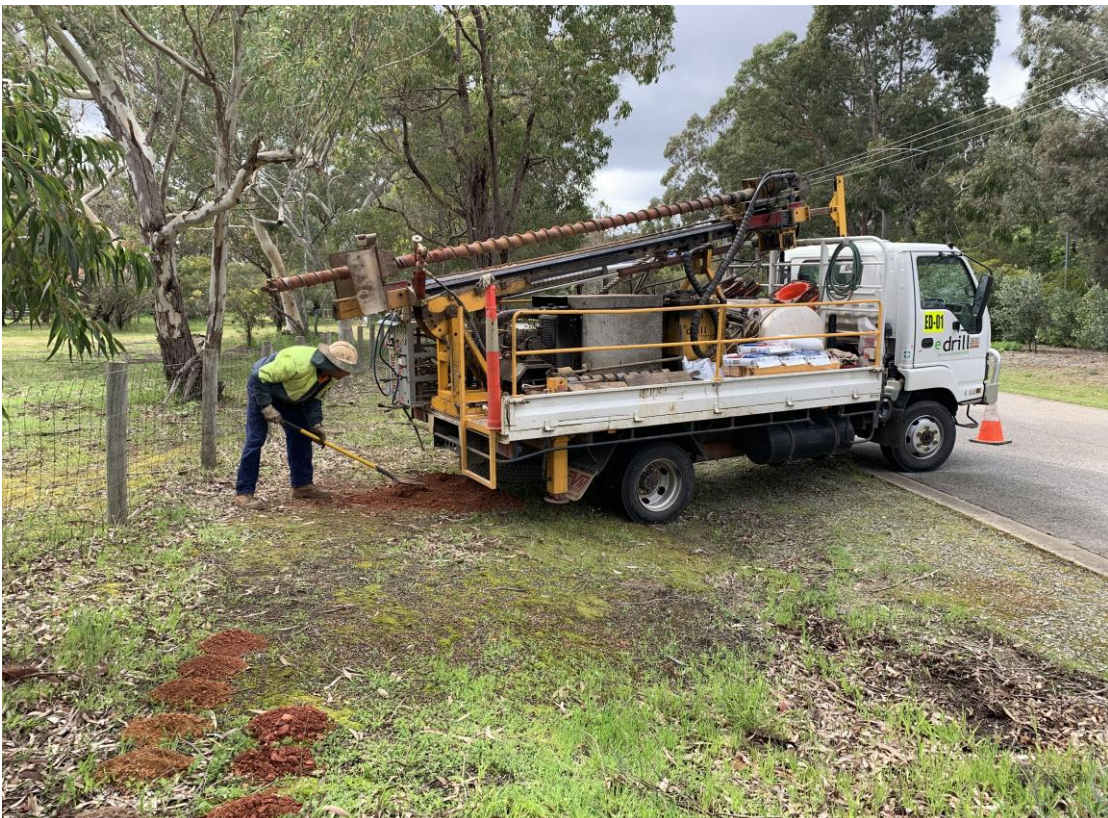
**Figure 2: Drill rig on location**
