# **LESMURDIE HOUSE**

## Heritage Impact Statement

For  
Saleeba Adams Architects  
November 2017

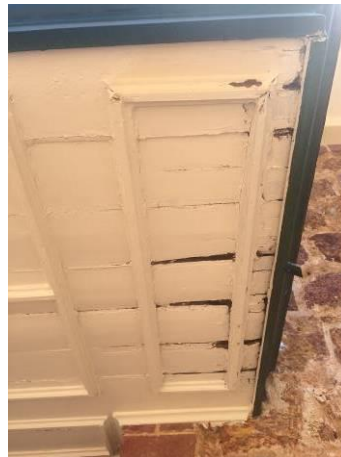
Figure 16 Soffit of main entrance canopy

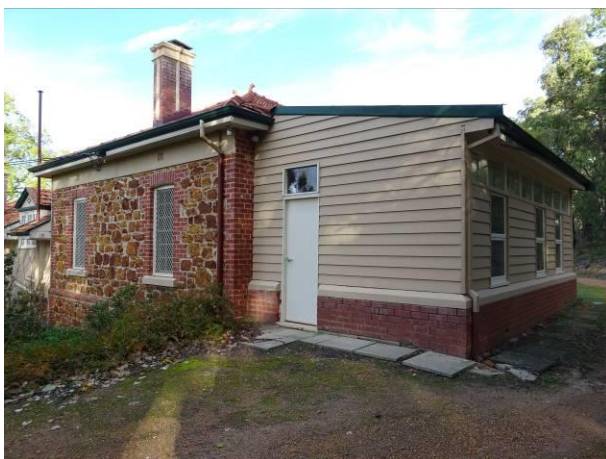
Figure 22 North facade, sunroom

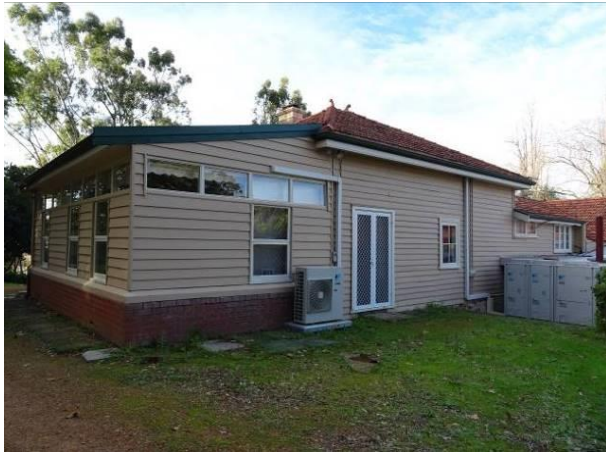
Figure 29 South facade of Upper Level

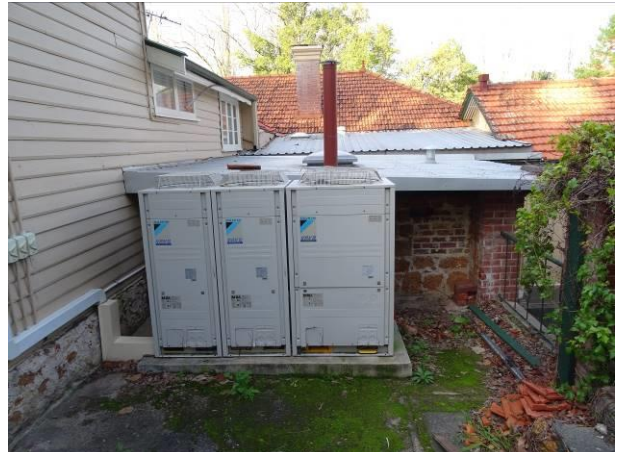
Figure 30 Condenser units to west

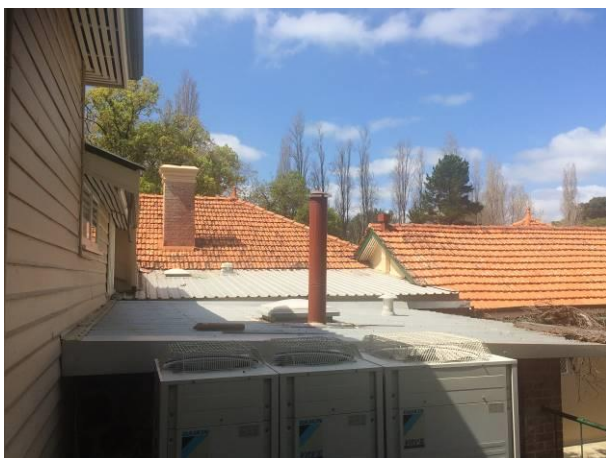
Figure 31 View over condenser units

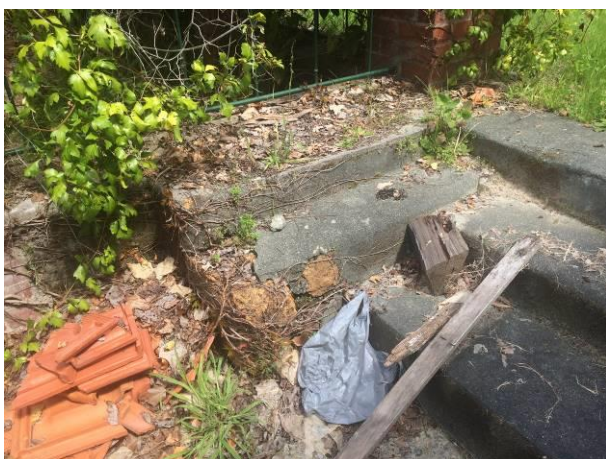
Figure 32 Stairs to condenser unit area

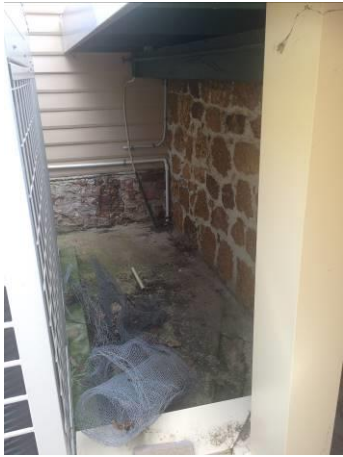
Figure 34 wall behind condenser units

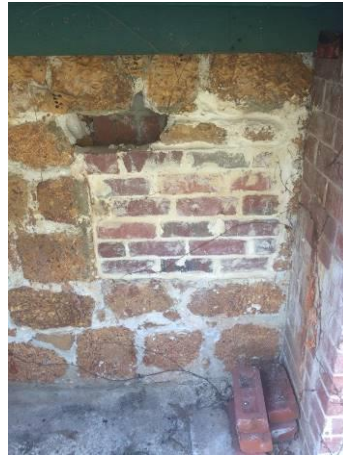
Figure 35 brick patch to wall behind condenser units

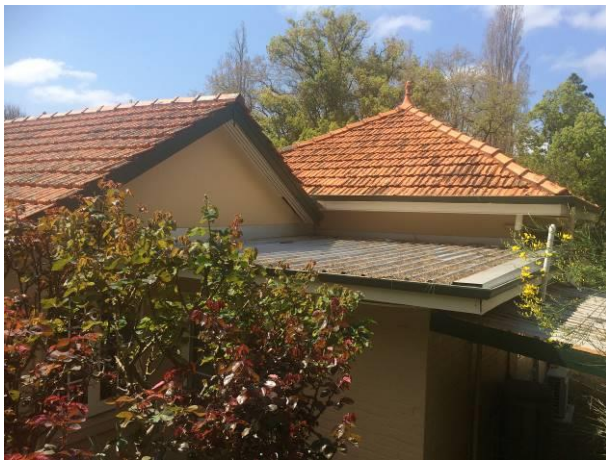
Figure 36 West facade, roof over bathroom 2

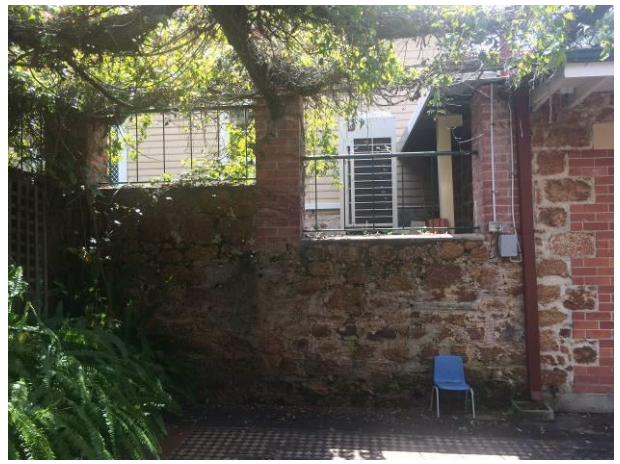
Figure 39 Courtyard wall looking north

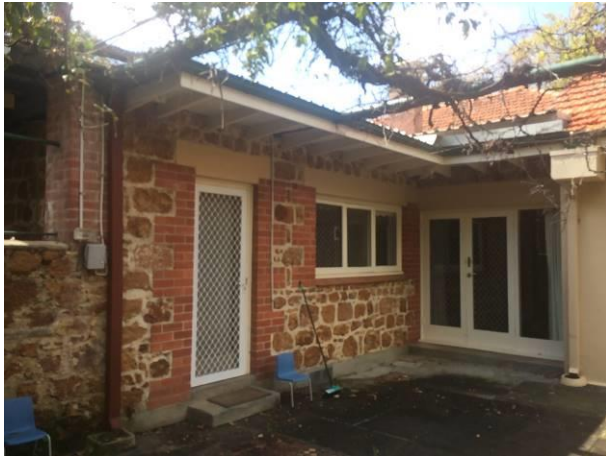
Figure 40 View of Kitchen and Dining room doors

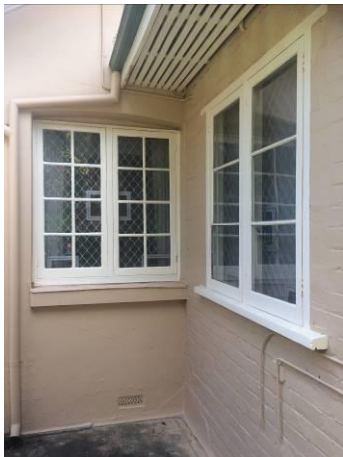
Figure 42 View of windows to bathroom 2 & bedroom 4

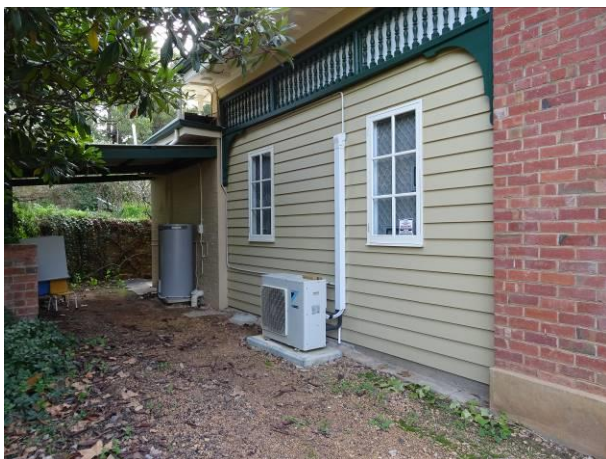
Figure 44 South elevation, showing lean-to to be demolished

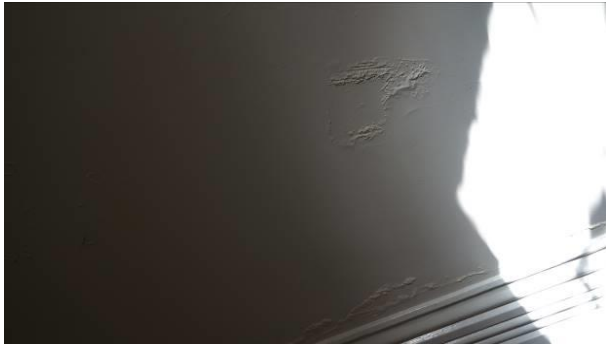
*Figure 64 Main entry, evidence of damp*

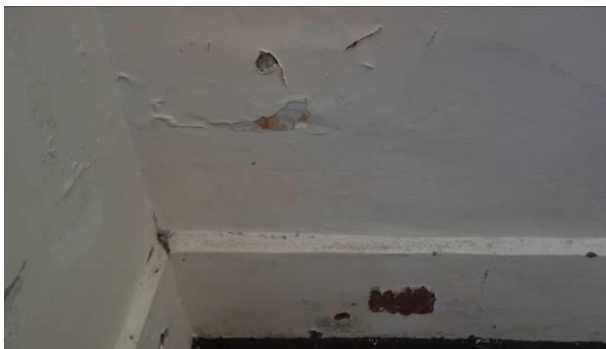
Figure 83 Evidence of damp to bedroom 3

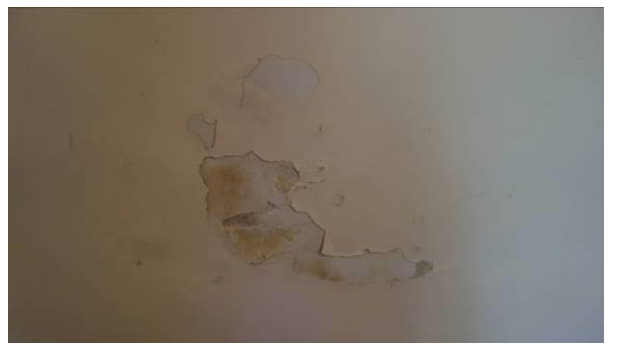
Figure 86 Evidence of damp bedroom 4

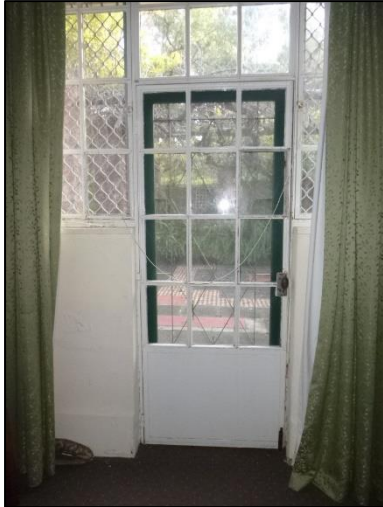
Bedroom 3 with metal framed door and matching adjacent windows

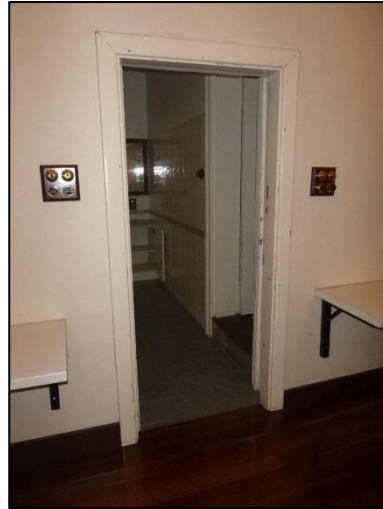
Bathroom 2 door with Bedroom 4 door in the background (with steps)

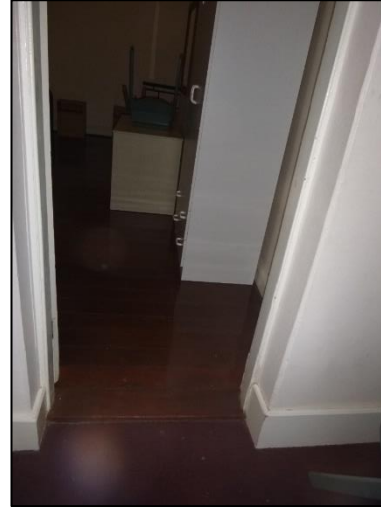
Bedroom 4 with limited circulation space to the latch side of the door

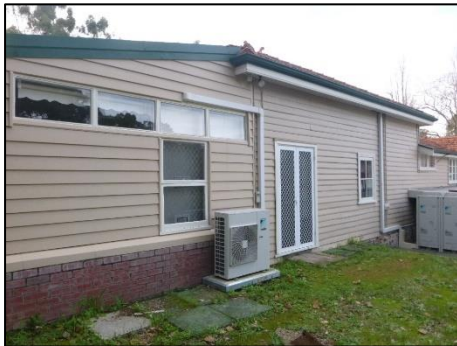
| Entrance name | Existing condition - Clear open door width with door leaf retained | Gap or opening when leaf and door stop are removed | Int / ext door circulation space is achieved with current door swing | Lip / Step | Comment<br><br><u>Legend:</u><br>* AS1428.1 2009 Clause 13.2 (850mm)<br>** AS1428.1 2001 (800mm)<br># AS1428.1 2009 Figure 31 |
|---|---|---|---|---|---|
| Double entrance door | | | | | Not assessed however on review of the photographs, this is a double door with an external step.<br><br>It is presumed this doorway / internal hall may form a new, principal entrance to the Upper Level and all compliance requirements that pertain to doorways must be achieved as per AS1428.1 2009 Clause 13. |

Side door that may form a new, principal entrance to the Upper Level

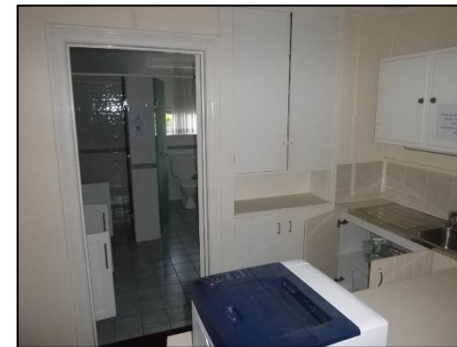
Bathroom 3 – Kitchen bench may obstruct ease of access if this bathroom is repurposed as a unisex accessible toilet
