# **LESMURDIE HOUSE**

## Heritage Impact Statement

For  
Saleeba Adams Architects  
November 2017

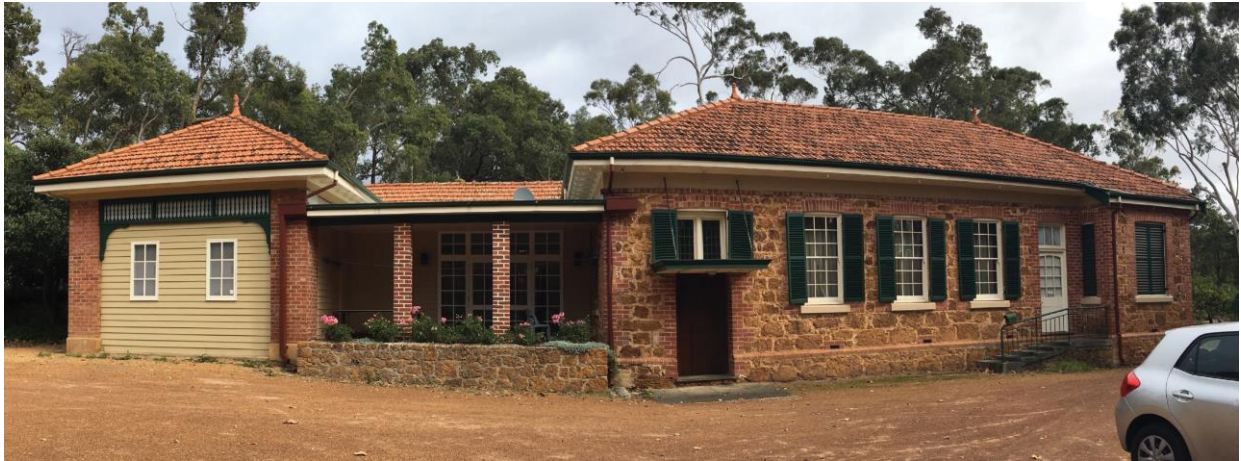
Figure 8 East Façade

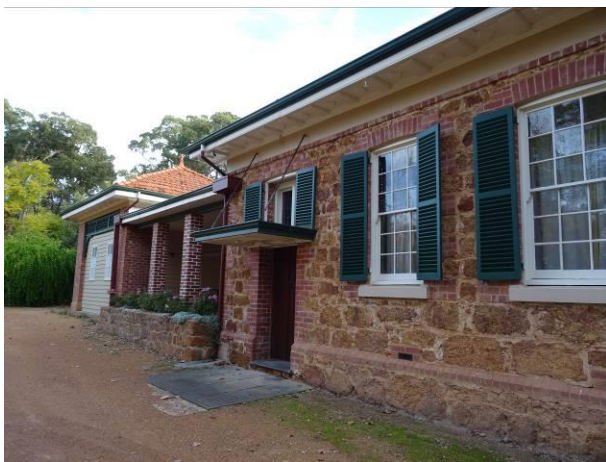
Figure 9 East facade

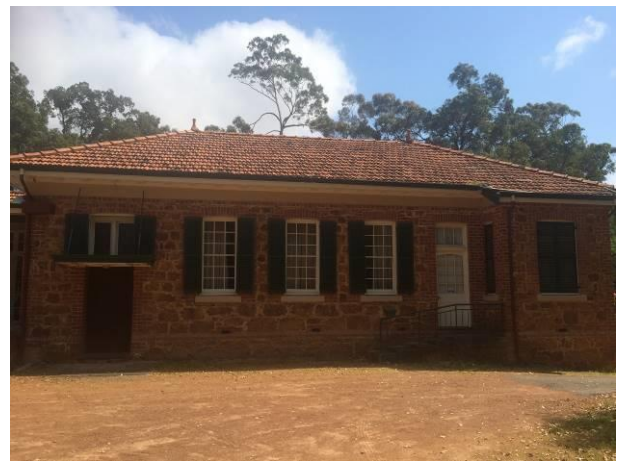
Figure 10 East façade

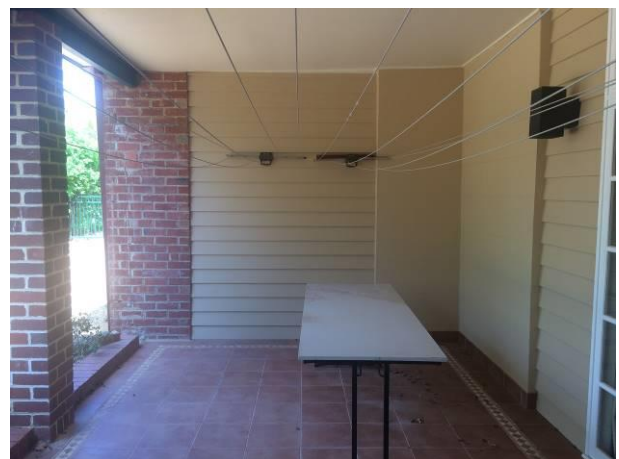
Figure 12 Terrace looking south

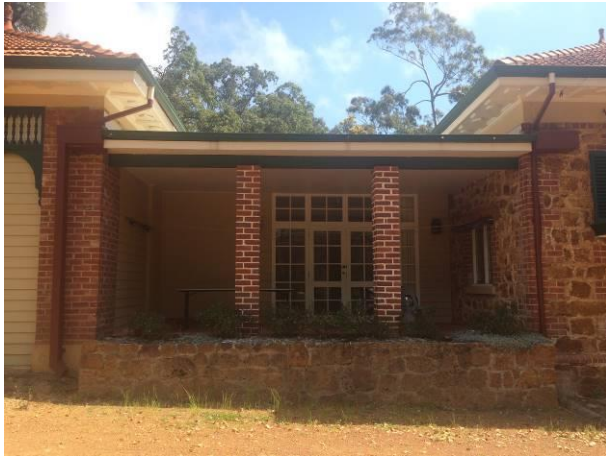
Figure 13 Terrace looking west

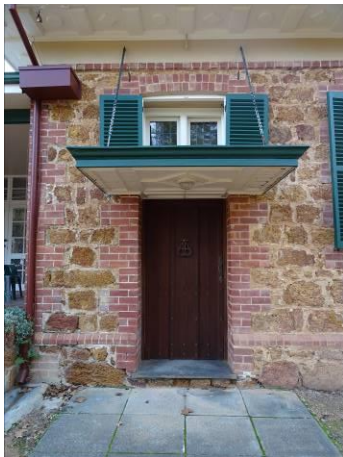
Figure 15 Main entrance, east facade

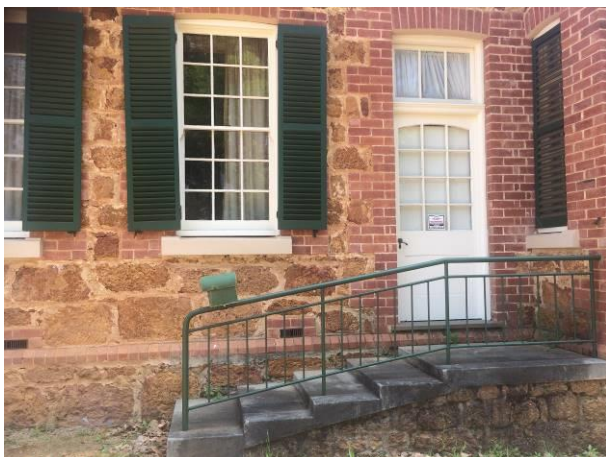
Figure 17 East facade, external stairs

- Glazing film to windows to achieve safety requirements
- Refurbishment of existing bathrooms
- Demolition of the current sunroom to the west
- Existing concrete and stone stair to the east façade to be replaced with framed timber ramp to provide universal access

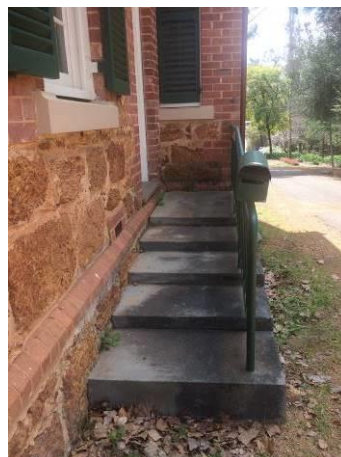
Figure 18 East facade, external stairs

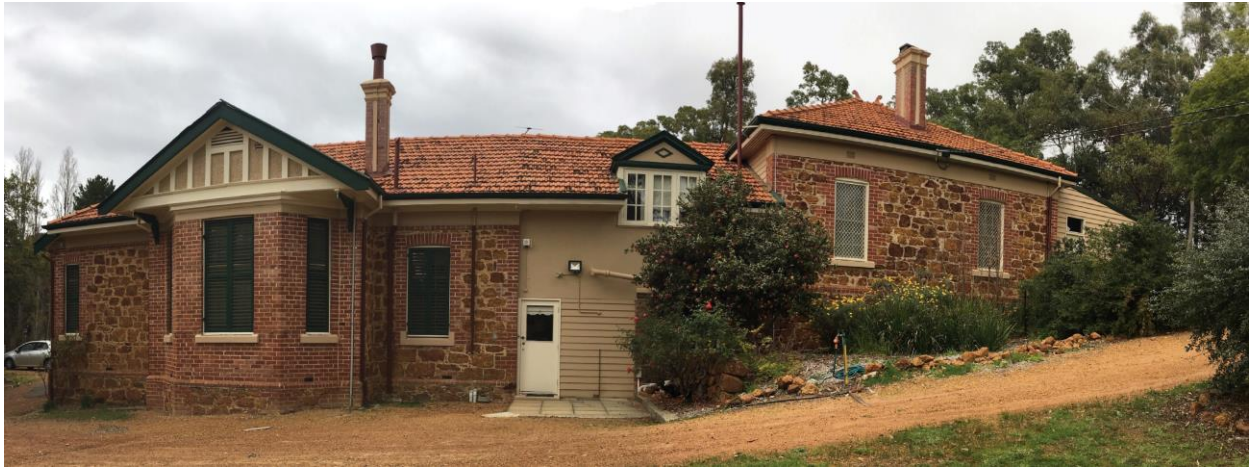
Figure 19 North facade

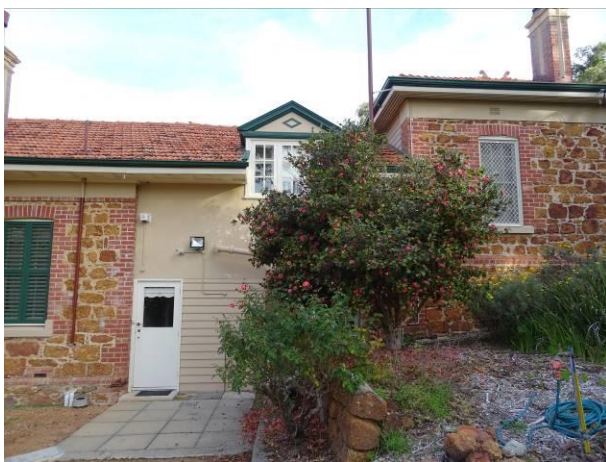
Figure 20 North facade

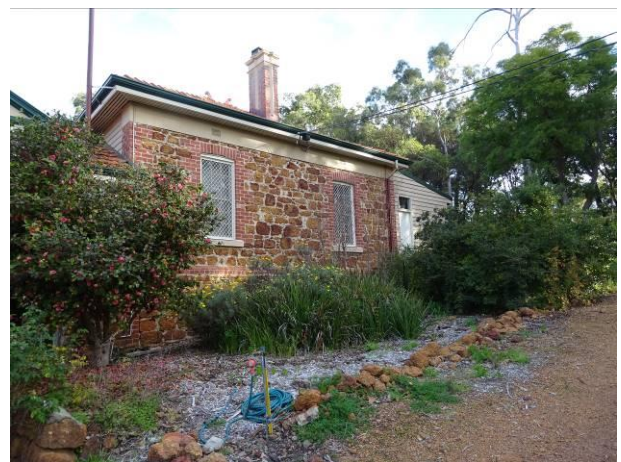
Figure 21 North facade

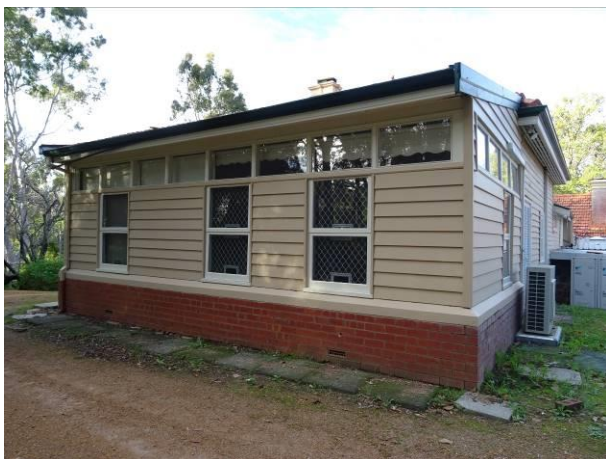
Figure 27 Sunroom (former veranda), west facade

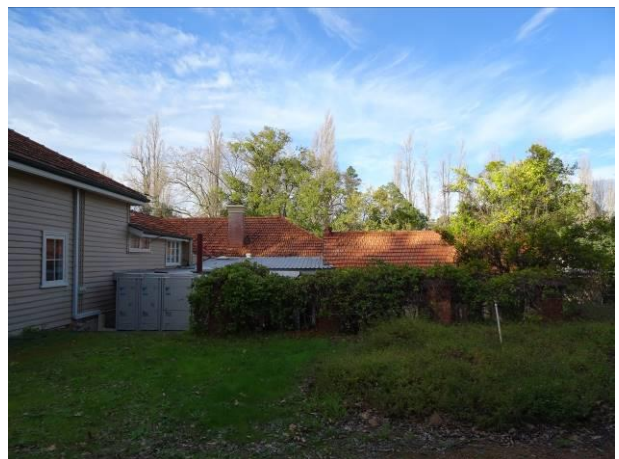
Figure 28 West facade

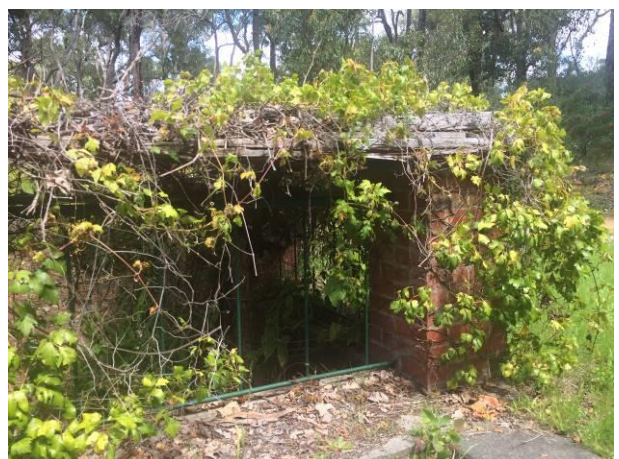
Figure 33 view over the open air dining room

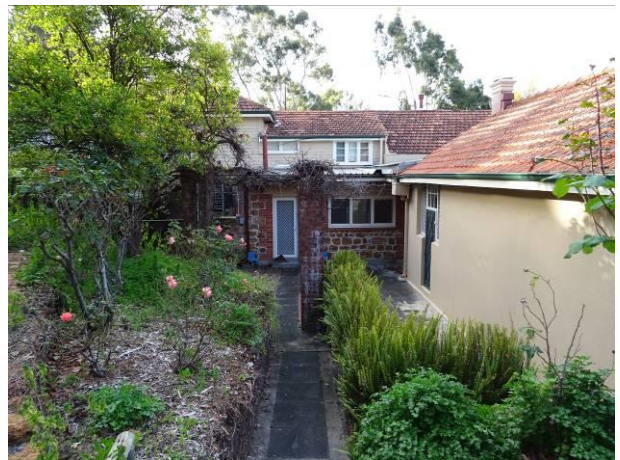
Figure 37 view looking north towards kitchen

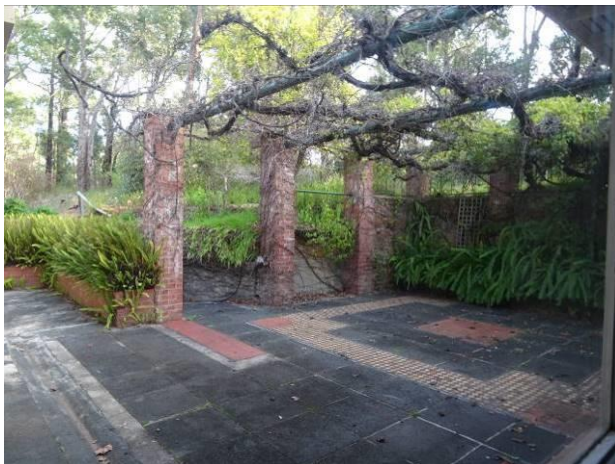
Figure 38 Courtyard with grape vine

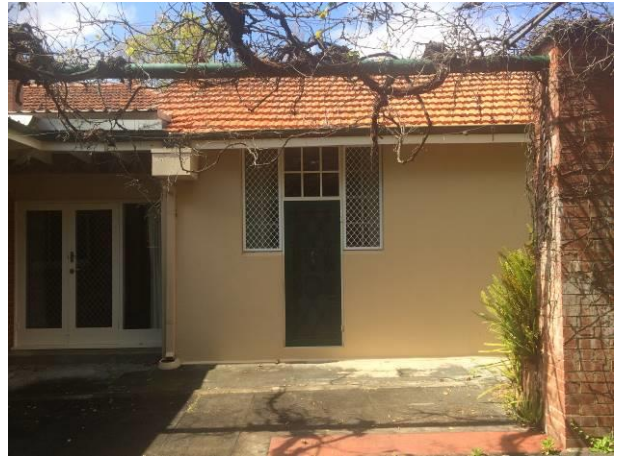
Figure 41 west facade

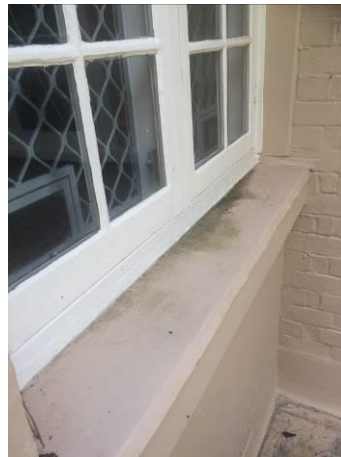
Figure 43 pressed metal capping to sill

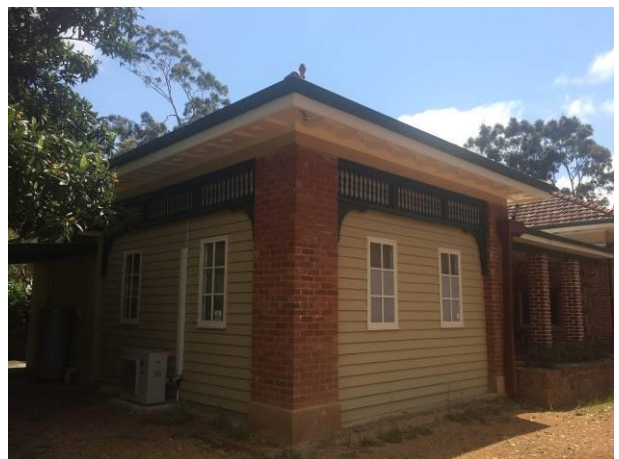
Figure 45 South elevation

| SOUTH | <ul style="list-style-type: none"> <li>Patch minor cracking above existing opening</li> </ul> |

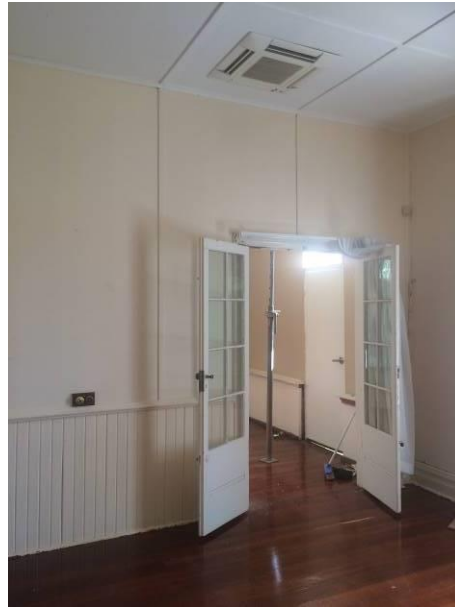
Figure 122 Bed 8, west wall

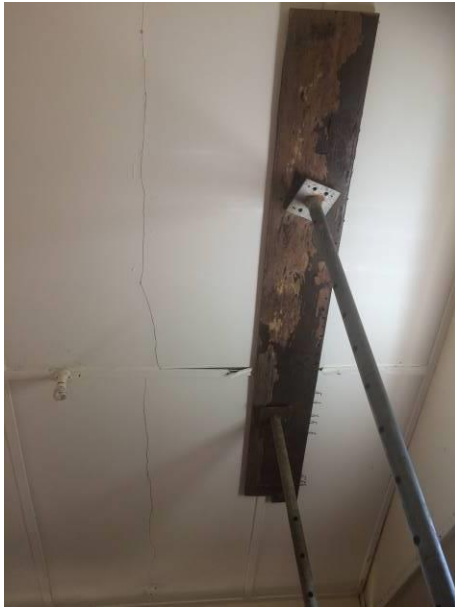
*Figure 127 Sunroom, ceiling*

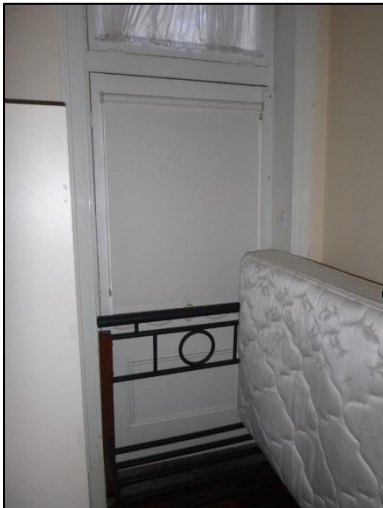
Bedroom 2 with no internal latch side and steps externally

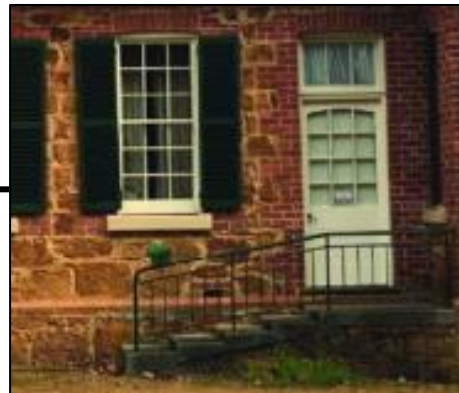
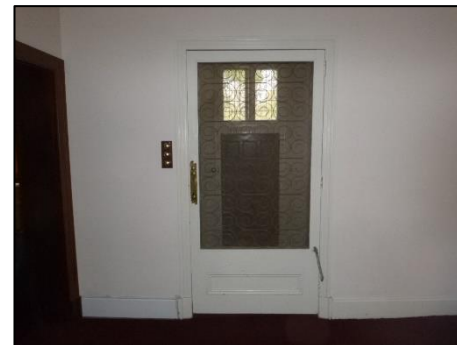
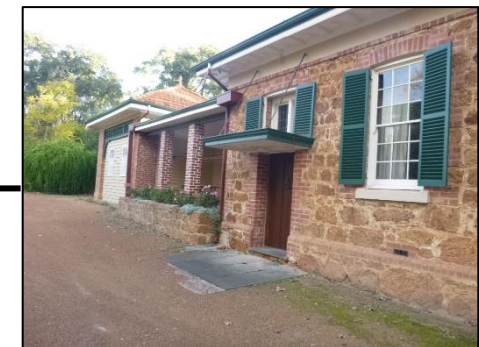
| Entrance name | Existing condition - Clear open door width with door leaf retained | Gap or opening when leaf and door stop are removed | Int / ext door circulation space is achieved with current door swing | Lip / Step | Comment<br><br><u>Legend:</u><br>* AS1428.1 2009 Clause 13.2 (850mm)<br>** AS1428.1 2001 (800mm)<br># AS1428.1 2009 Figure 31 |
|---|---|---|---|---|---|
| Main Entry | | | | | <p>Locked and not assessed.</p> <p>Steps located between the internal and external doors.</p> <p>This entrance could be retained, so long as a comparable / accessible method of access is also provided.</p> |

Main entrance, with steps internally (within the entrance lobby)

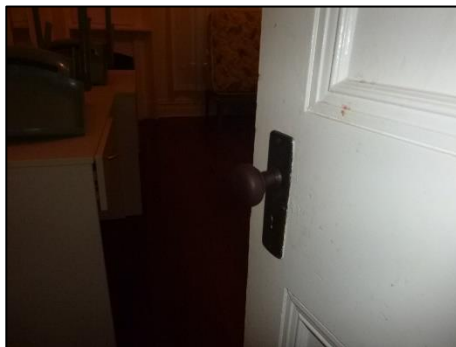
A knob style handle is non-compliant. Further consultation may be necessary if these are deemed an essential heritage element to be retained.
